Town of Amherst
Planning Advisory Committee Meeting
Agenda

RE: Recommendation of 19 Spring Street, Amherst, NS (PID: 25031626)

To: Planning Advisory Committee
From: Emily Wainwright, Dangerous and Unsightly Premises Administrator
Date: September 23, 2024
Re: Recommendation of 77 Station Street (PID 25124017)

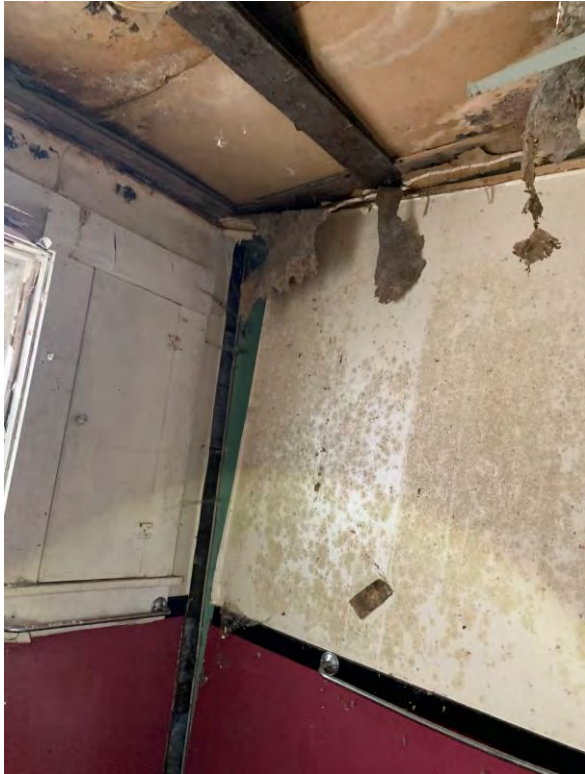
Significant water damage to main floor kitchen.

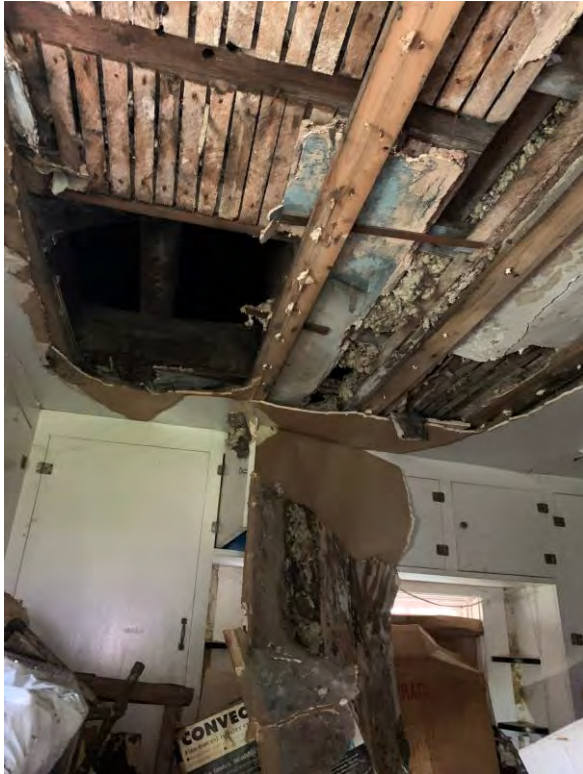
Significant water damage to main floor kitchen.

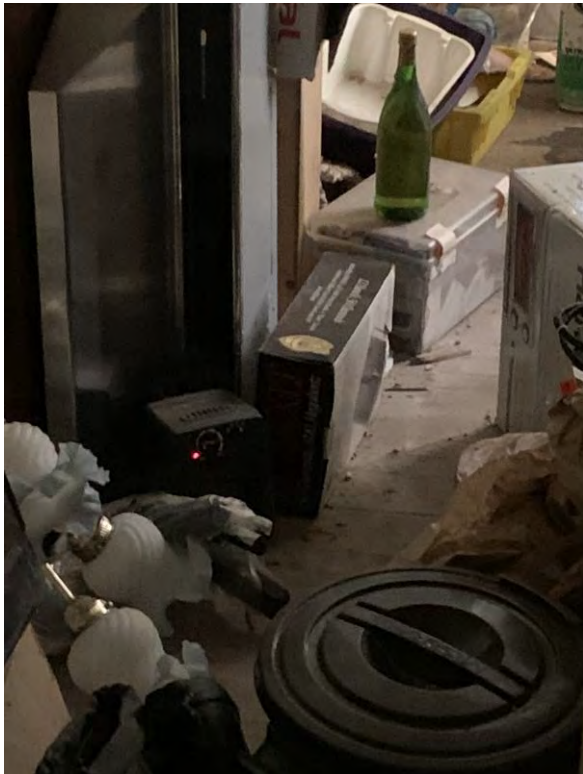
Space heater on and running.

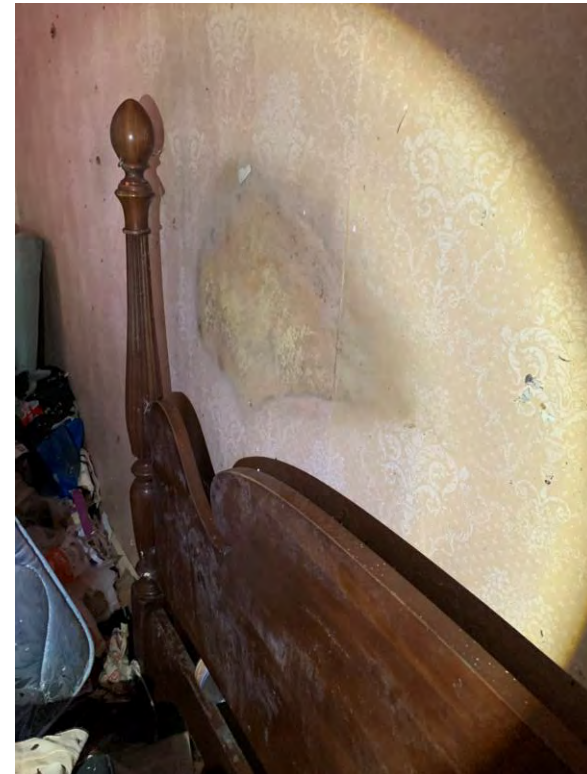
Second-floor bedroom. Light appeared to scorched wallpaper.

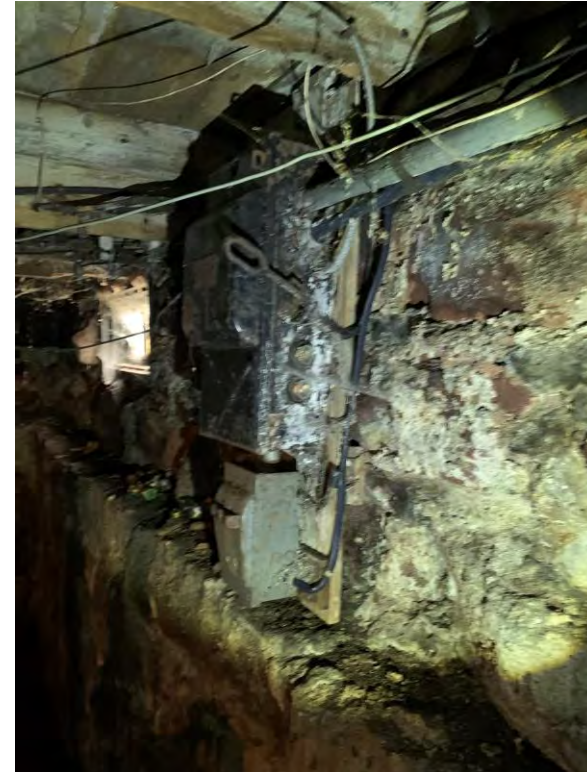
May 30, 2024 Invoice received from electrician noted:
Inspection found dangerous wiring through home. Knob and tube wiring present and bare copper exposed and live. Main switch gear found to be very poor condition. Overall electrical is about a 1/10 conditions and has many hazards present.

Basement: Main gear box in extremely poor condition. Accessible through occupied unit

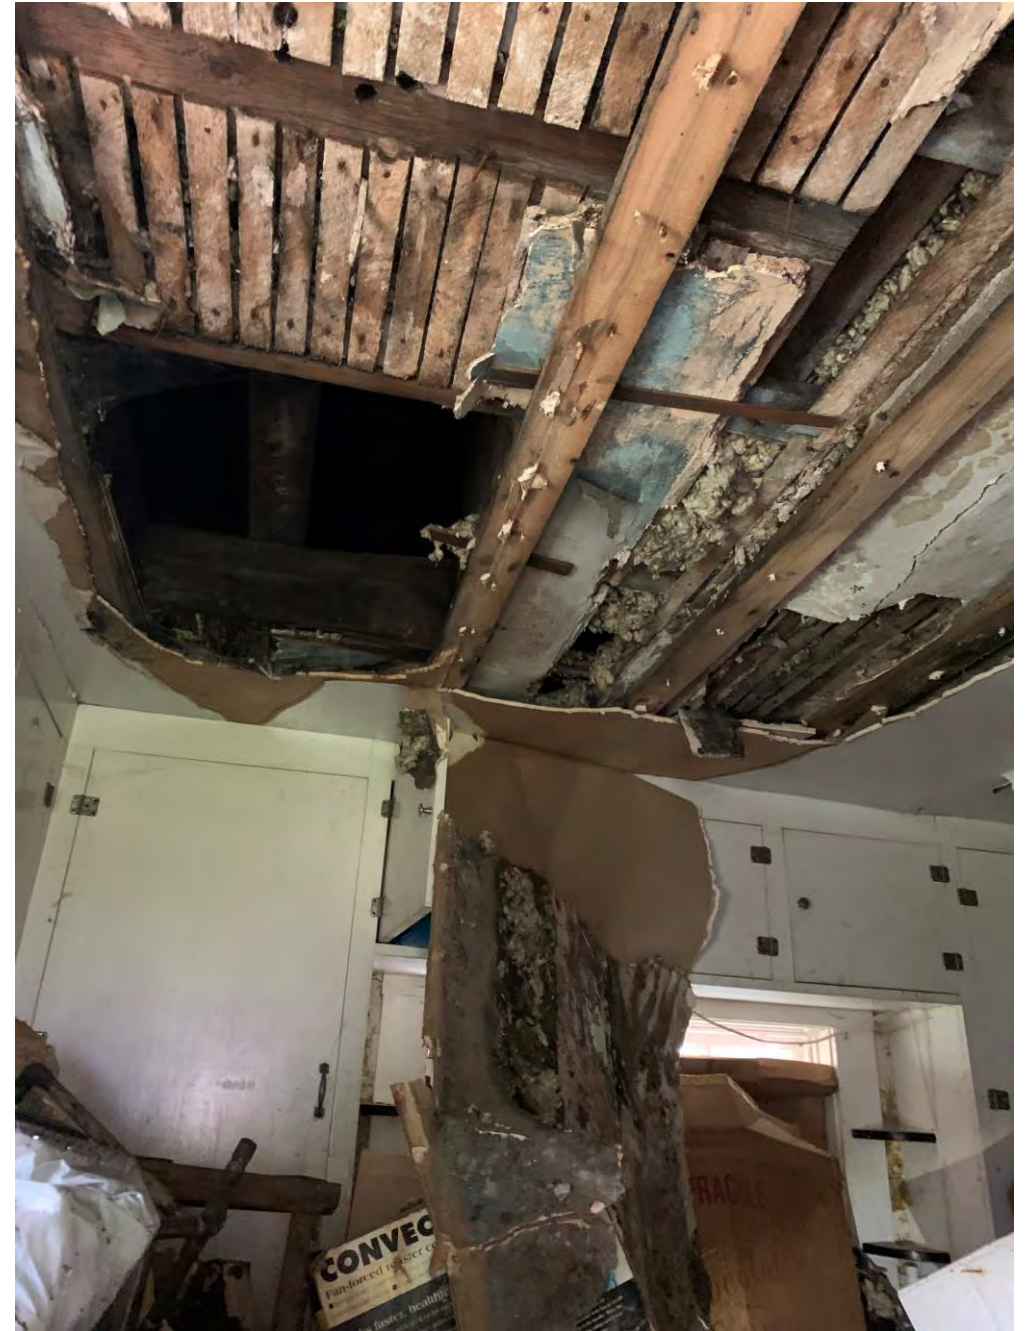
Interior wall has separated from exterior wall

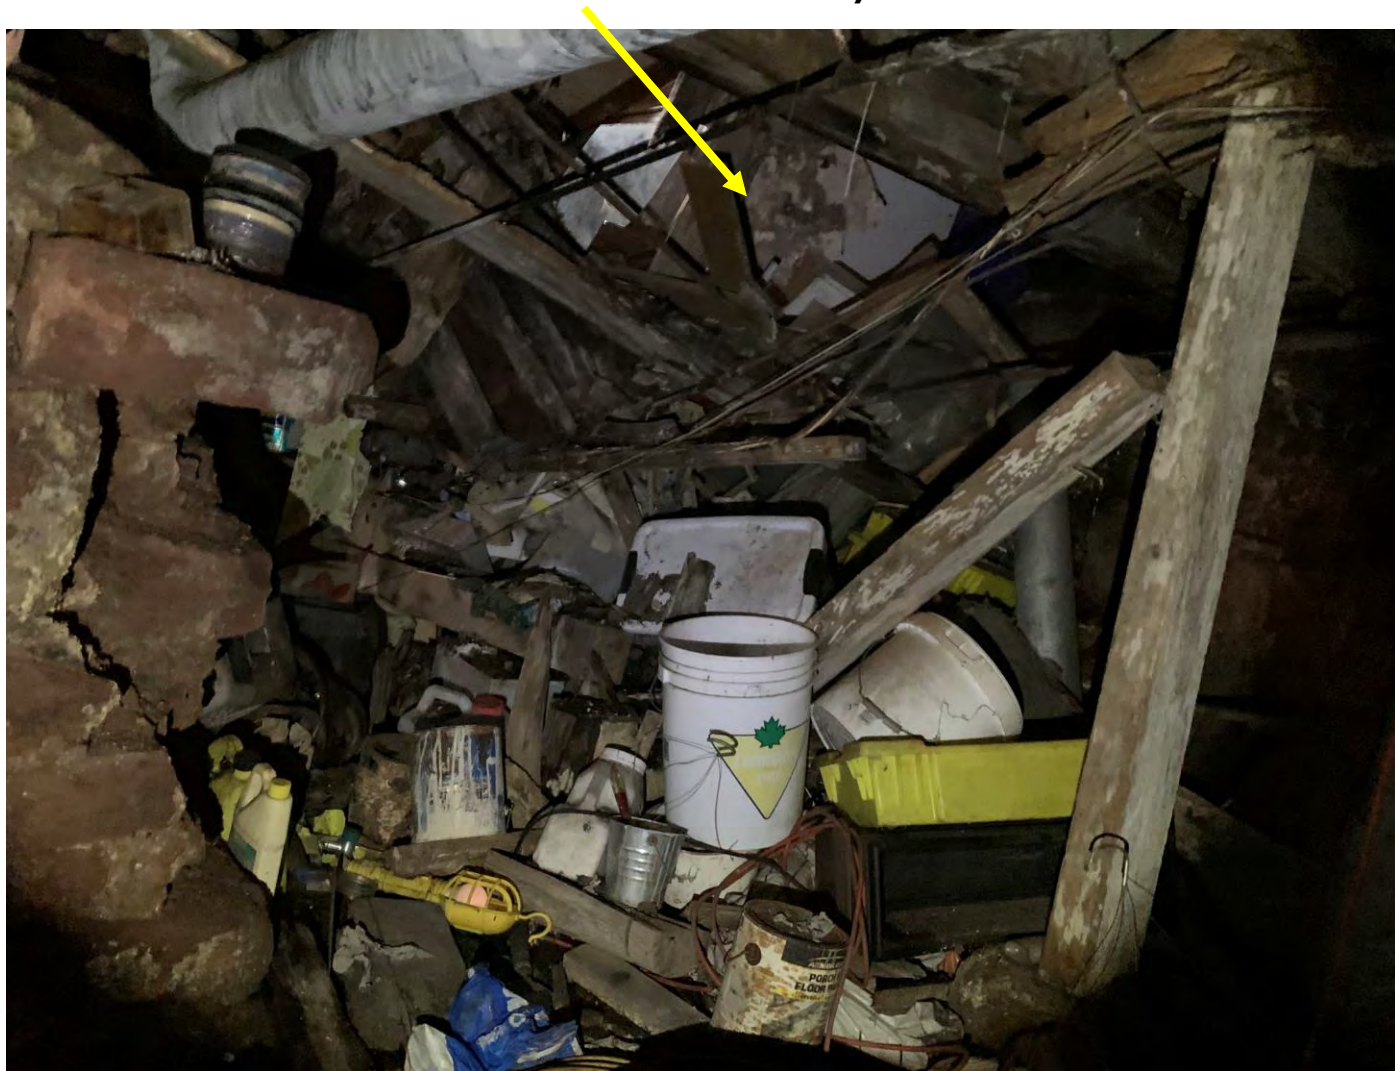
**Kitchen has collapsed into basement
and little to no floor remains (refrigerator
has fallen into the basement)**

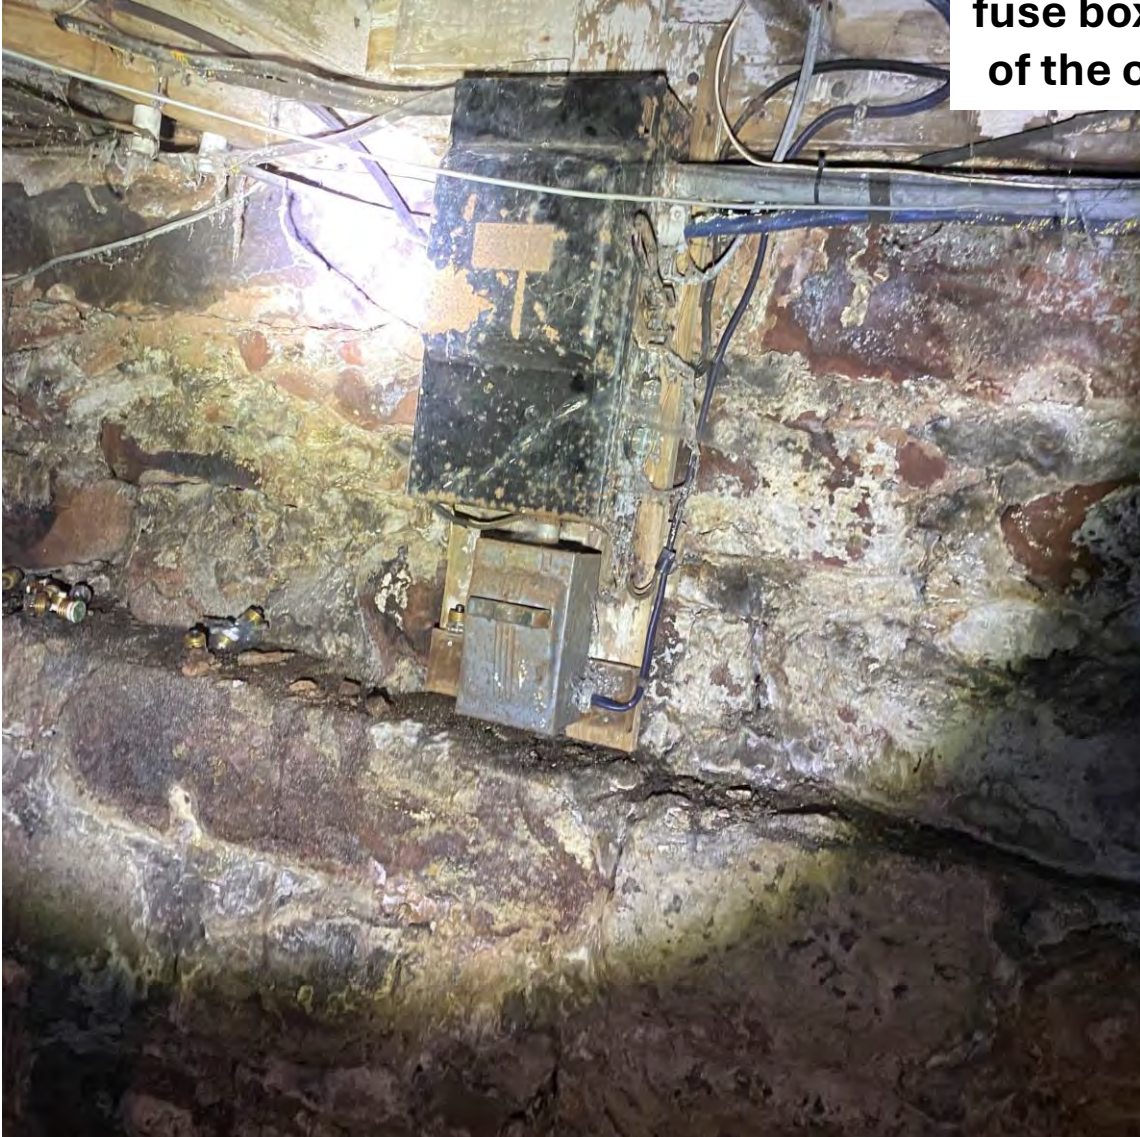
Main gear switch and fuse box in basement of the occupied unit

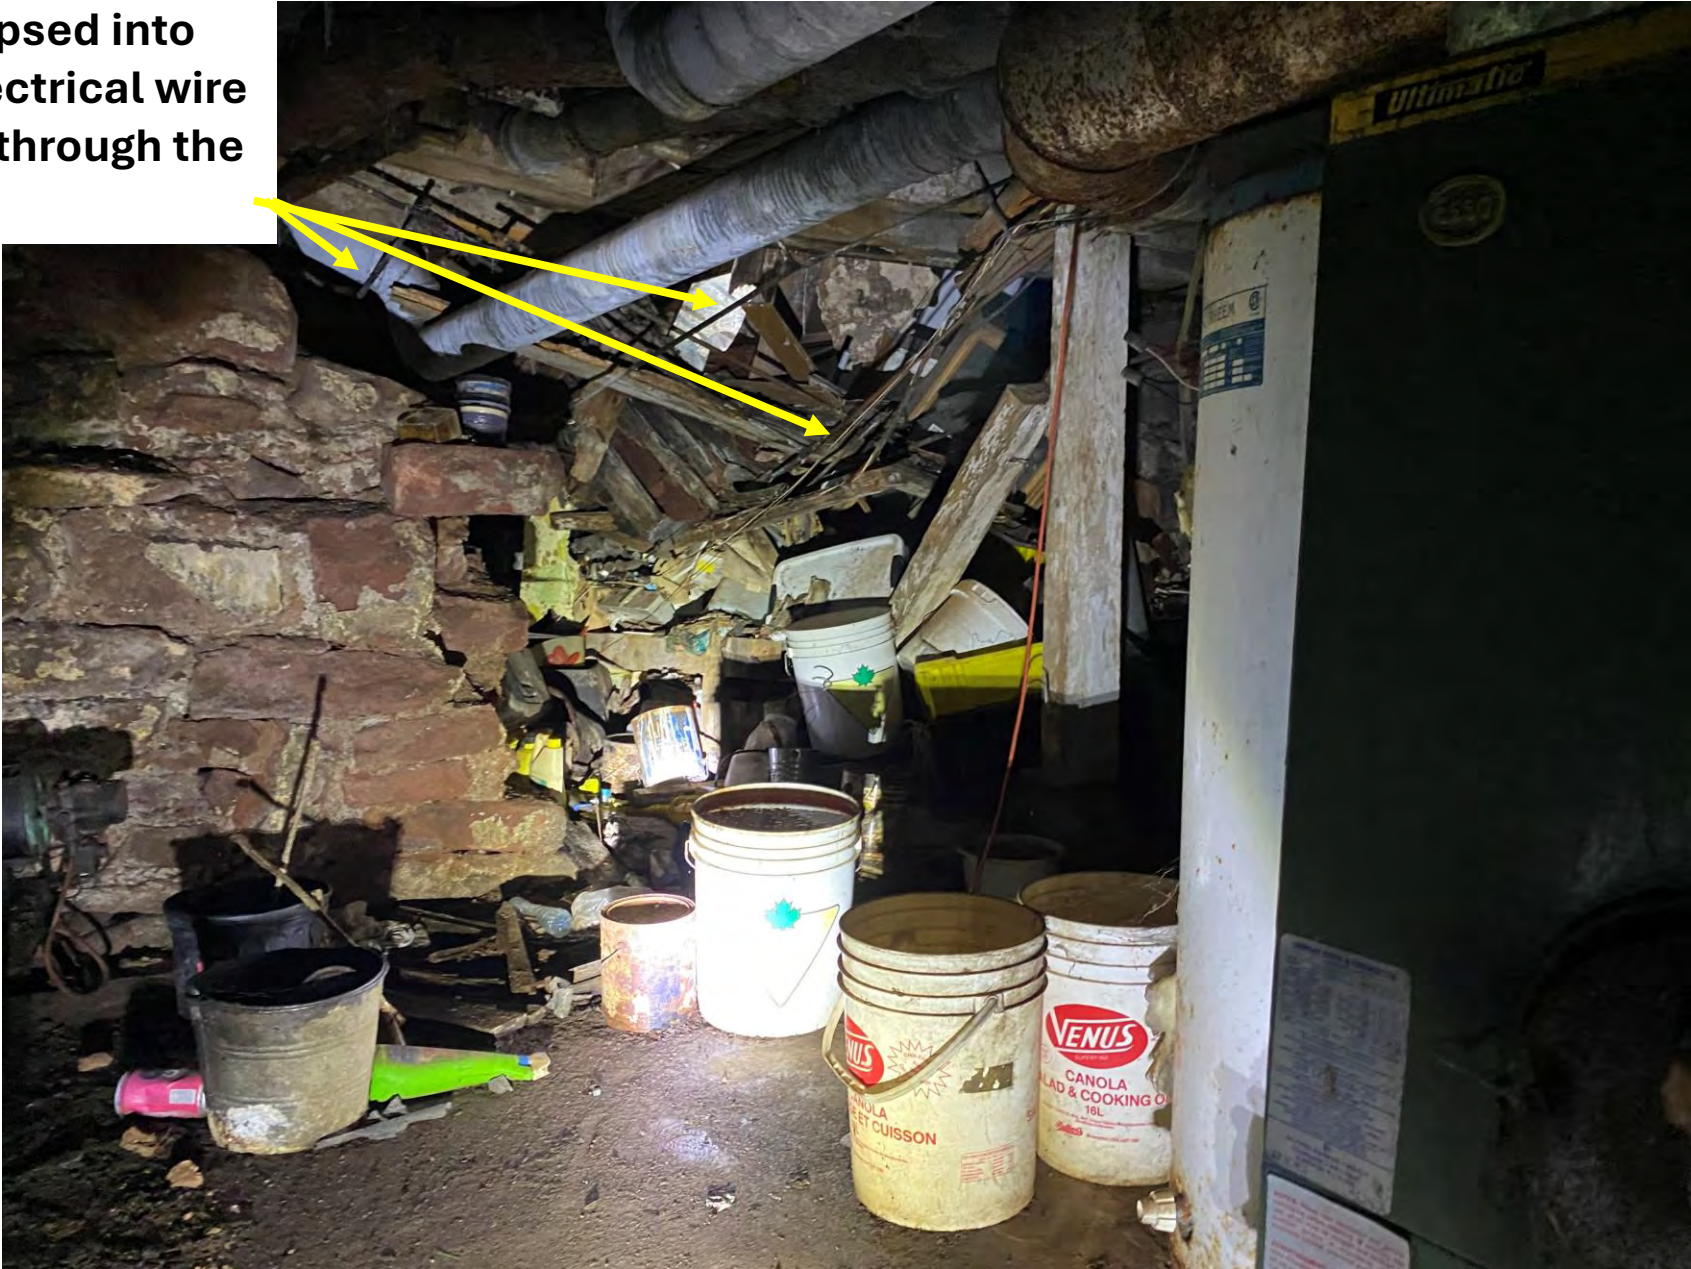
Kitchen has collapsed into basement. Many electrical wire and water lines run through the debris.

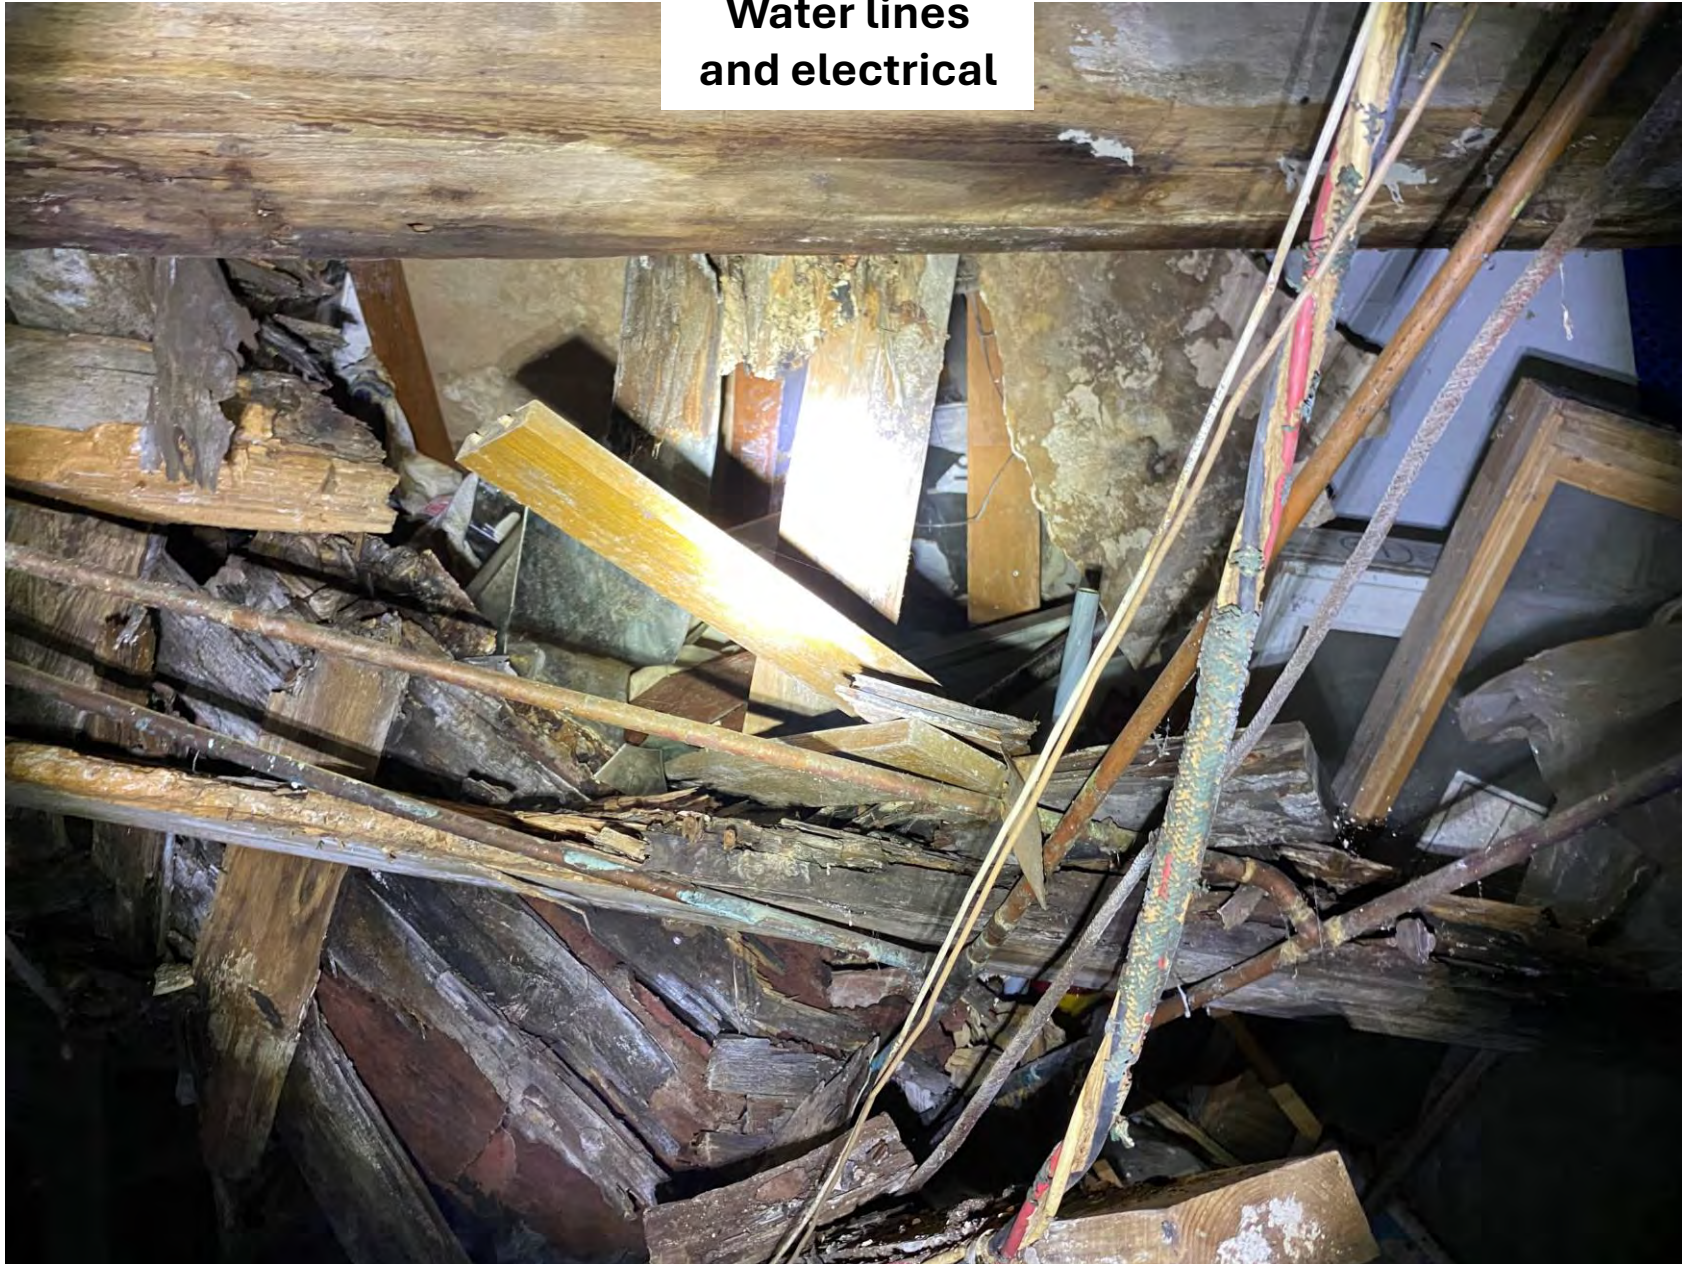
**Water lines
and electrical**

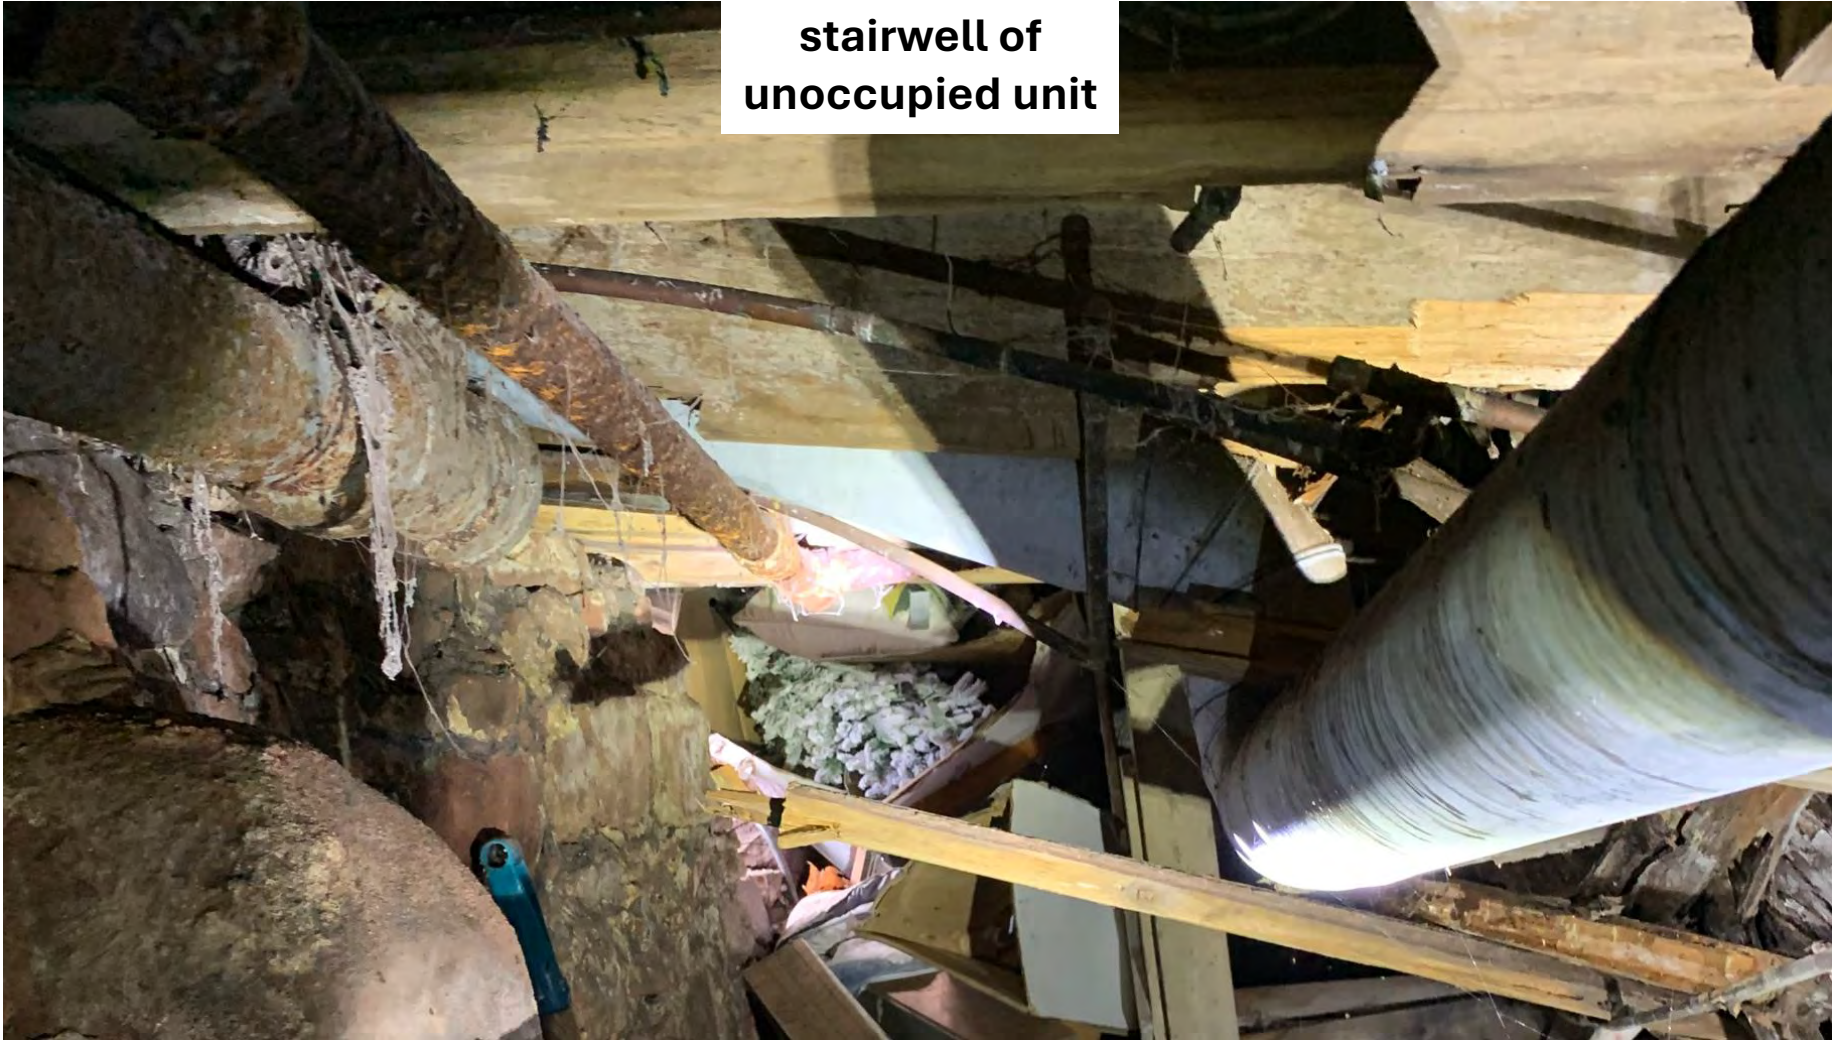
**Basement
stairwell of
unoccupied unit**

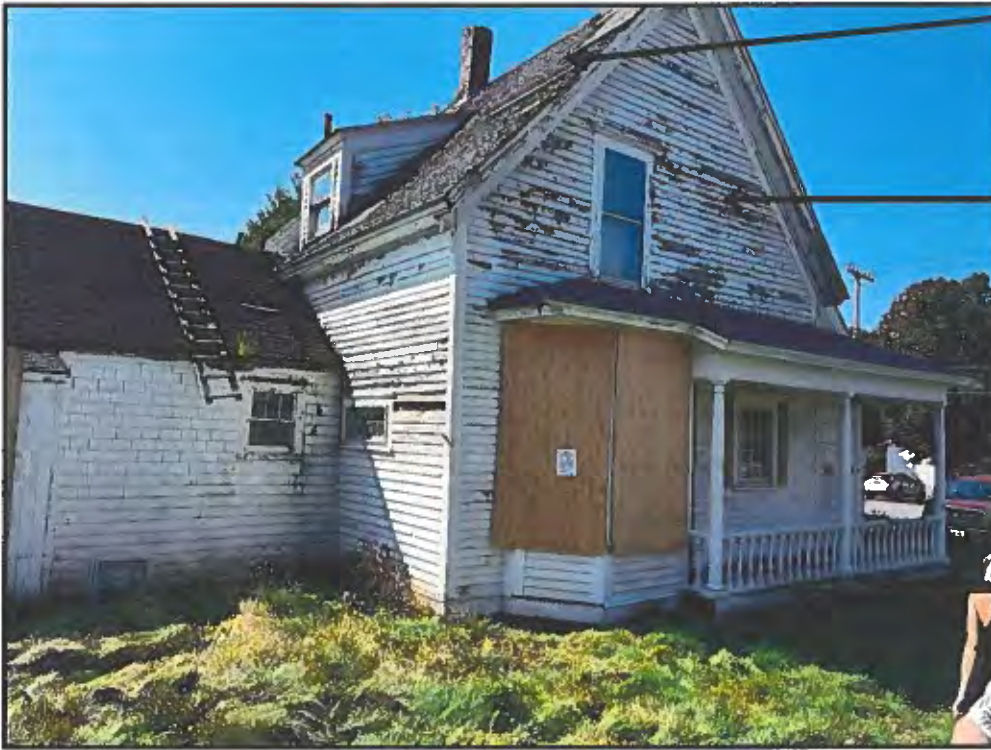
Damaged & missing roof shingles

Damaged and missing siding

Roof and walls are bowed with many broken structural elements indicating that the building is experiencing significant and active structural failure

Necessary replacement of all doors and windows to meet code standards

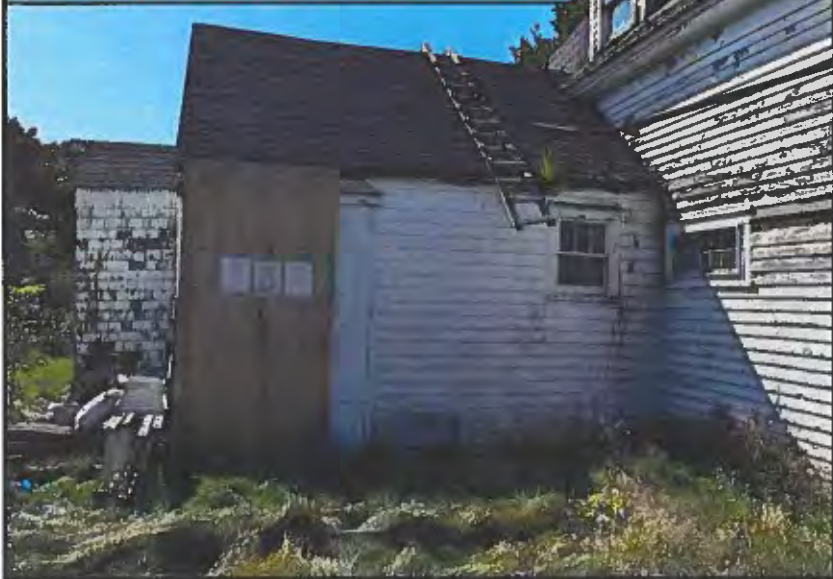
Deteriorating chimney

Damaged roof shingles

Damaged and missing siding

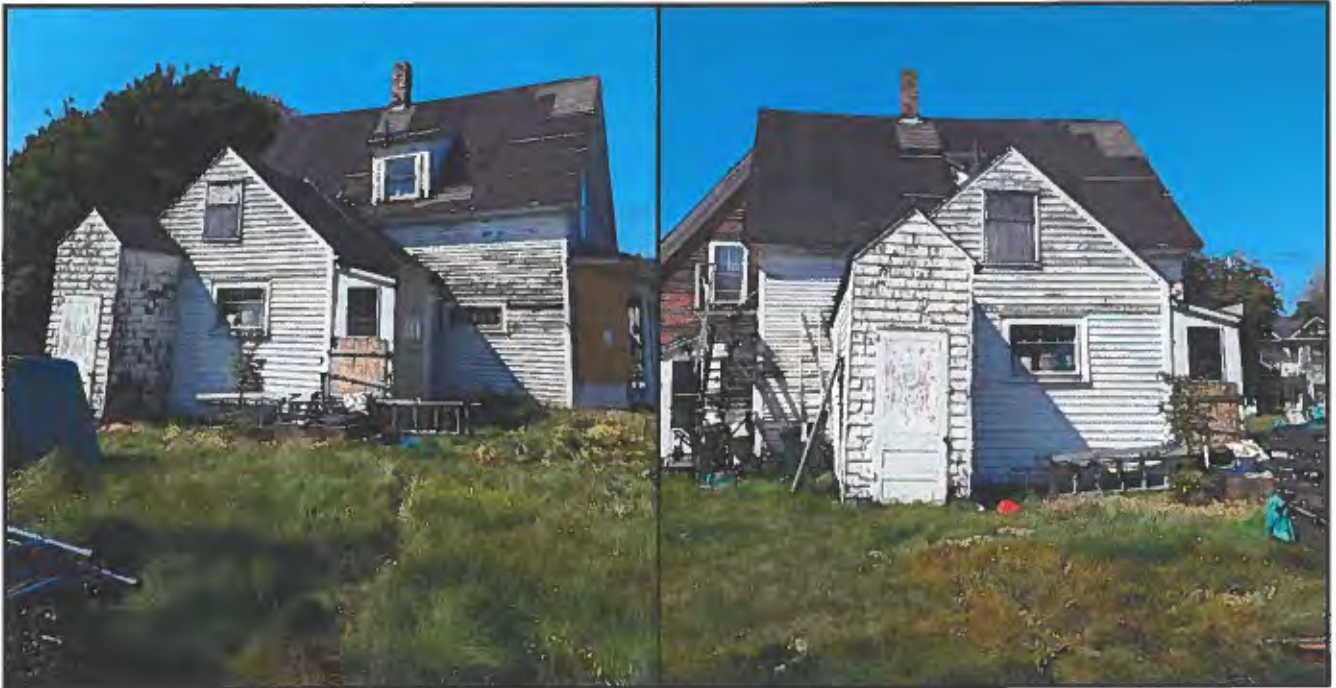
**Damaged eaves
and soffits**

**Damaged and
missing siding**

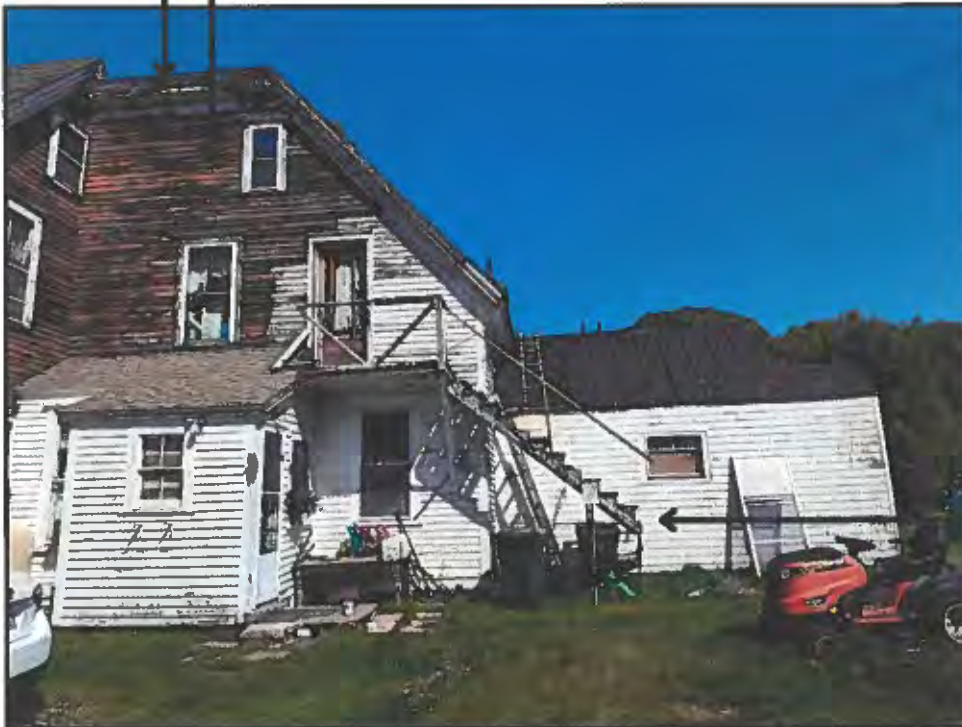
**Extensive
deterioration of
the second-floor
deck and stairs**

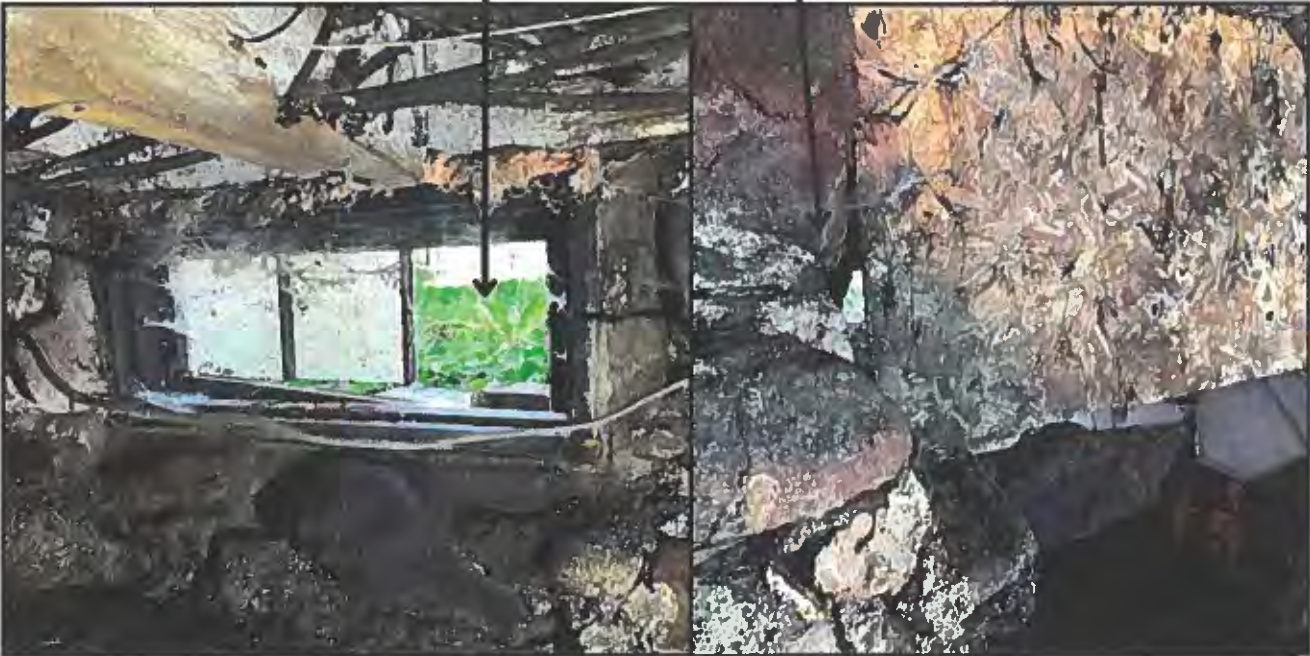
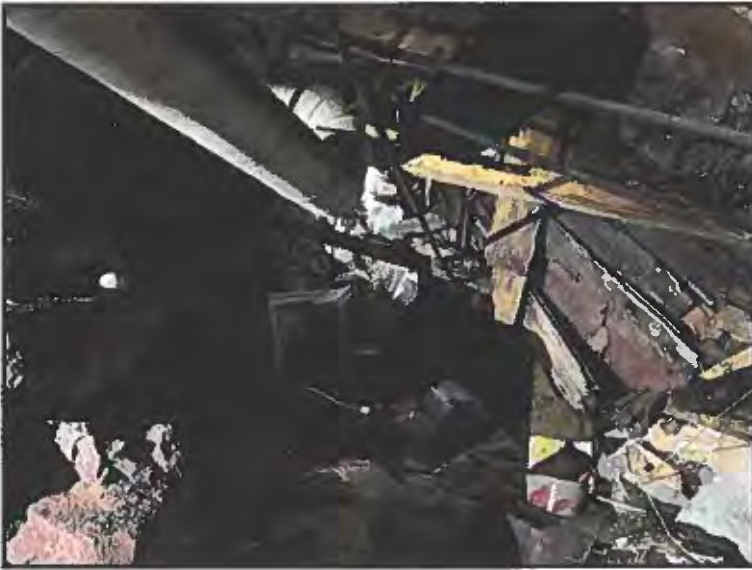
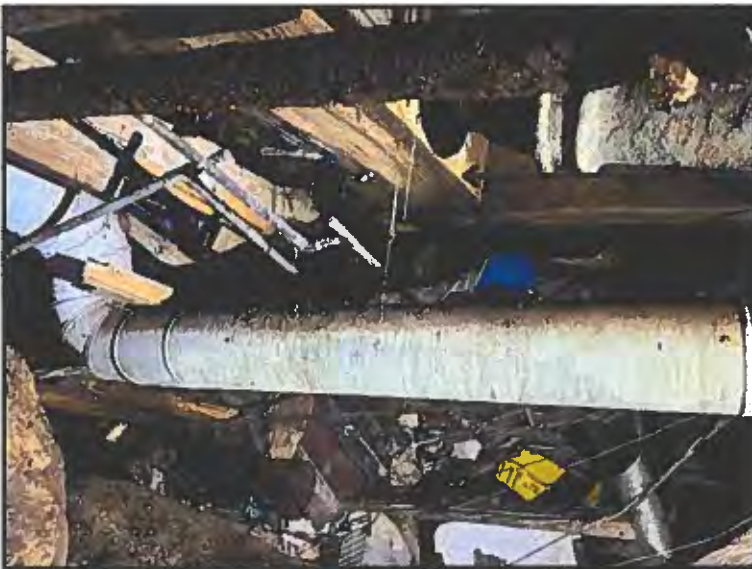
All three images show large section of floor above has collapsed into basement causing significant structural damage, damage to mechanical and electrical services and leaves structure above highly unstable.

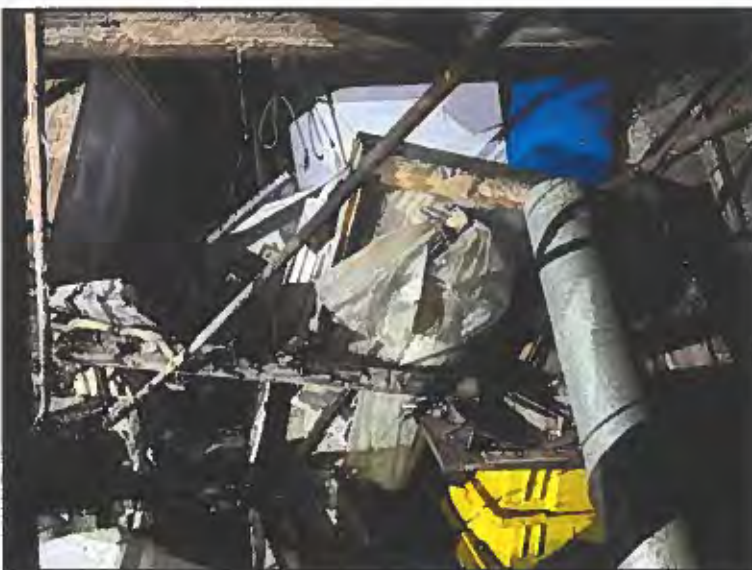
Significant amount of personal belongings and debris, some of which appear to be supporting collapsed floor and structural elements. Removal of this material may trigger further structural instability and potential collapse of the surrounding areas.

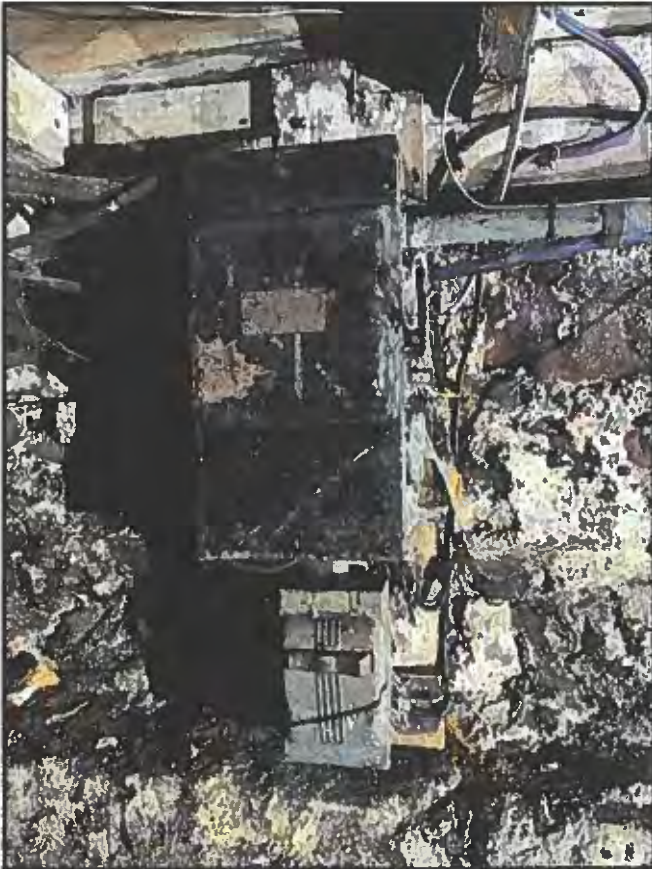
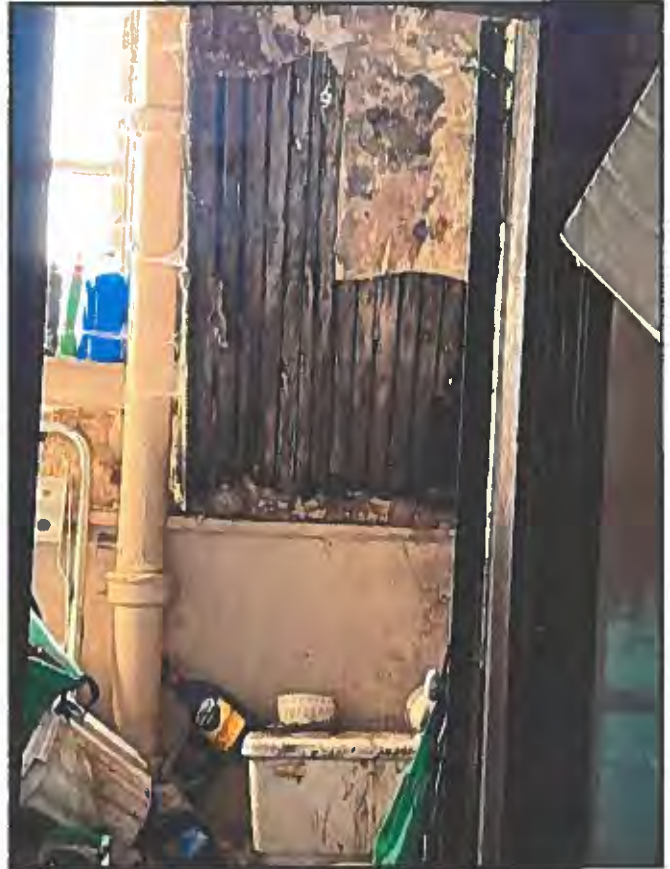
Outdated main power entrance, all electrical needs to be replaced to meet current code standards.

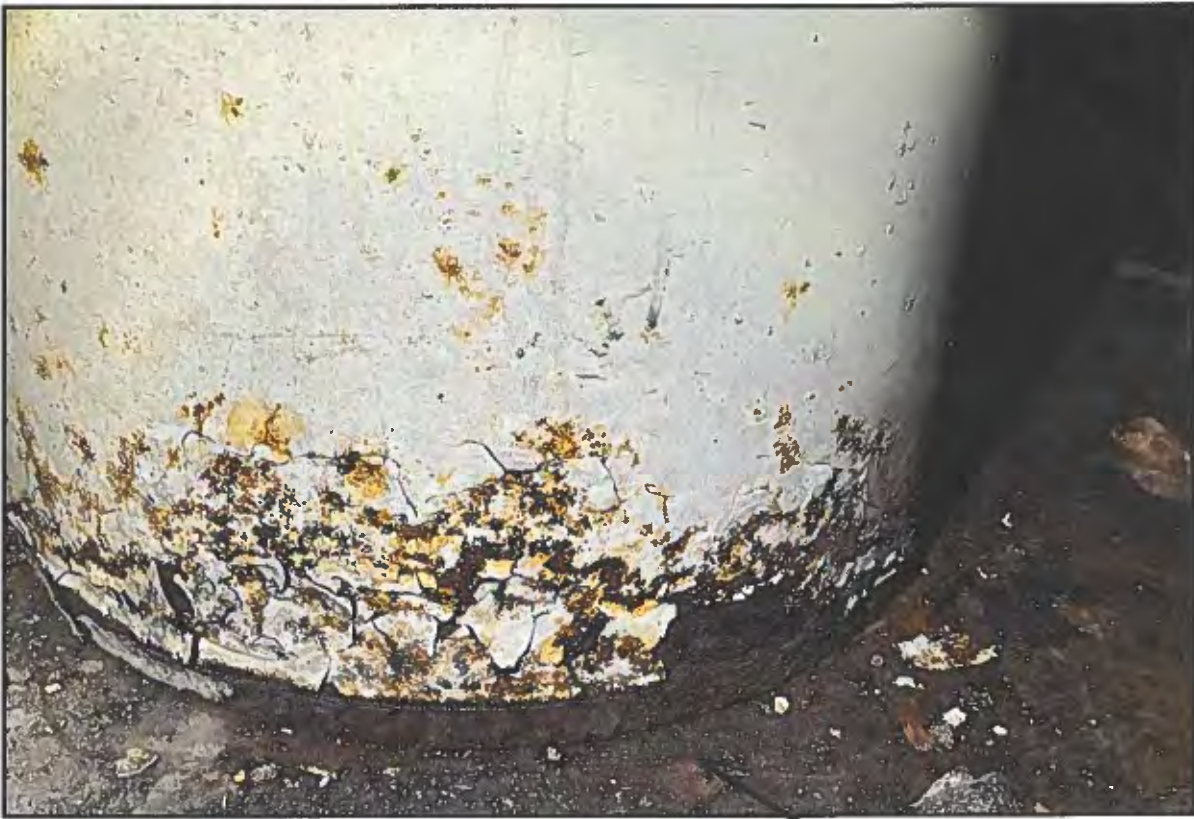
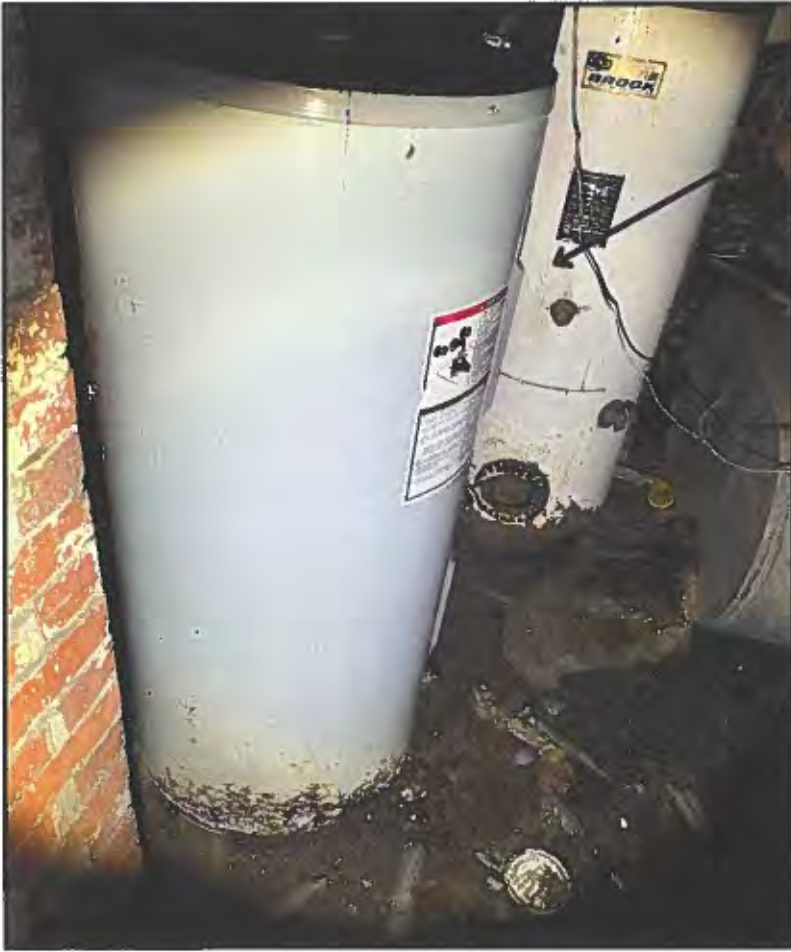
Failed plumbing and plumbing fixtures. All plumbing needs to be replaced to meet current code standards.

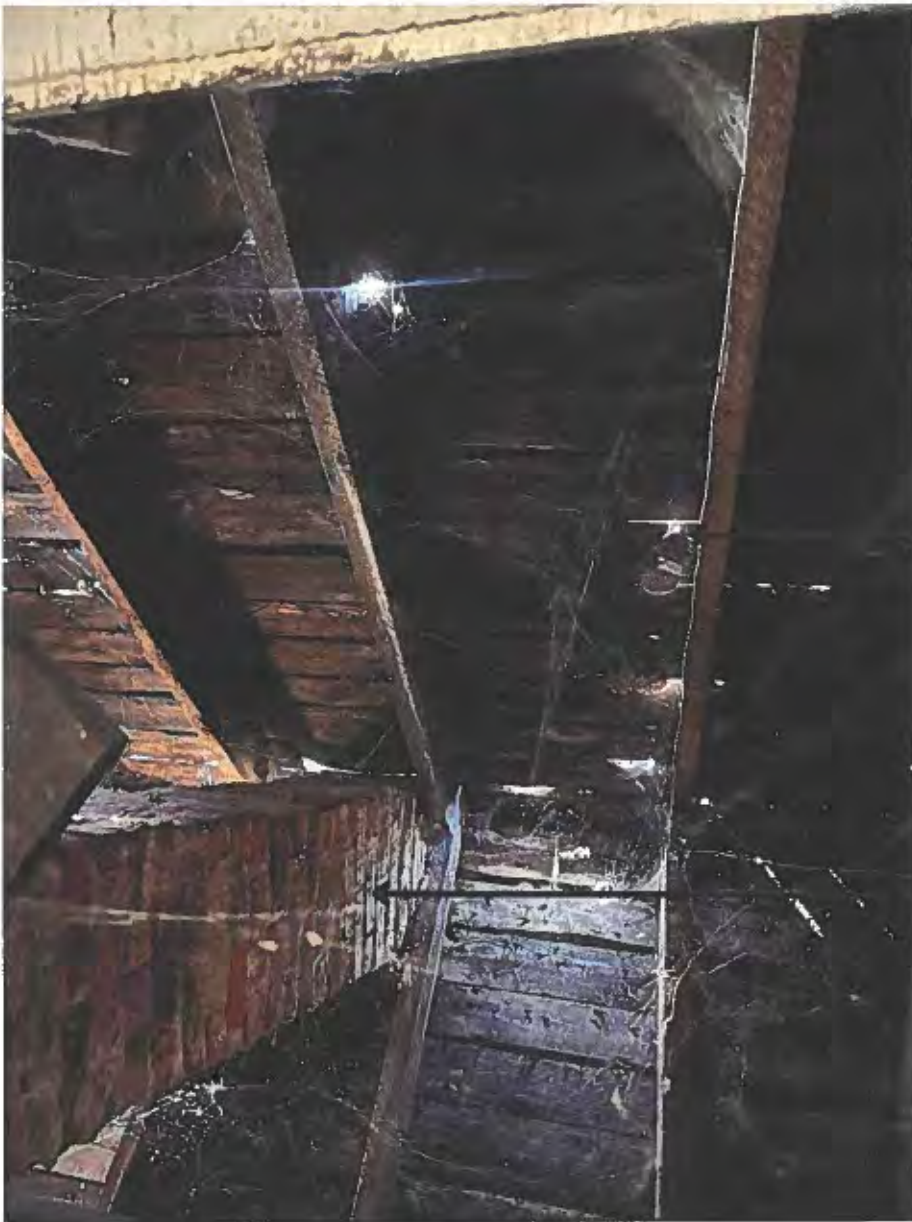
**Visible holes
through majority
of roof**

**Deteriorating
chimney**

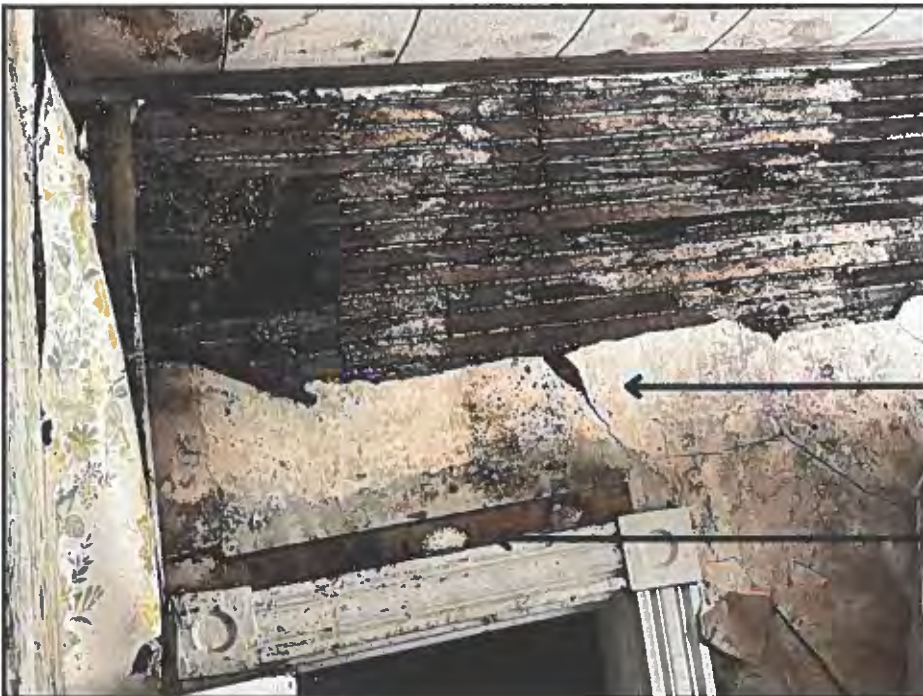
Years of unaddressed water damage in walls and ceilings

Numerous cracks in walls due to settlement

mold
