Town of Amherst
Planning Advisory Committee Meeting
Agenda

RE: Recommendation of 19 Spring Street, Amherst, NS (PID: 25031626)

To: Planning Advisory Committee
From: Emily Wainwright, Dangerous and Unsightly Premises Administrator
Date: September 23, 2024
Re: Recommendation of 77 Station Street (PID 25124017)

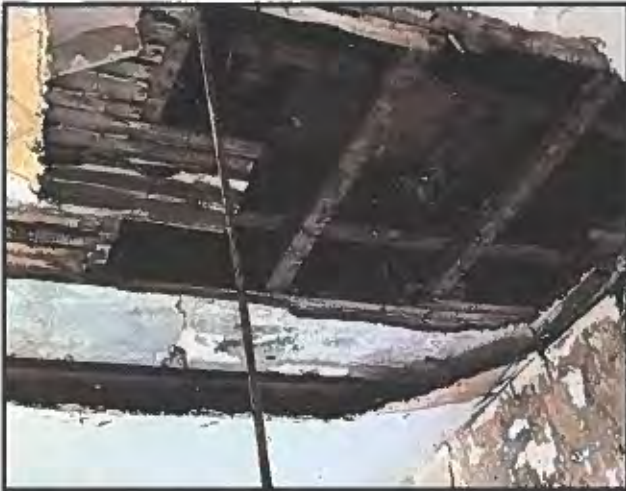
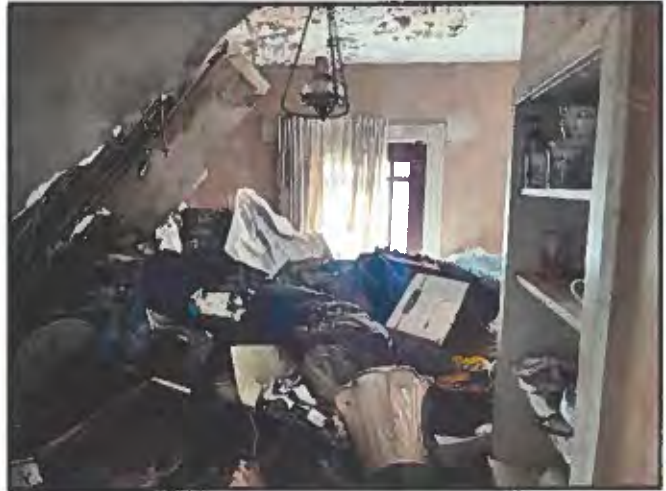
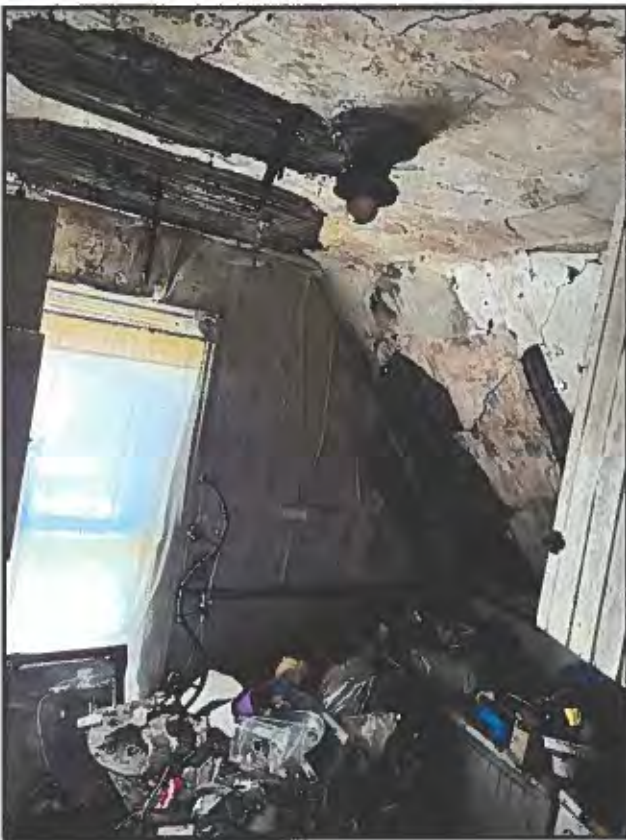
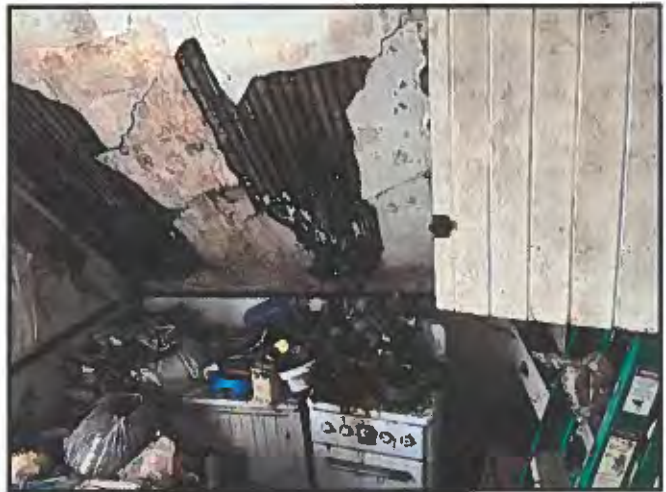
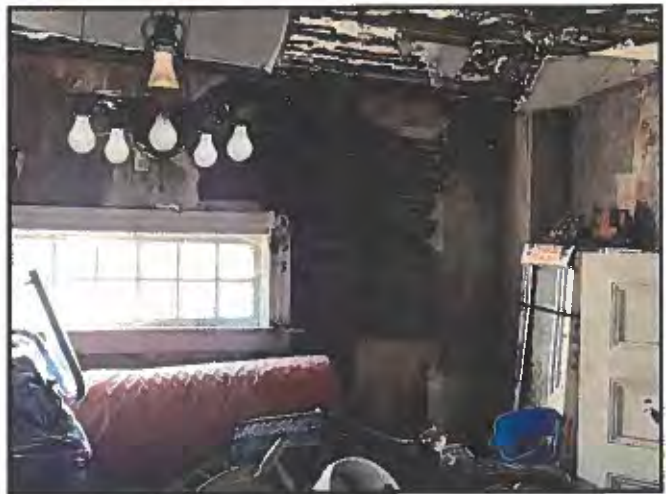
All images show extensive damage to interior finishes due to prolonged water damage, structural settlement, prolonged mold issues and the build up of personal belongings and debris causing multiple bio hazards. All interior walls, ceilings, floors, moldings, finishes, etc. will need to be replaced.

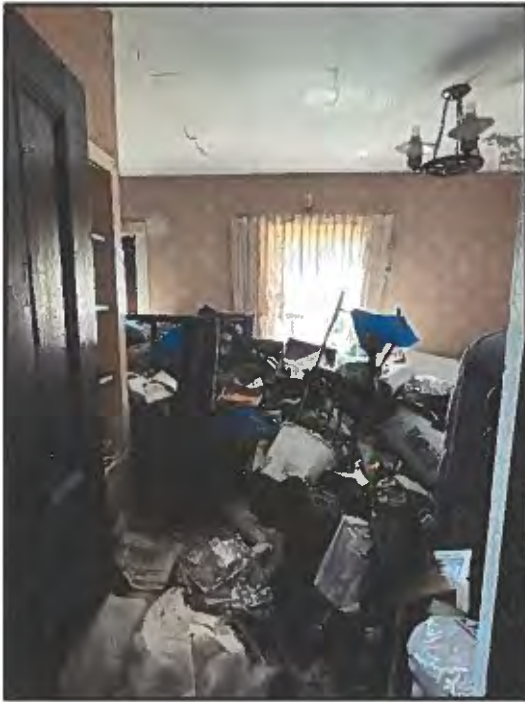
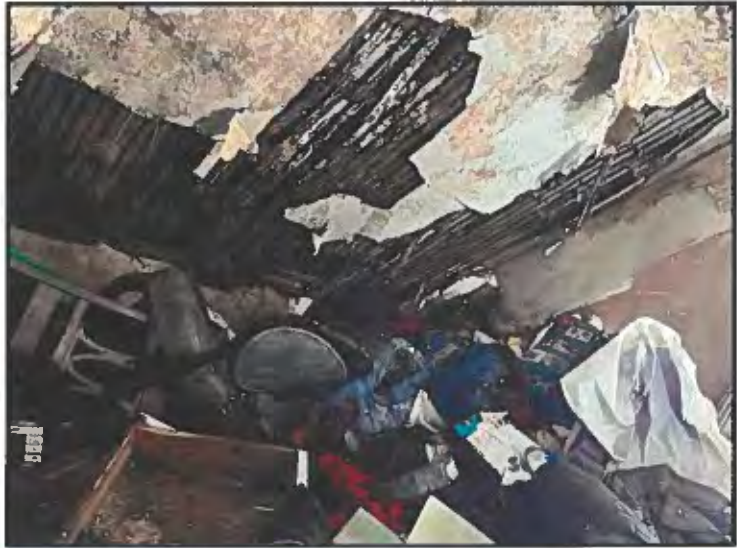
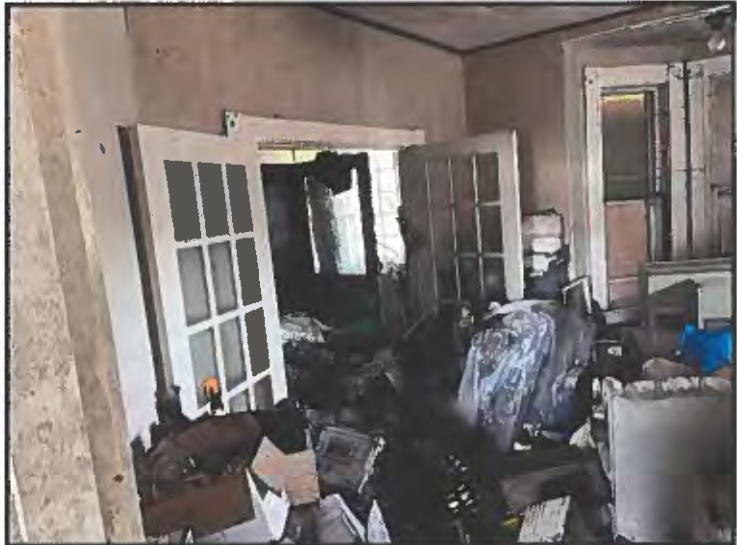
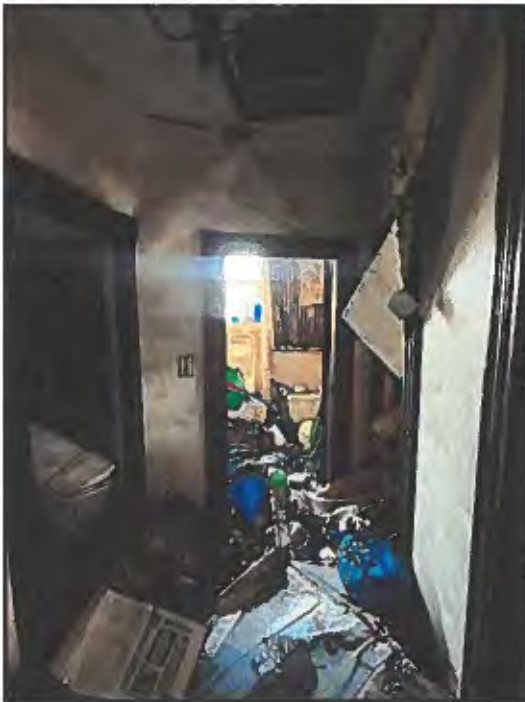
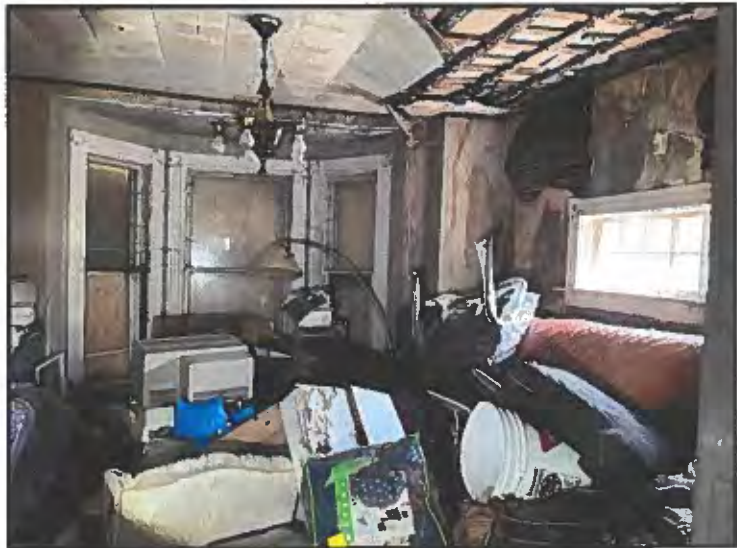
All images show extensive damage to interior finishes due to prolonged water damage, structural settlement, prolonged mold issues and the build up of personal belongings and debris causing multiple bio hazards. All interior walls, ceilings, floors, moldings, finishes, etc. will need to be replaced.

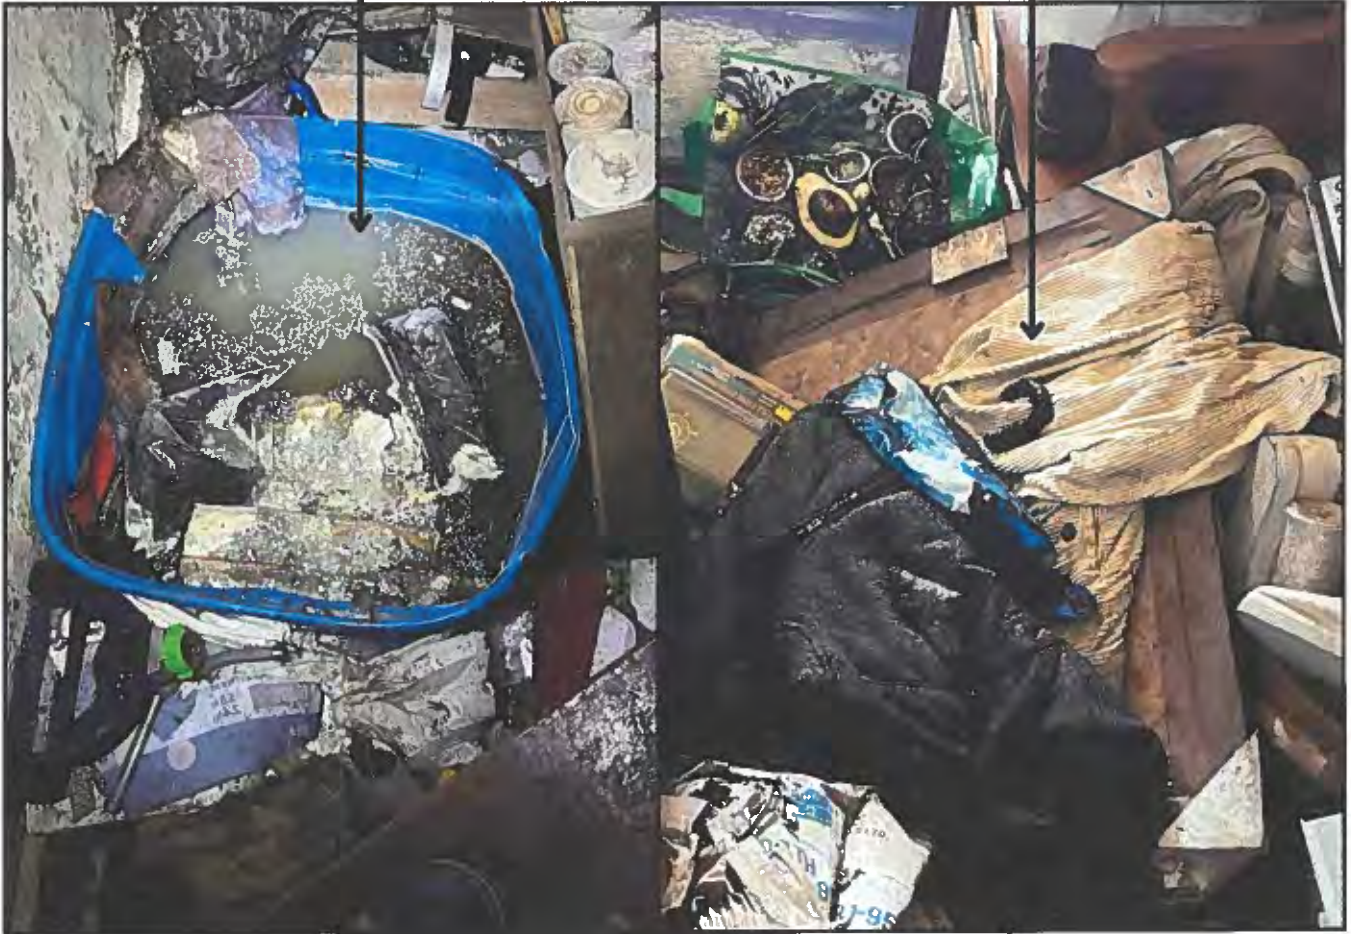
Significant amounts of personal belongings and debris on floors

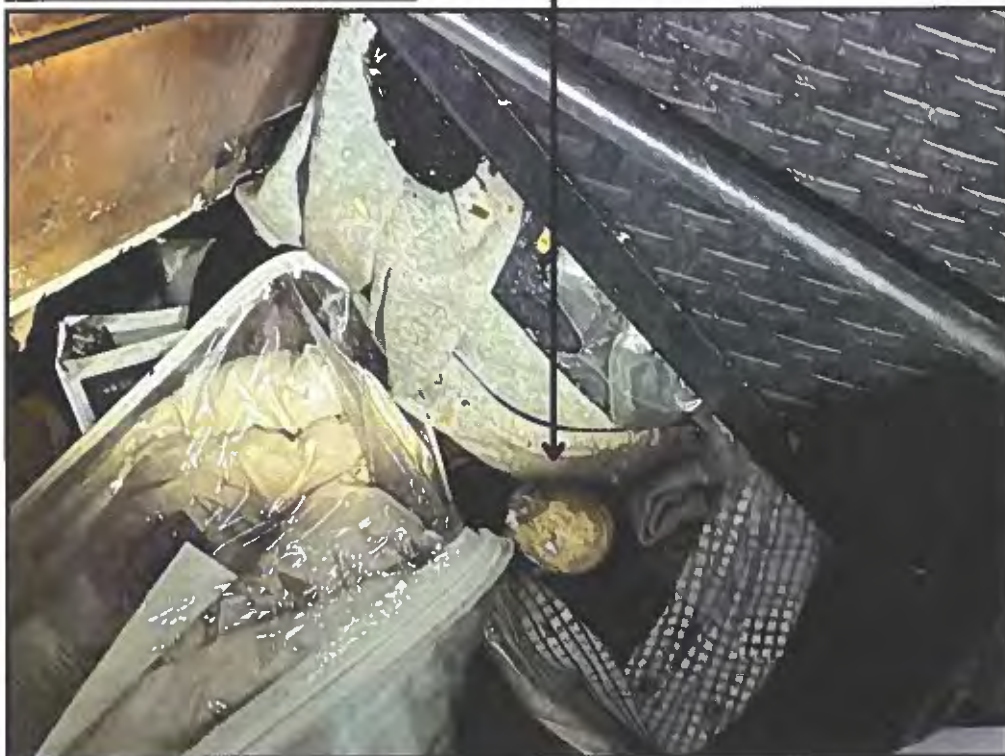
Outdated plumbing

Various bio hazards and mushroom growth
