# MEMO

To: Planning Advisory Committee  
From: Emily Wainwright, Dangerous and Unsightly Premises Administrator  
Date: September 2, 2025  
Re: Recommendation for Demolition of 8 Newton Avenue (PID 25024662)

TO: Planning Advisory Committee  
FROM: Marc Buske, Building Official 2  
DATE: August 26, 2025  
RE: Inspection - 8 Newton Avenue (PID 25024662)

# 8 Newton Avenue

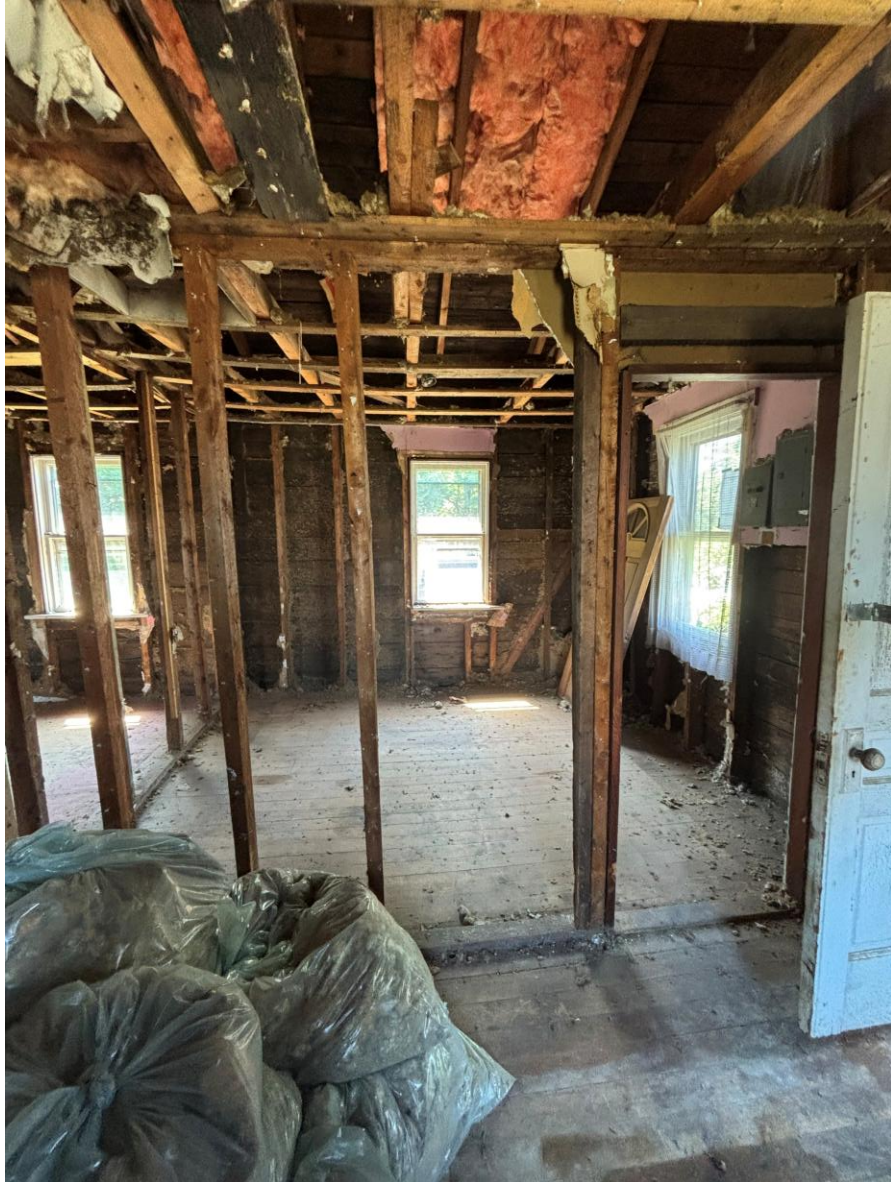
- There is no heating source.
- There are no water/sewer hookups (disconnected).
- The building significantly sags towards the middle (under the chimney) – possible sign of a broken center support beam.

- Floor System: The floor is sloping noticeably toward the center of the building. This movement is consistent with settlement due to the lack of a stable foundation. The slope indicates that beams, joists, and subfloor are significantly compromised.

Significant sag – possible broken support beam

1. Installation of an approved foundation that complies with the **National Building Code (2020)**;
2. Completion of a subfloor that complies with the **National Building Code (2020)**;
3. Completion of the exterior, including weathertight windows, doors, and siding; and
4. Installation of a weathertight roof and fascia.

At the time of inspection, the building could be rehabilitated, but only at considerable cost. Required work would include the construction of a new foundation system, installation of new beams, replacement of floor joists and subflooring, and complete reinstatement of mechanical, plumbing, and electrical systems.
