**Town of Amherst  
Planning Advisory Committee Meeting**

**Agenda**

**Re: PID # 25005729, 59 Church Street, Amherst, NS**

Re: Building Review, Corner of Church & Prince Arthur St., Amherst, NS/J49-07819

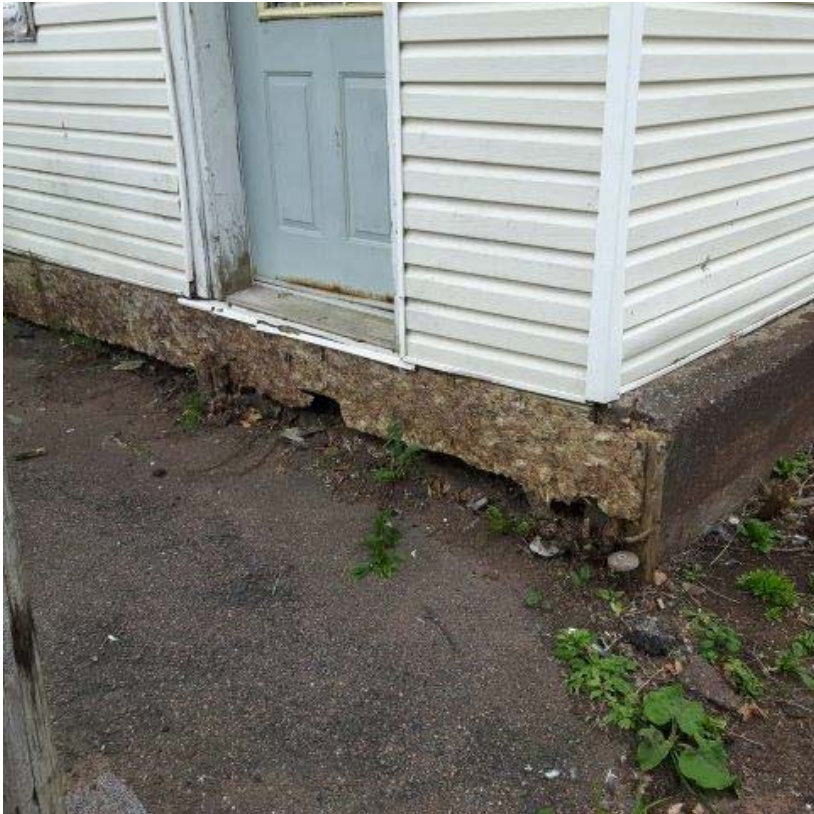
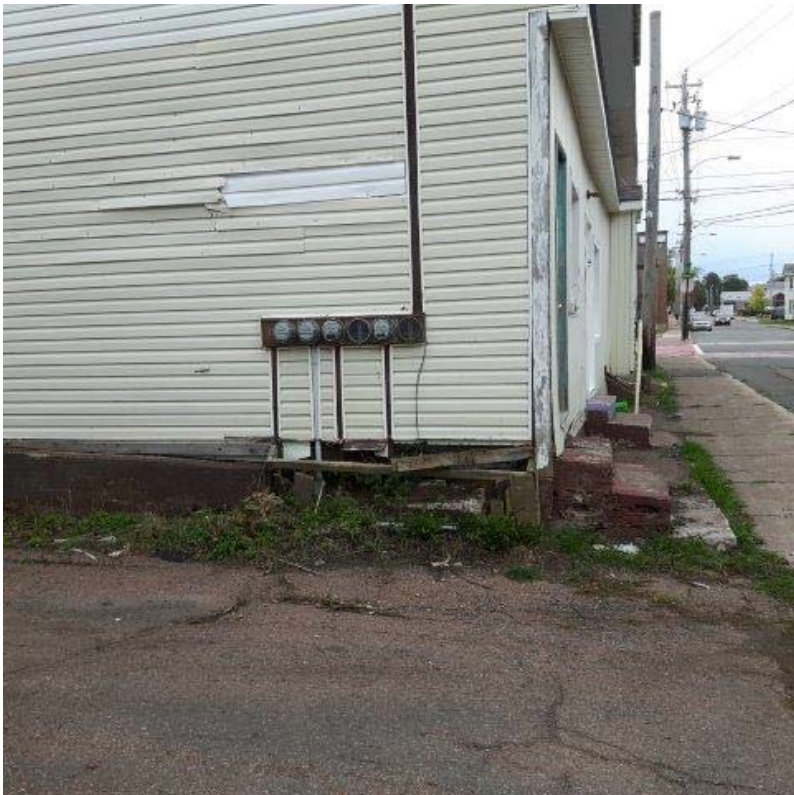
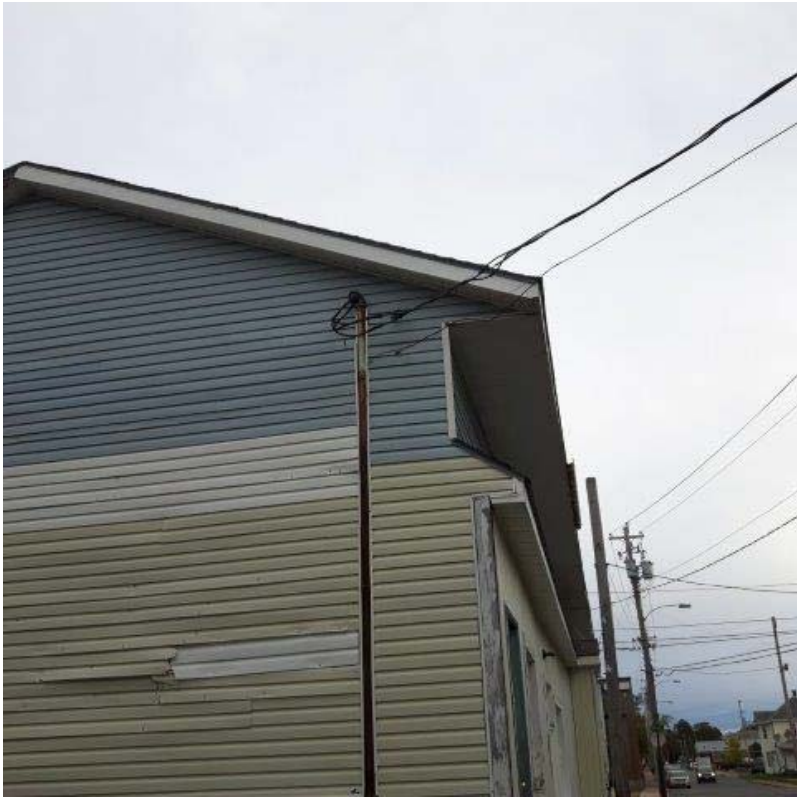
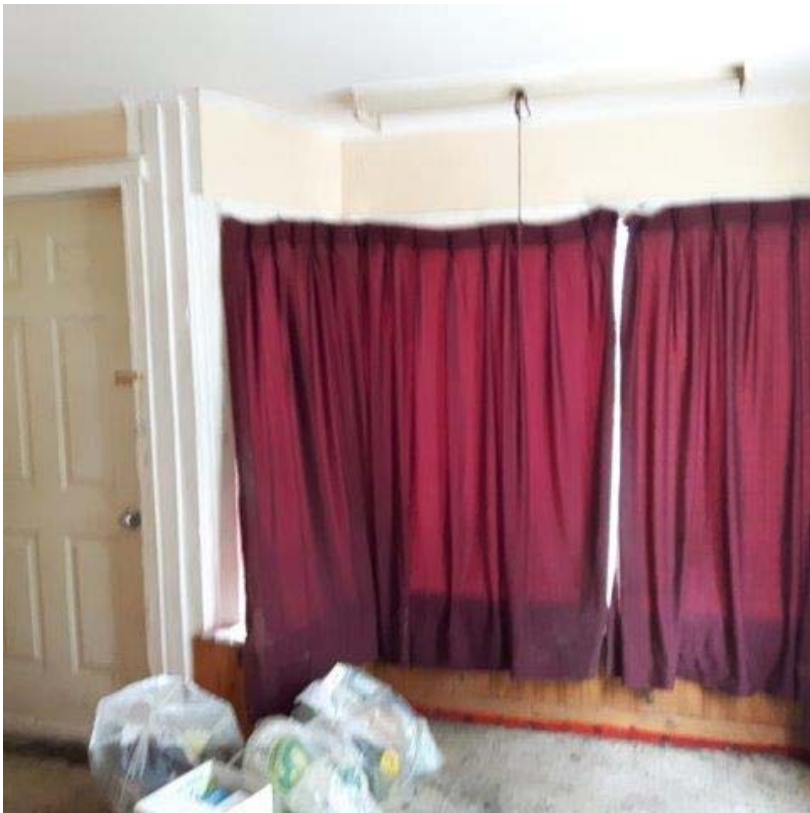
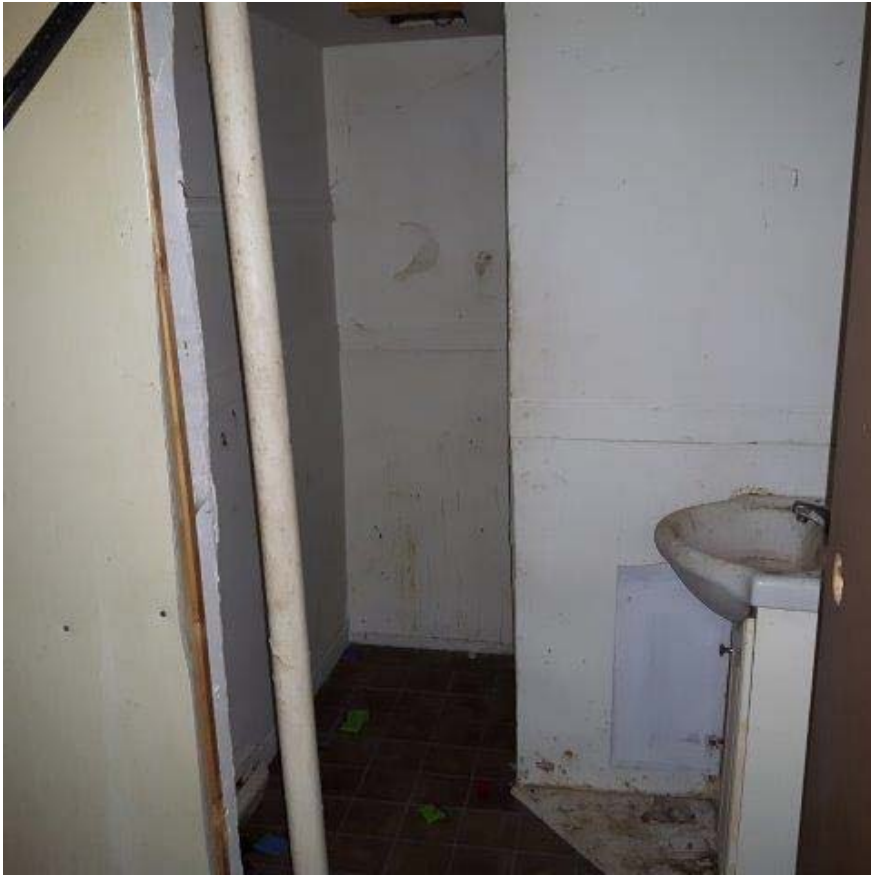
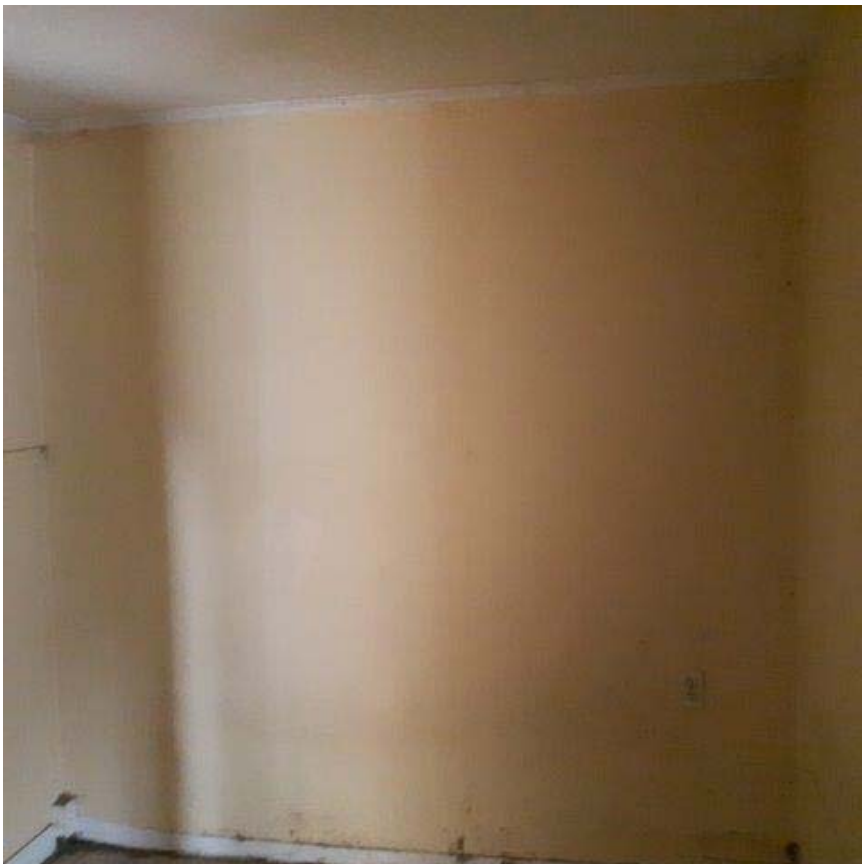
- Collapse of several portions of the foundation, open to exterior.
- Structural fatigue and partial structural support failure in basement.
- Façade compromised and at places open to exterior, weather and wear.
- Structural failure shown at several locations throughout structure.
- Partial collapse of foundation interior.
- Electrical shock risk due to exposure of wiring, disarray of utility in basement, degradation of panel and entrance, and water penetration.
- Collected pools of water in basement. Exposed plumbing issues and multiple signs of water damage.
- Signs of wildlife penetration and several carcasses located on site.
- Debris and garbage located through out structure.
- Compromised building envelope to the point of being a health risk.

It is in the opinion of this inspector that the building site be secured and marked for demolition or major restoration. This building poses an imminent risk to transients, as well as threatens the safety of the public in its present state.

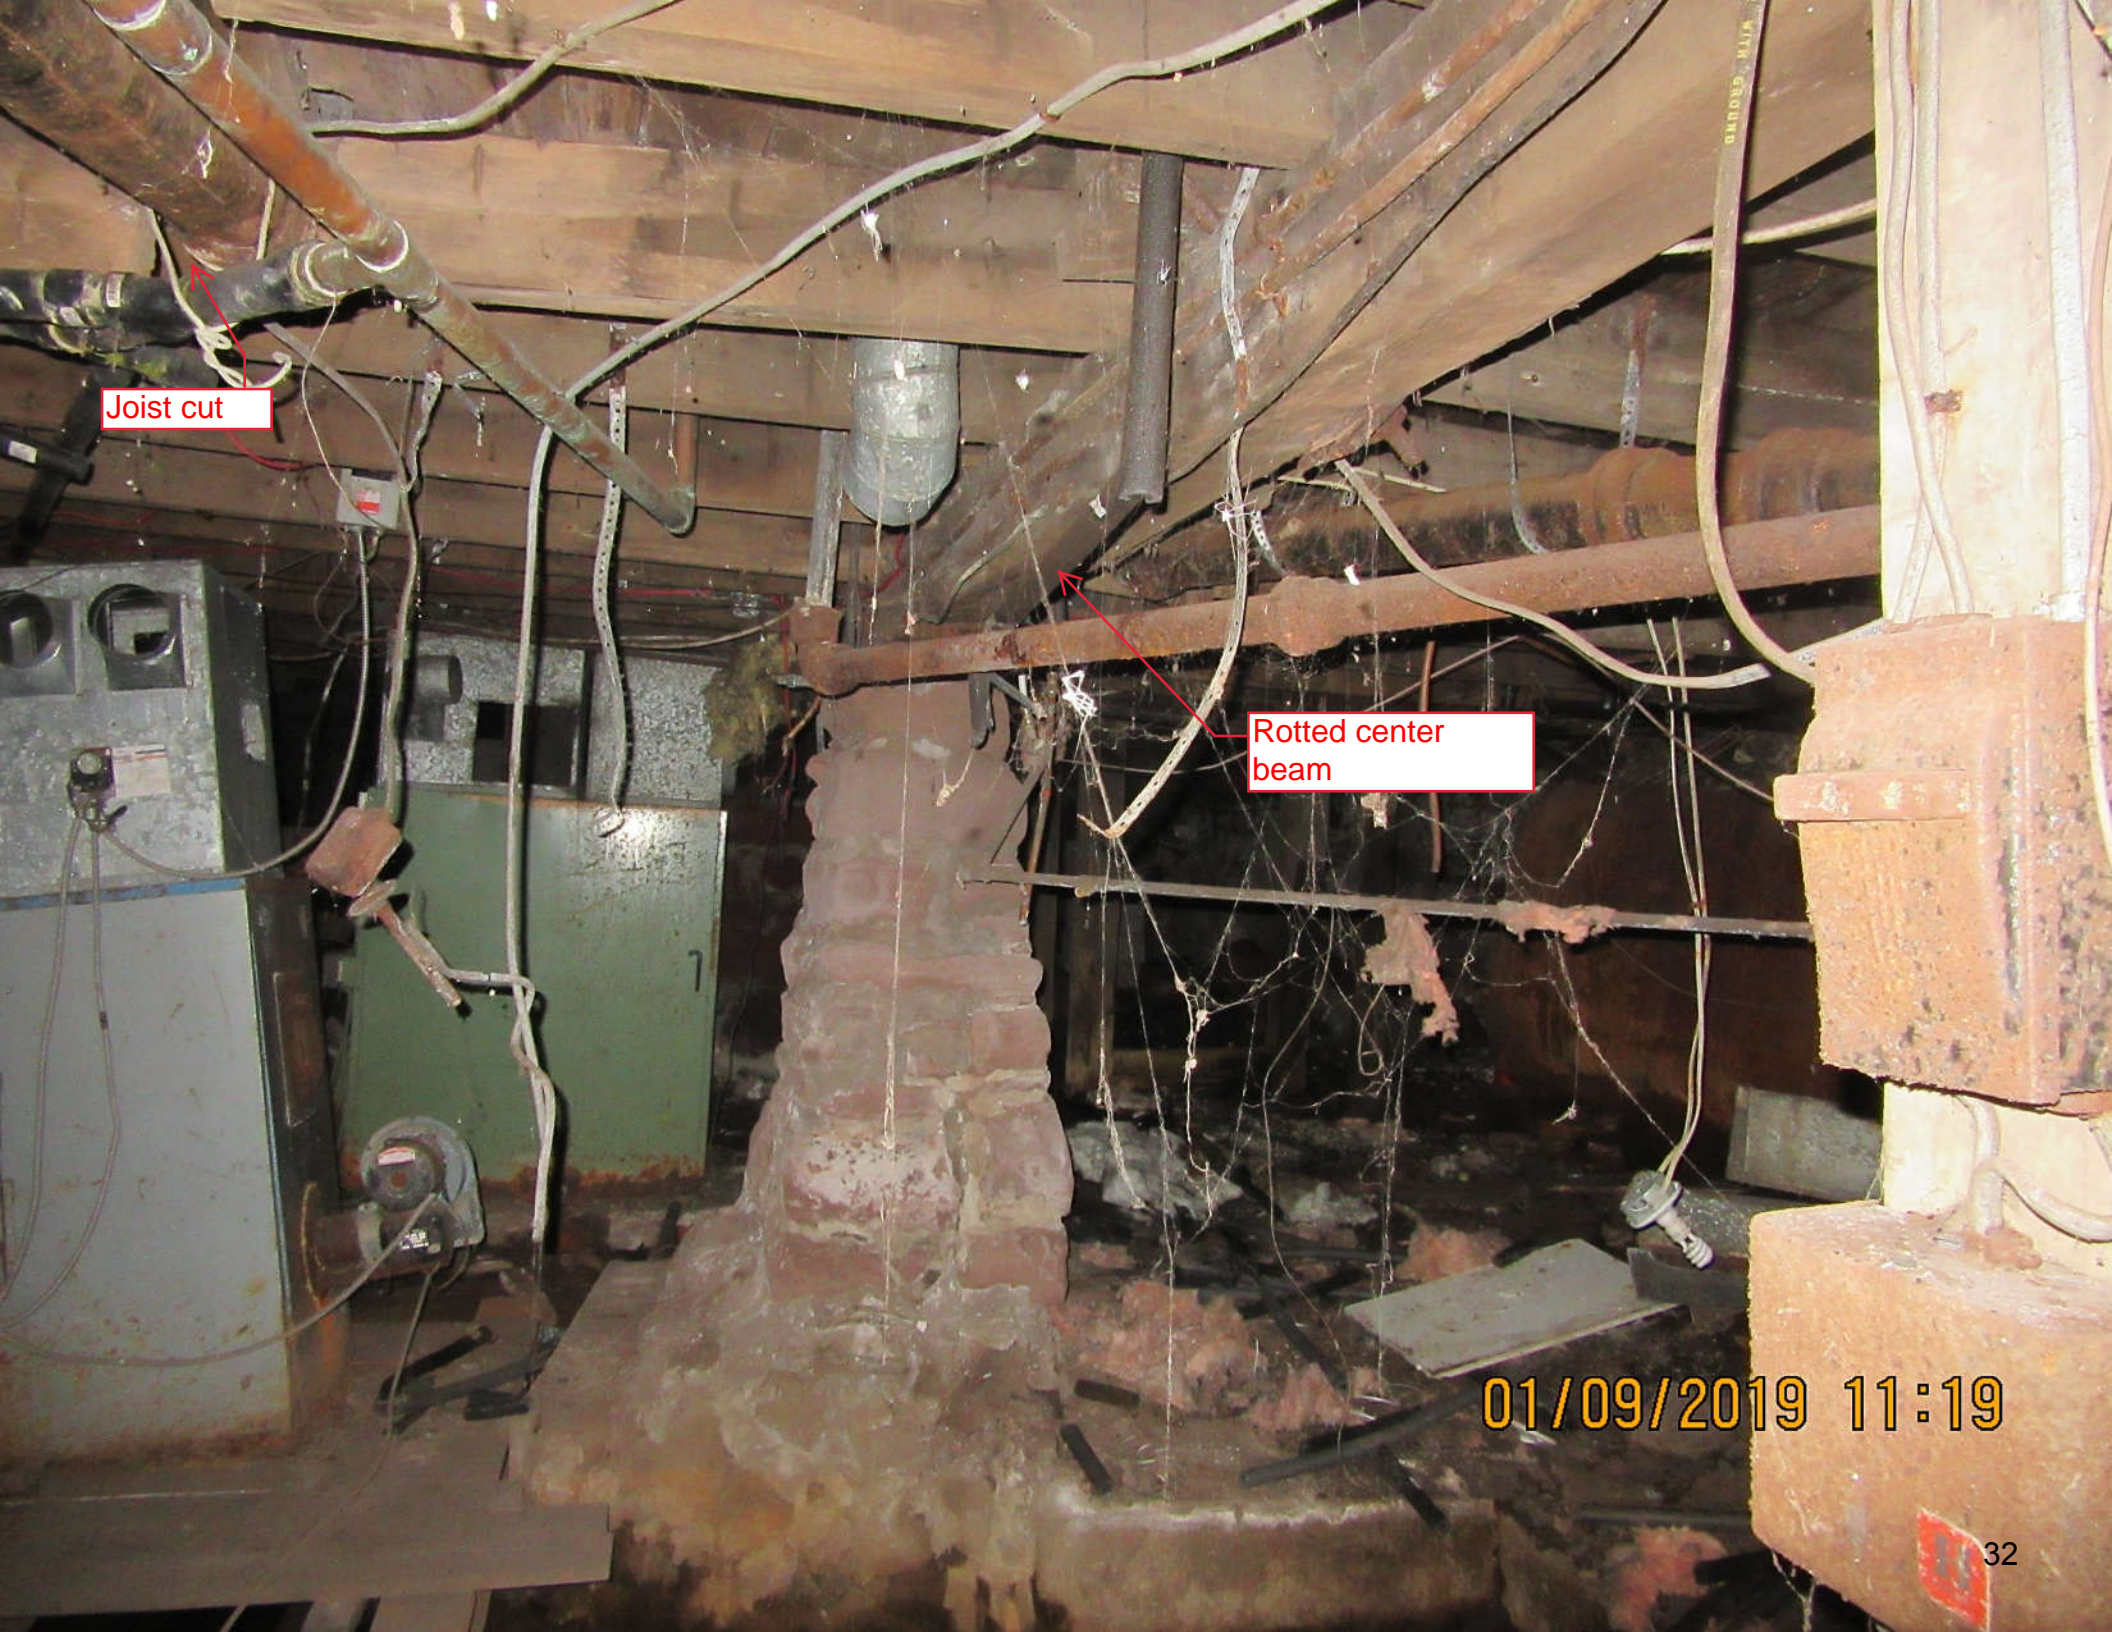
01/09/2019 11:19

Joist cut

Rotted center beam

Given the extent of the deterioration and deficiencies, complete replacement of the floor system would be required including the wood sills as well as foundation upgrades. With the poor condition of the overall building, it is my opinion, this level of investment would not be justified.

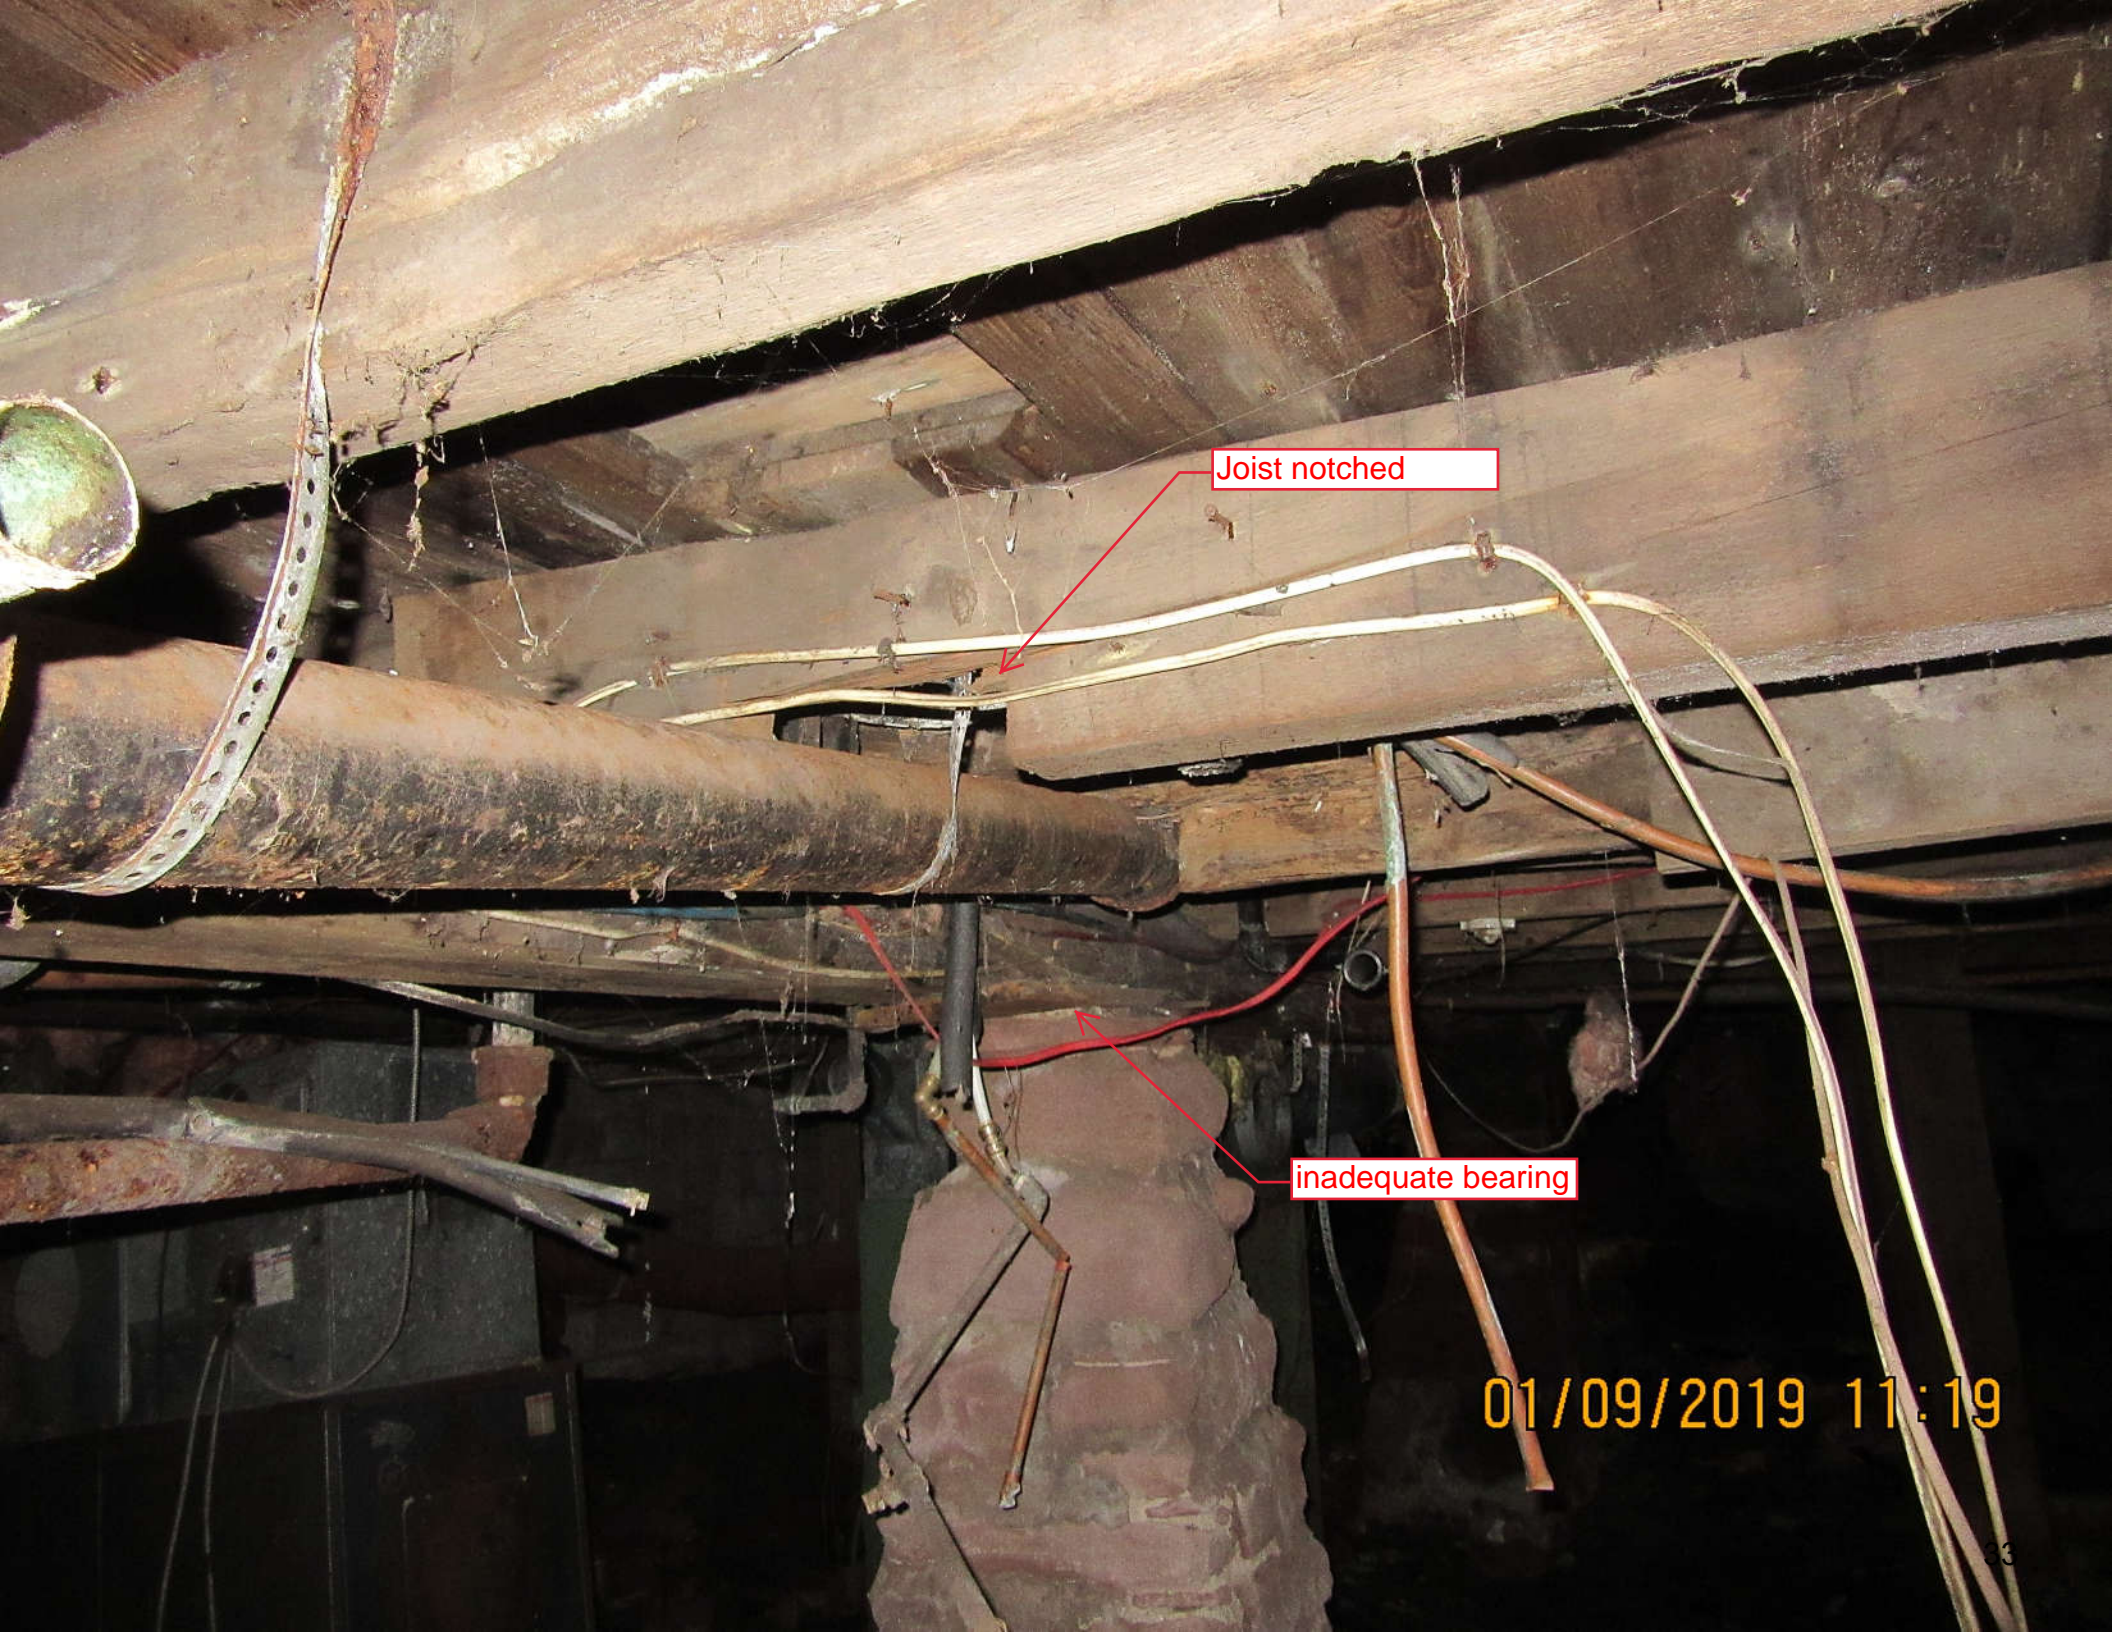
01/09/2019 11:19

Joist notched

inadequate bearing

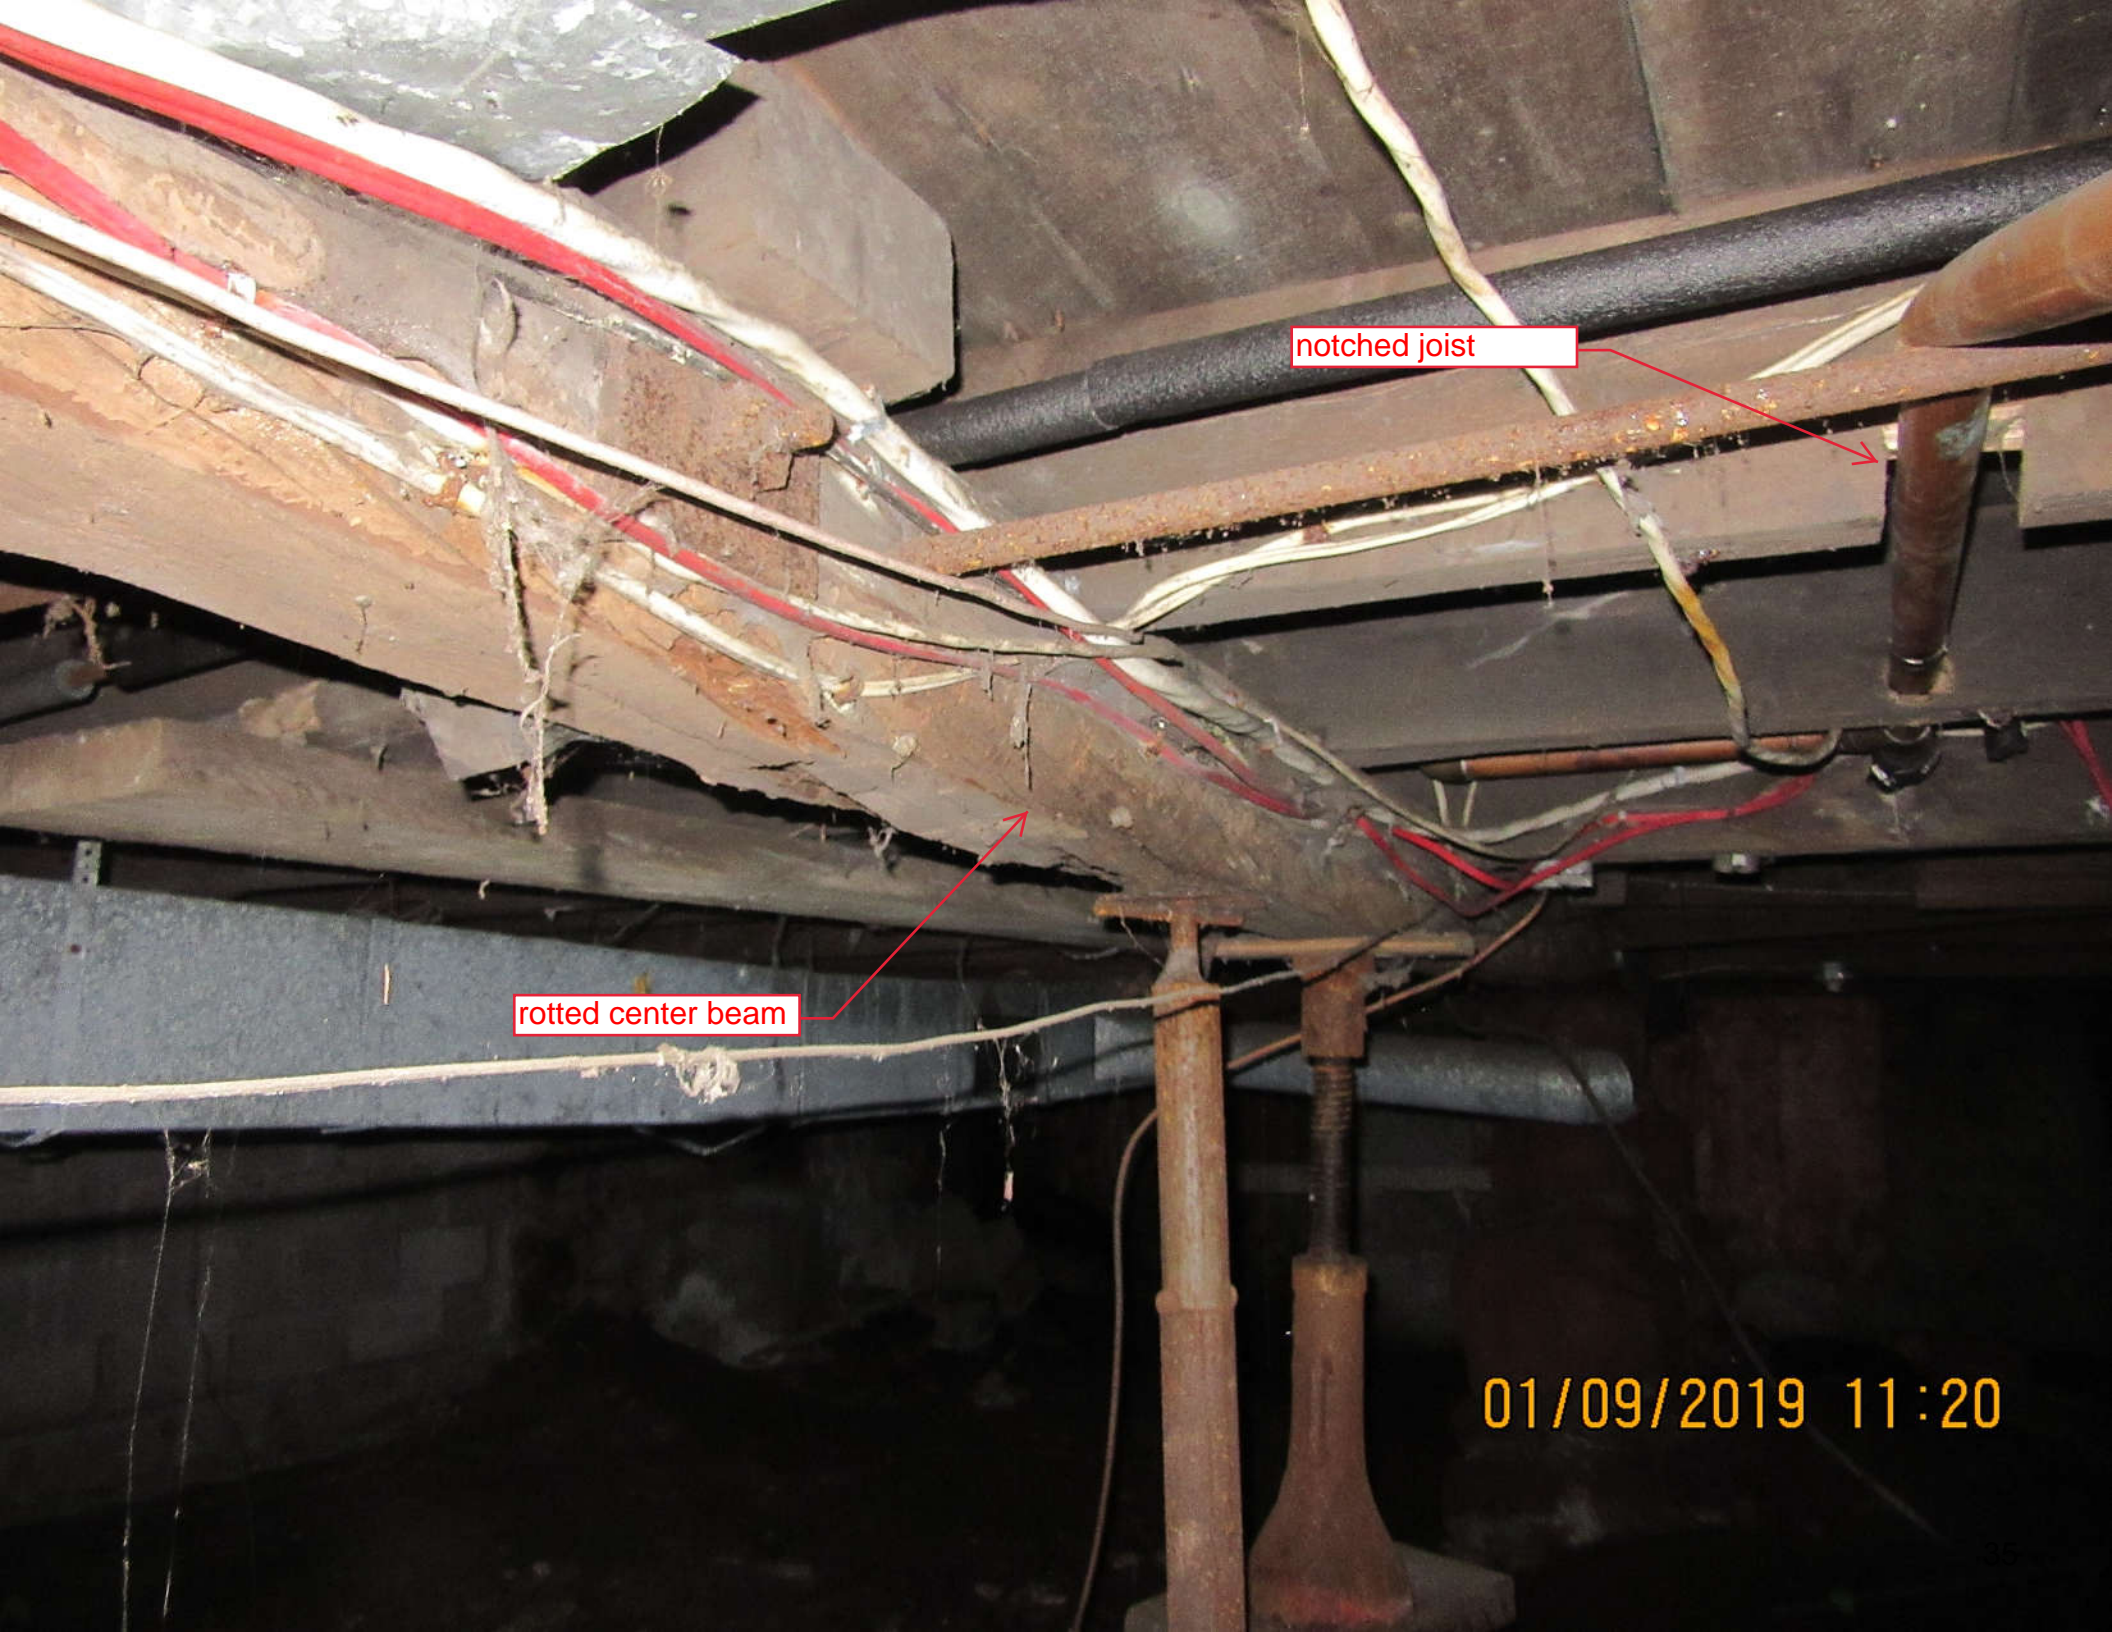
01/09/2019 11:20

sill completely deteriorated

end of joist rotted and dropped

foundation poor condition

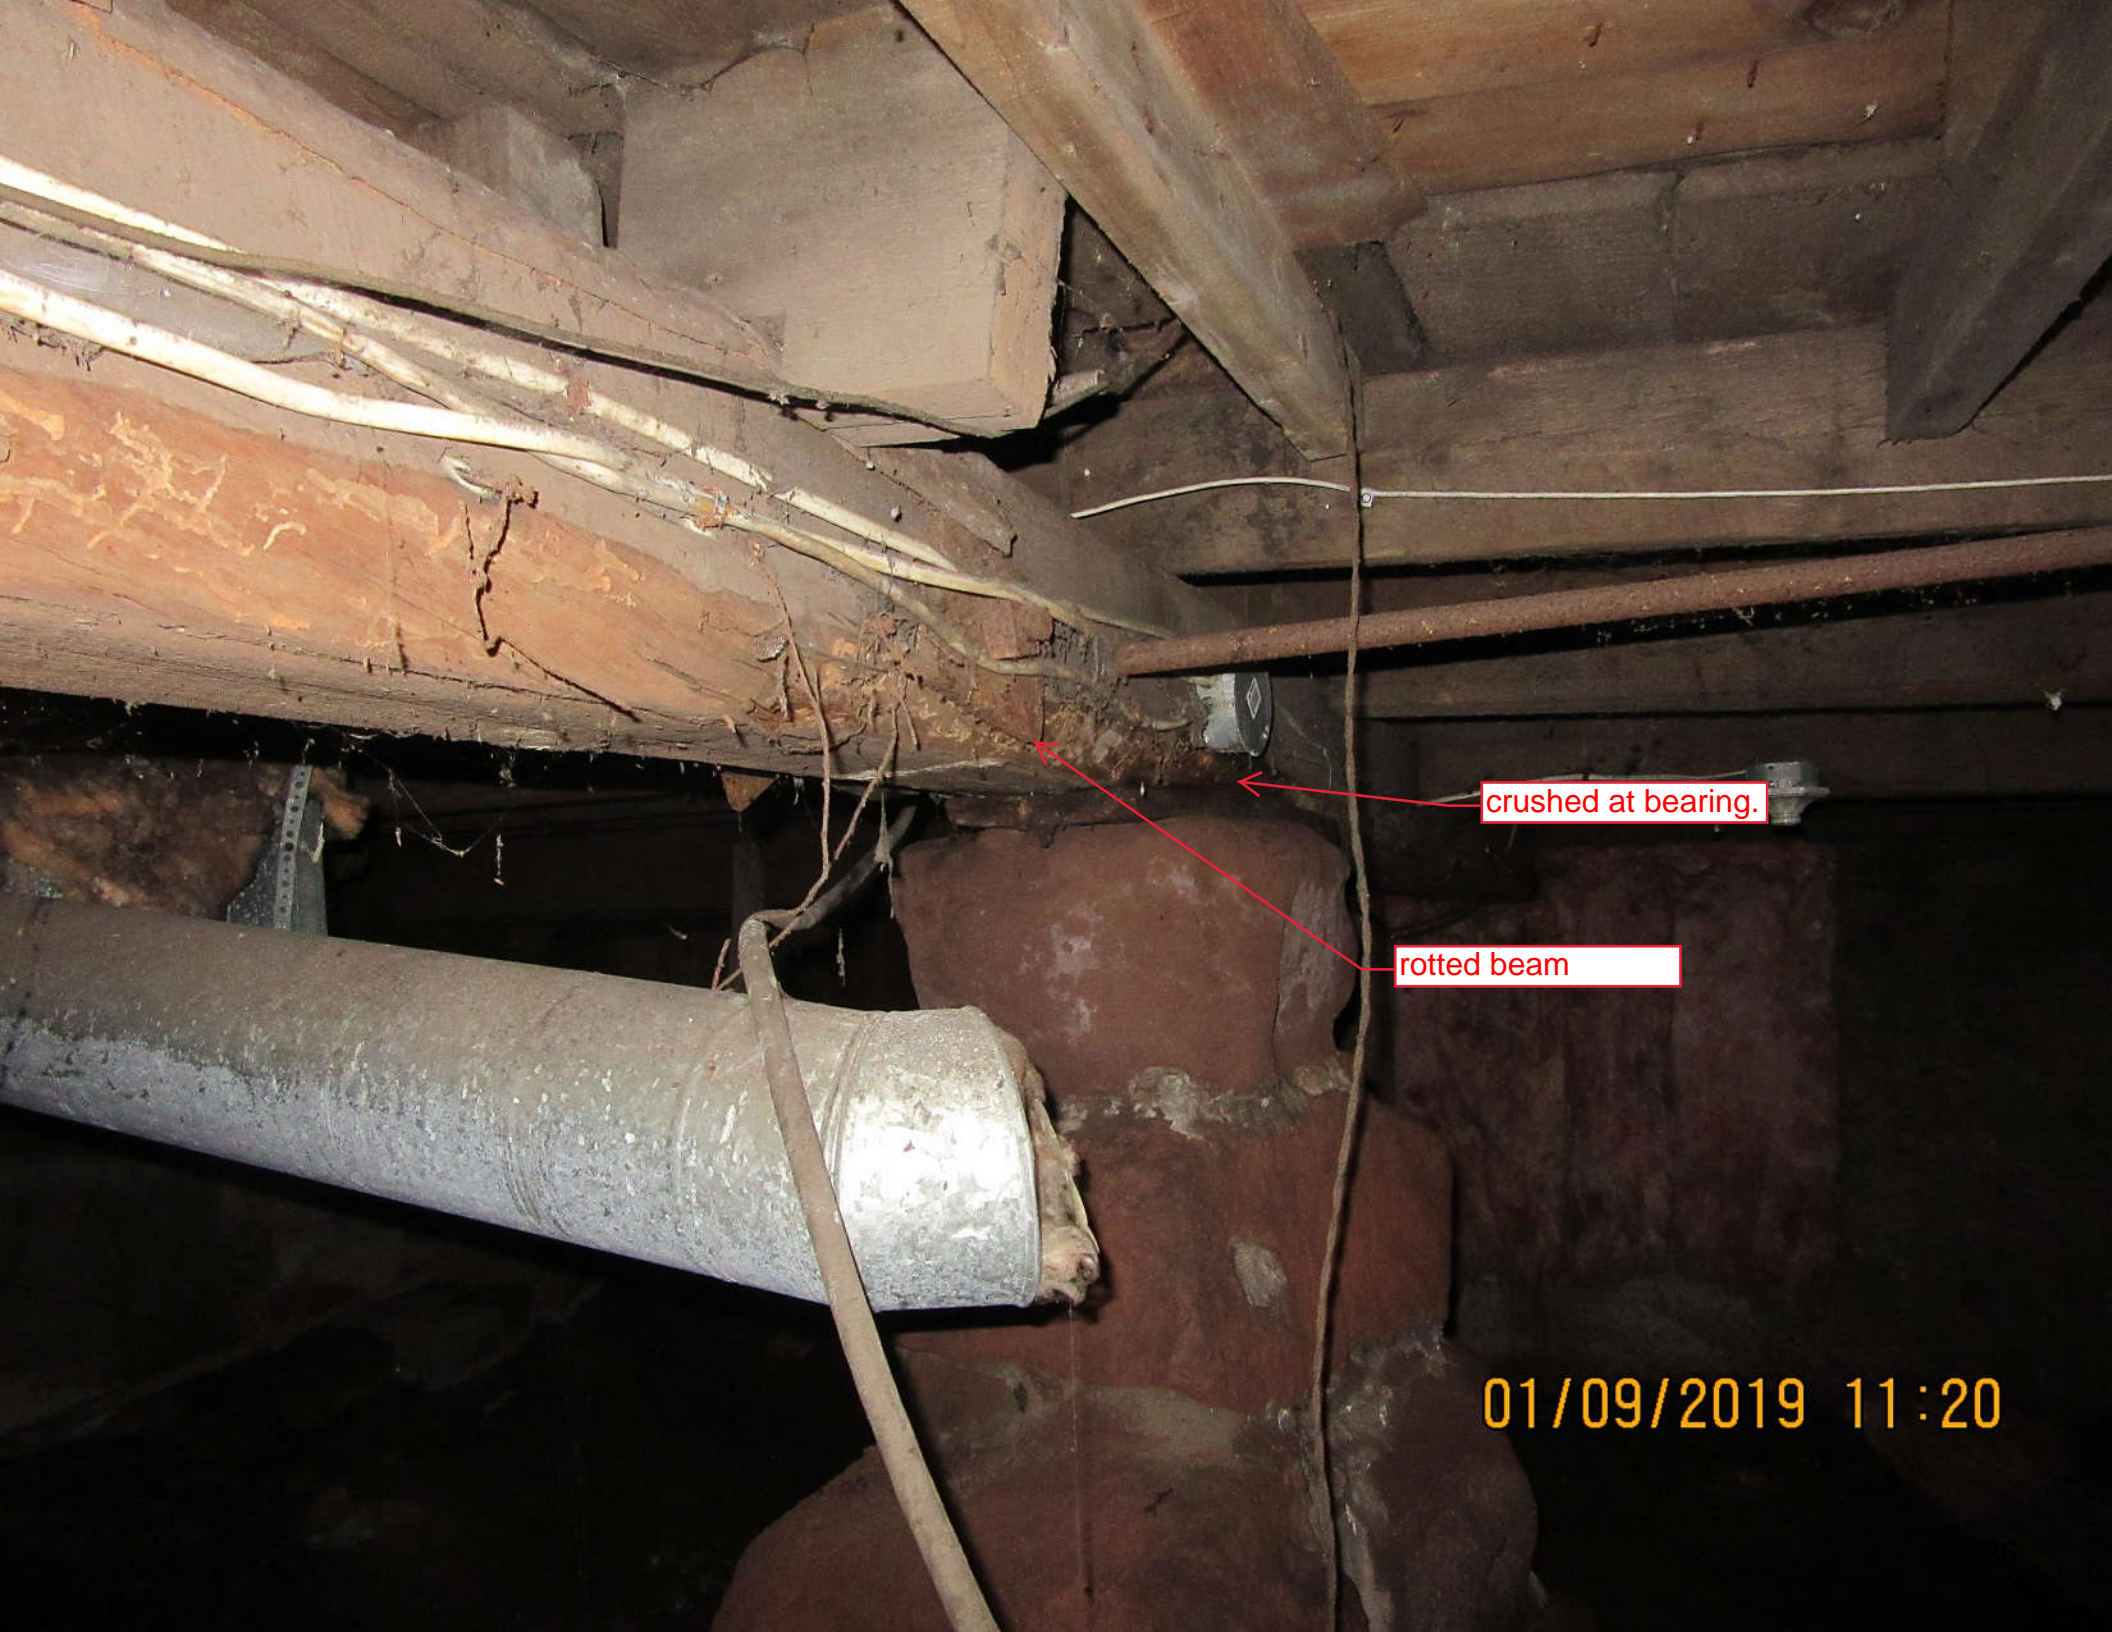
01/09/2019 11:20

notched joist

rotted center beam
