**Town of Amherst  
Planning Advisory Committee Meeting**

**Agenda**

**Re: PID # 25005729, 59 Church Street, Amherst, NS**

Re: Building Review, Corner of Church & Prince Arthur St., Amherst, NS/J49-07819

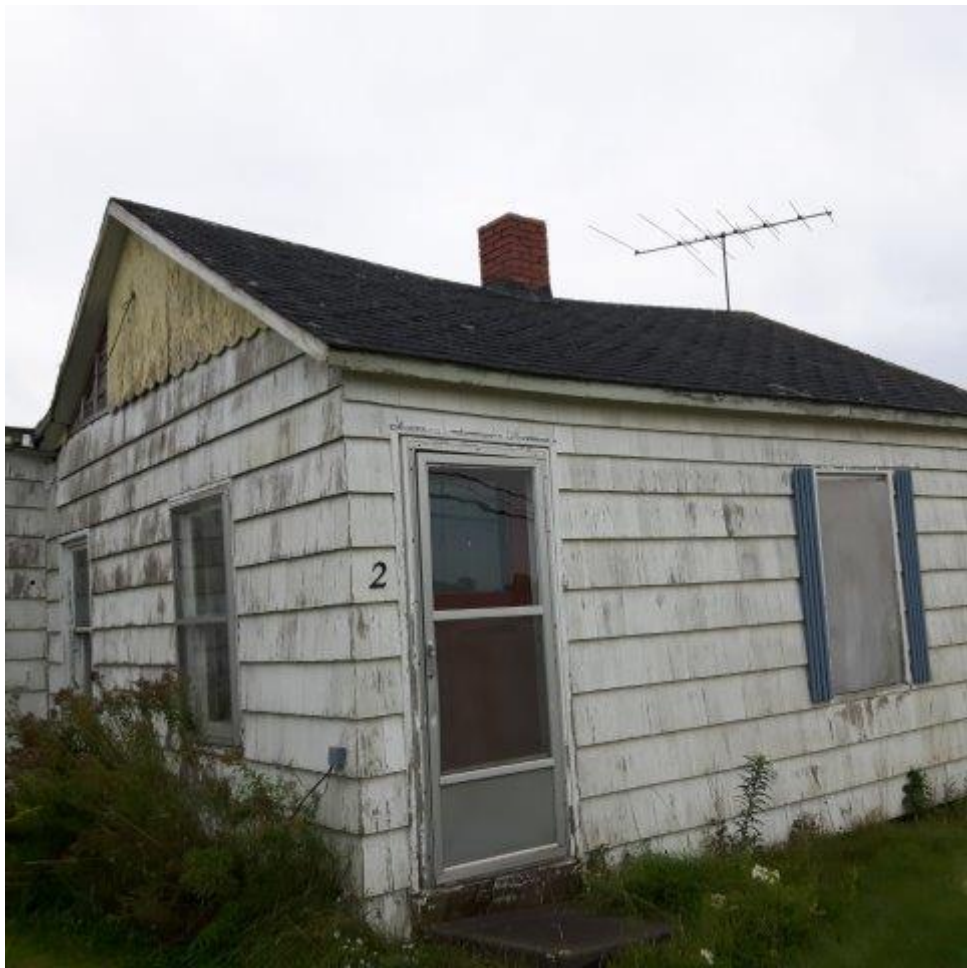
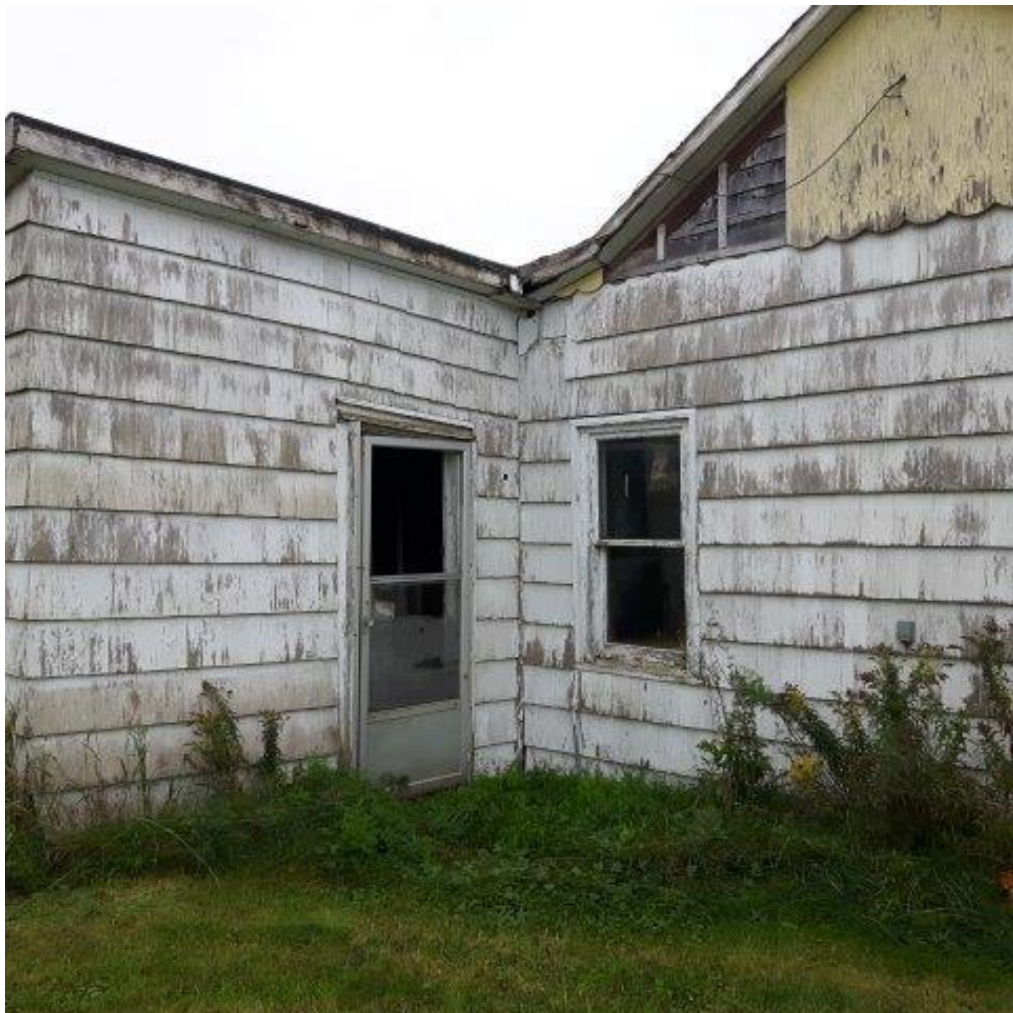
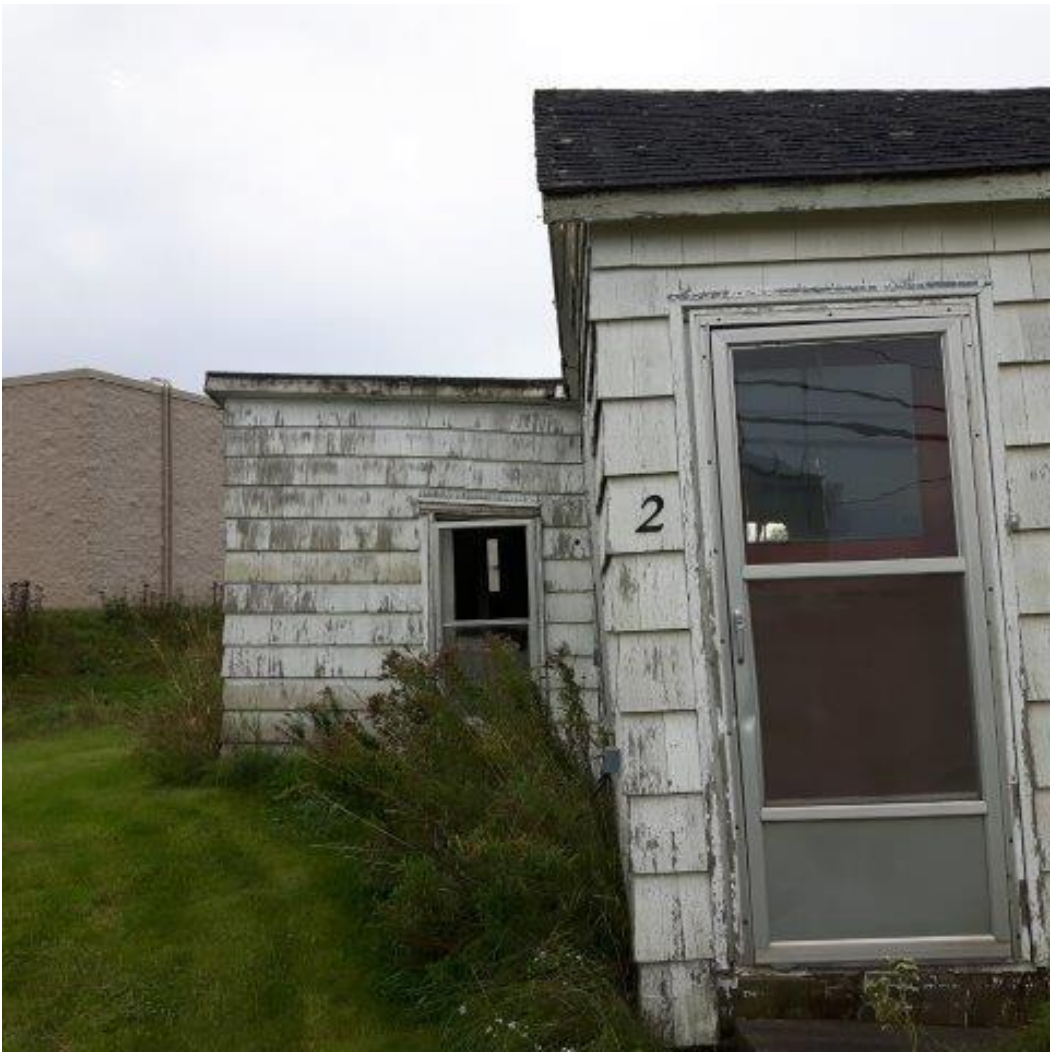
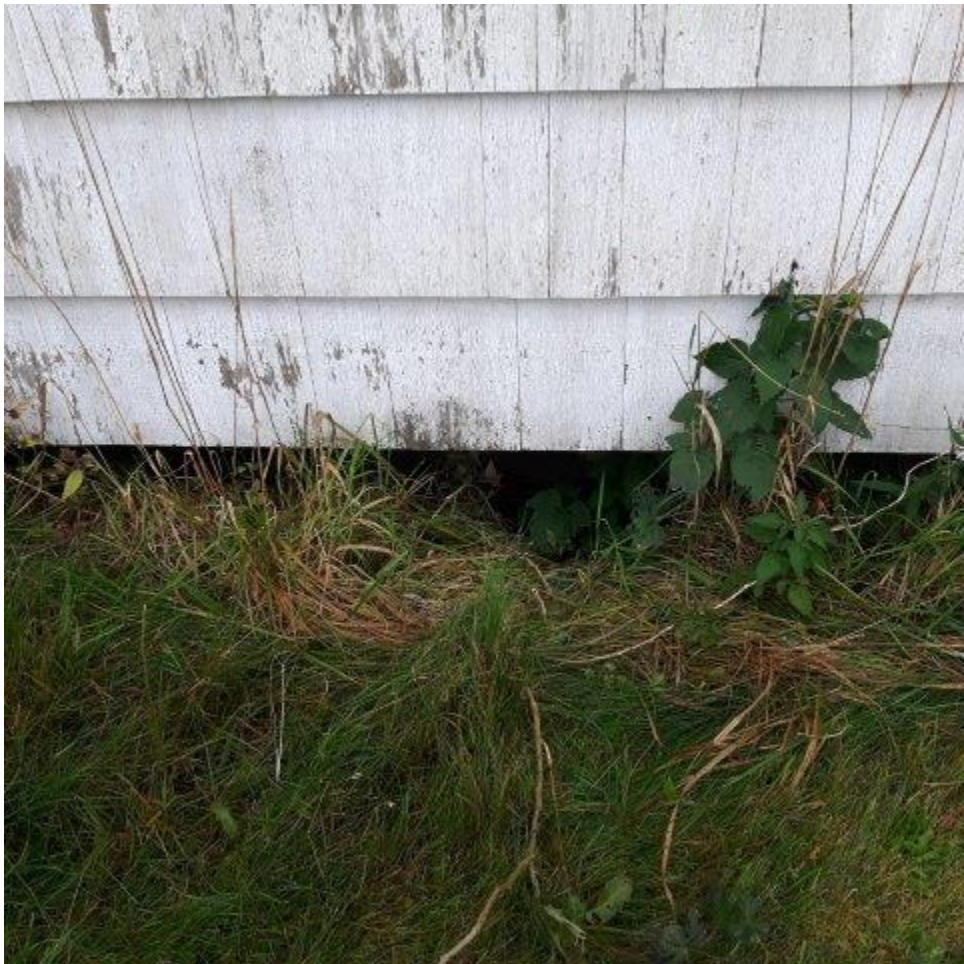
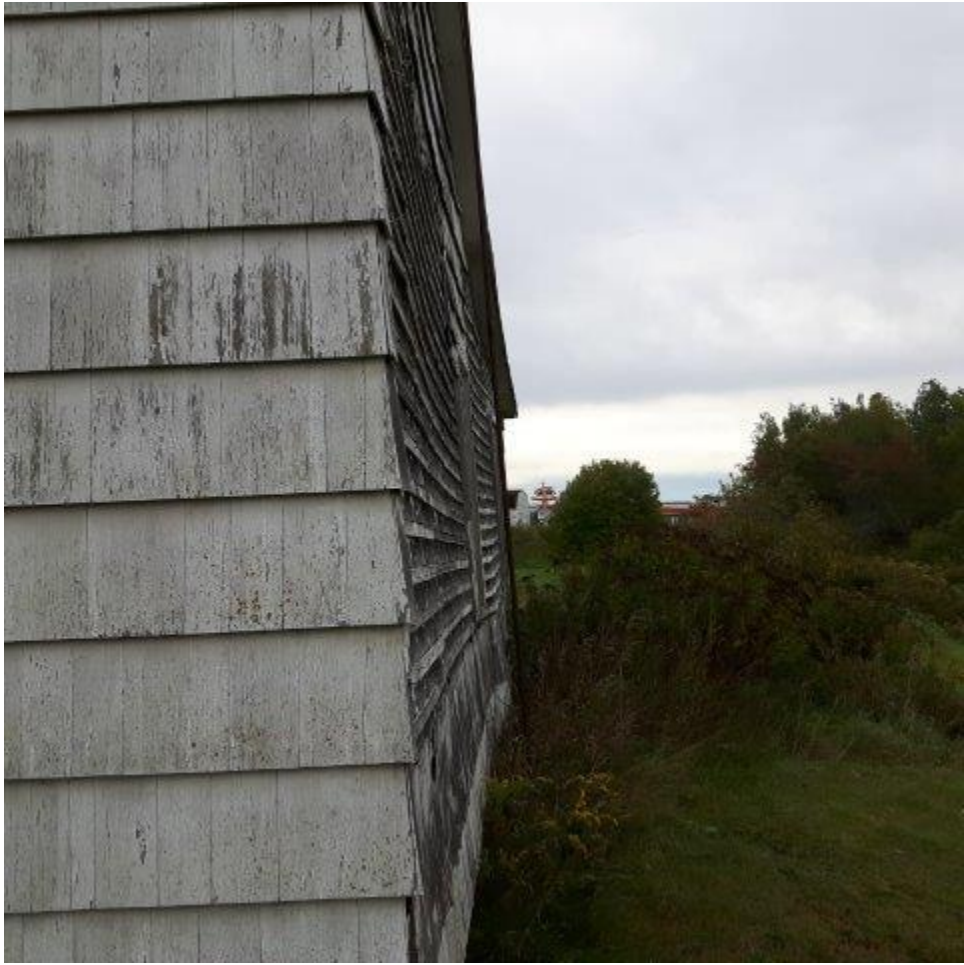
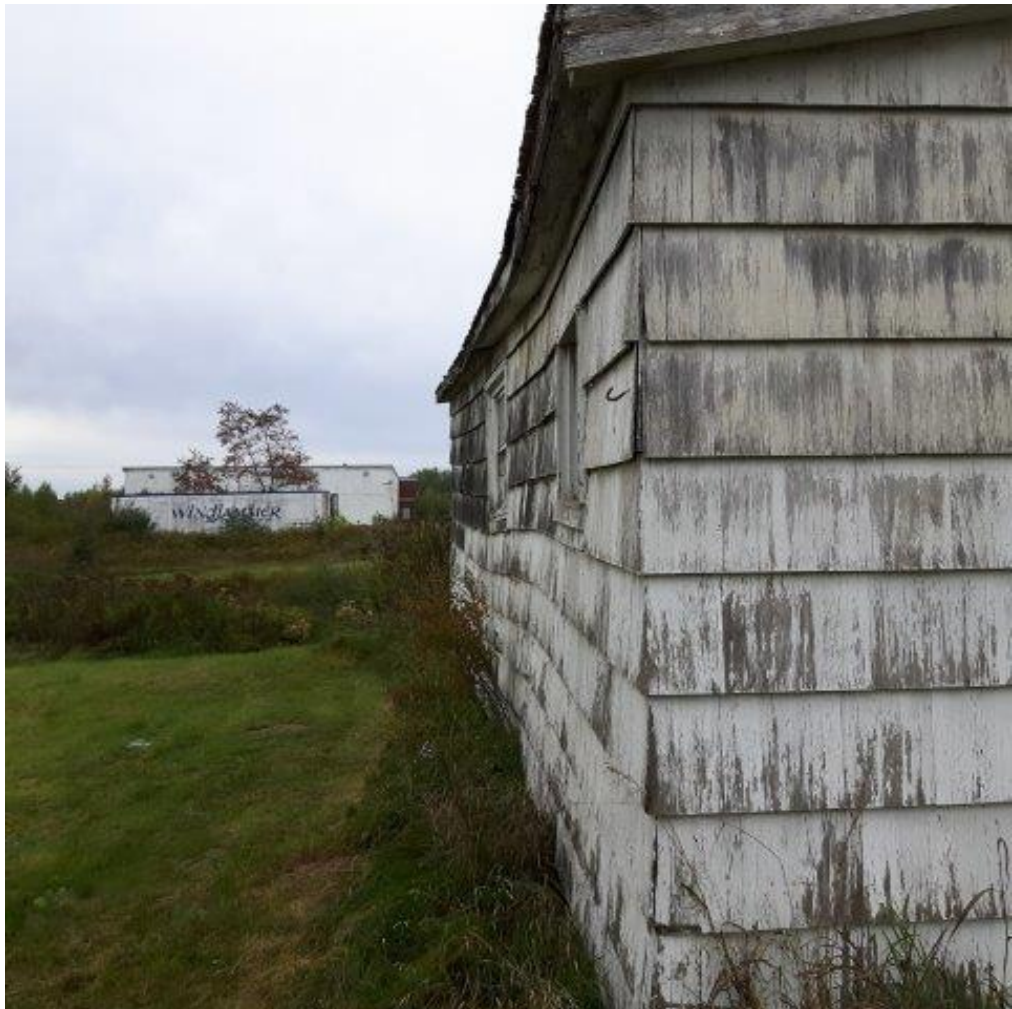
- Rot, failure and collapse of fascia and soffit at various locations around structure.
- Signs of façade and structural fatigue prominent around entire perimeter of building, including giving away of foundation support.
- Bowing of exteriors walls indicative of failure and eventual collapse.
- Roof, which shows significant signs of wear as well as sag, indicative of failure, has been jeopardized structurally and collapsed is probable.
- Several openings noted through to the interior from the exterior, indicative of component rot and failure, as well as transient traffic.
- Façade show signs of extreme wear and failure.
- Signs of collapse are evident from every face of the as the ground support fails and rots.
- Entire building showing signs of structural and outer wall failure to some degree.
- Building appears full of debris and garbage and constitutes a fire and safety hazard.

It is in the opinion of this inspector that the building site be secured and marked for demolition and that demolition be scheduled for the earliest opportunity. This building is in risk of collapse and reparations would realistically be beyond the point that would make economic sense.
