Town of Amherst
Planning Advisory Committee Meeting
Agenda

RE: Recommendation of 19 Spring Street, Amherst, NS (PID: 25031626)

To: Planning Advisory Committee
From: Emily Wainwright, Dangerous and Unsightly Premises Administrator
Date: September 23, 2024
Re: Recommendation of 77 Station Street (PID 25124017)

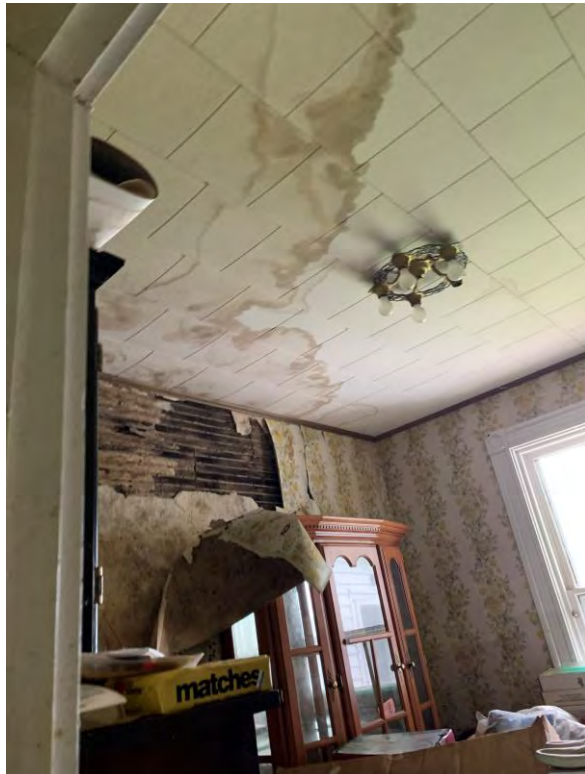
Main floor water damage.

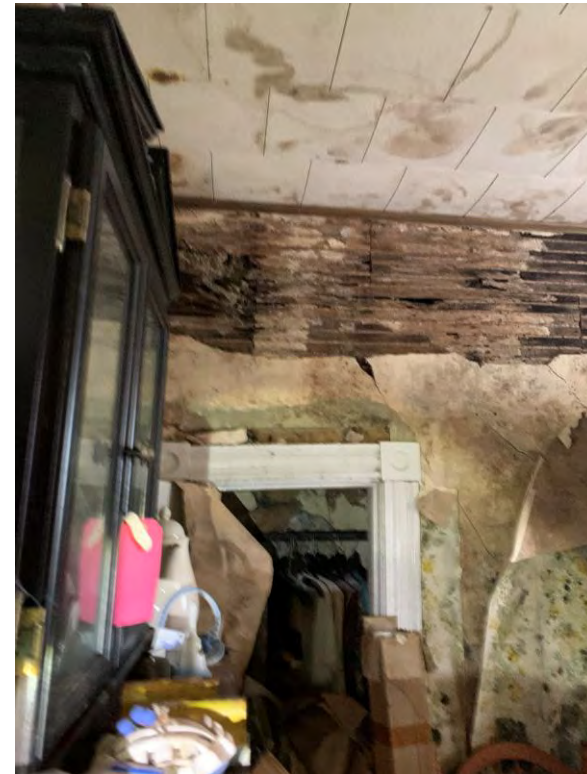
Main floor water damage.

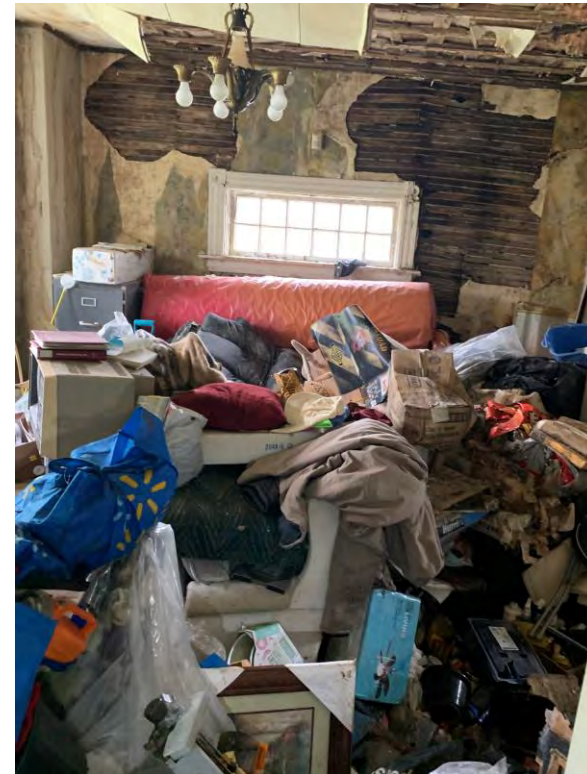
Main floor hoarding.

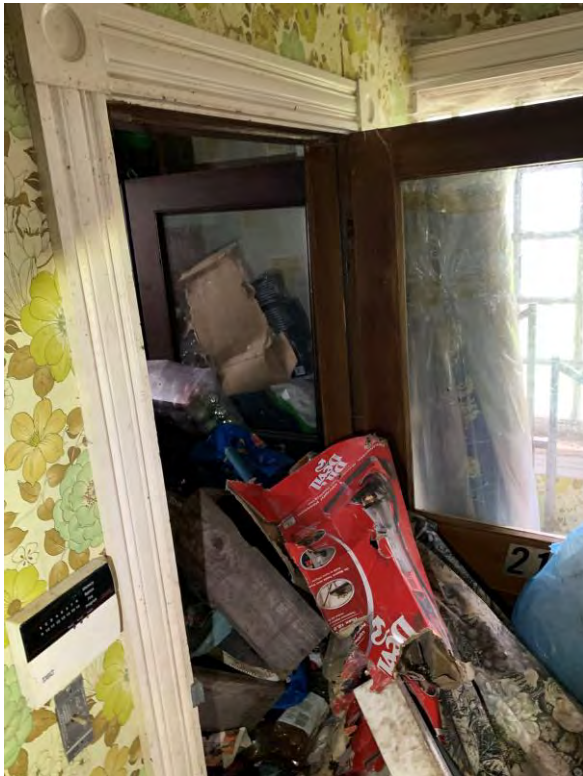
Main floor hoarding.

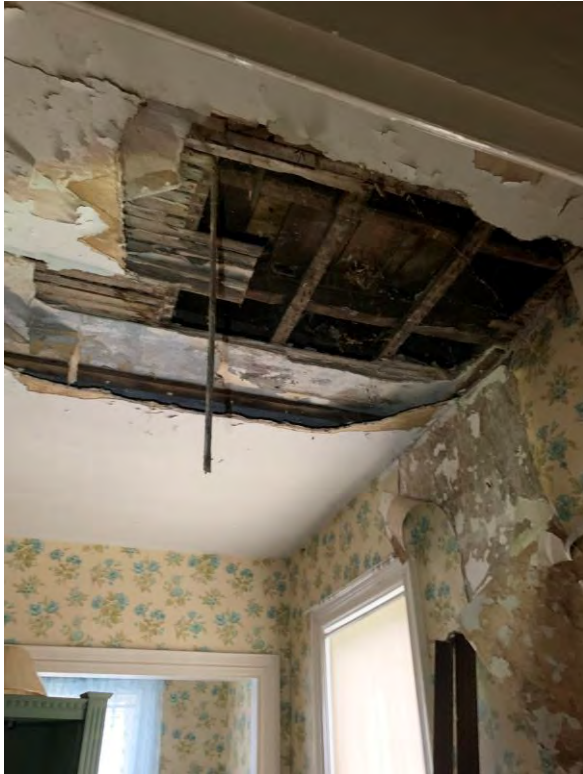
Second-floor hoarding/garbage.

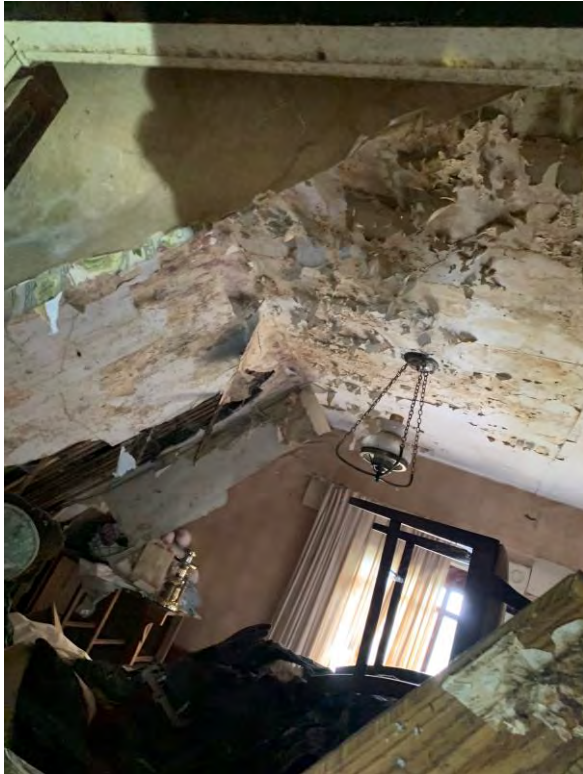
Second-floor water damage.

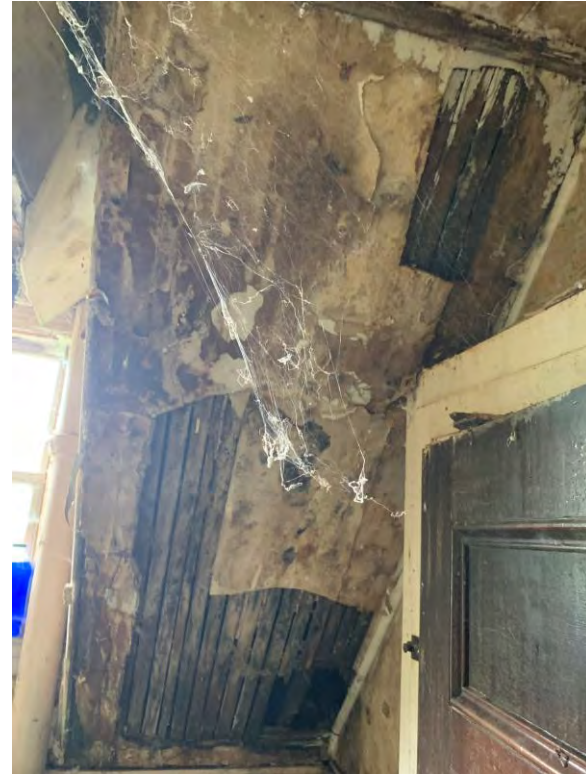
Second-floor bathroom water damage.

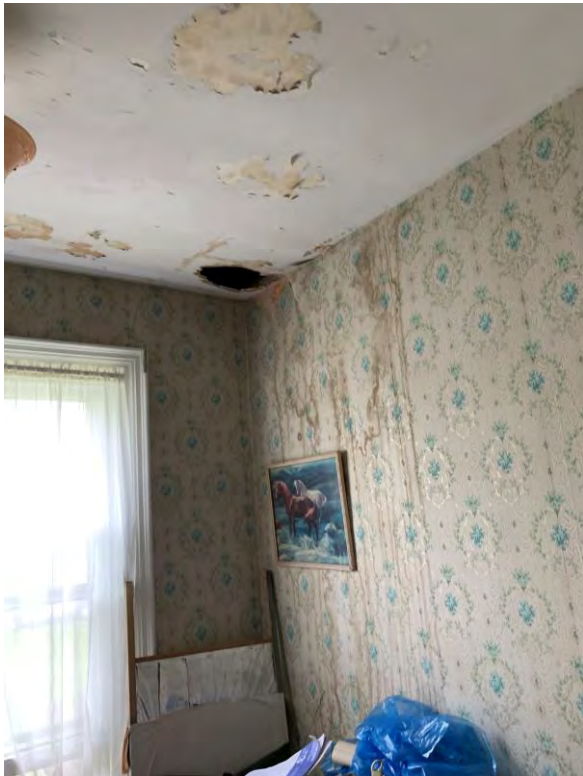
Minor water damage on second-floor.

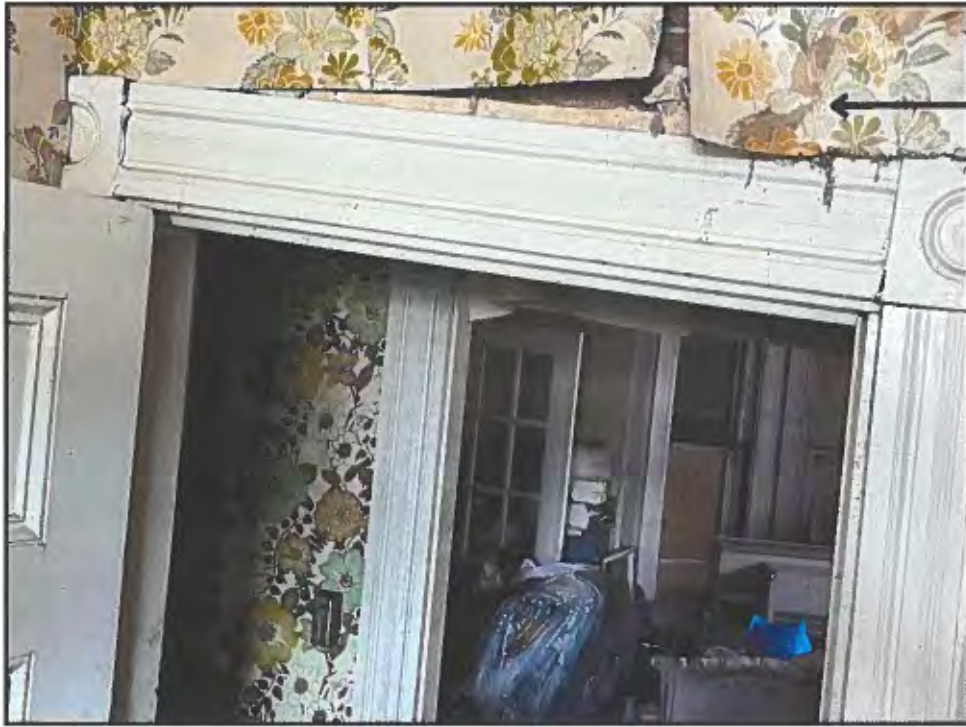
Slanted door frame due to active settlement. Approximately 3 1/2" of settlement in a 3'-0" run
