Town of Amherst
Planning Advisory Committee Meeting
Agenda

RE: Recommendation of 19 Spring Street, Amherst, NS (PID: 25031626)

To: Planning Advisory Committee
From: Emily Wainwright, Dangerous and Unsightly Premises Administrator
Date: September 23, 2024
Re: Recommendation of 77 Station Street (PID 25124017)

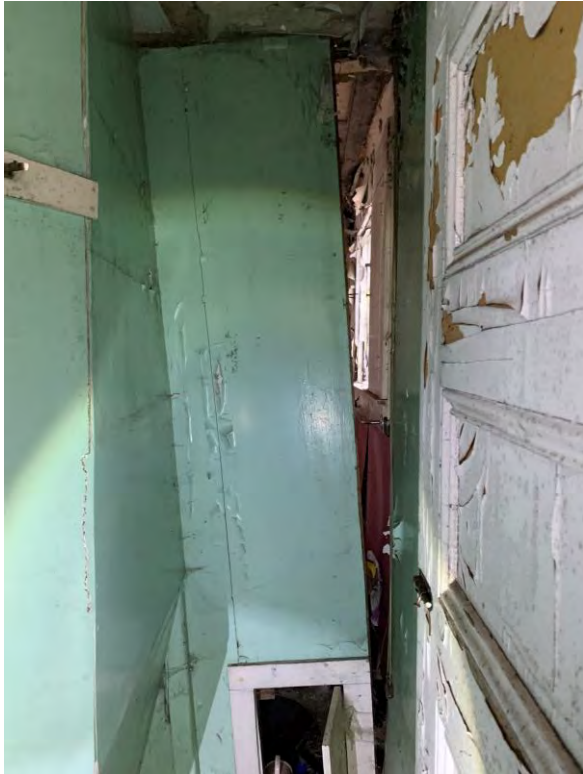
Interior Walls separating from exterior walls.

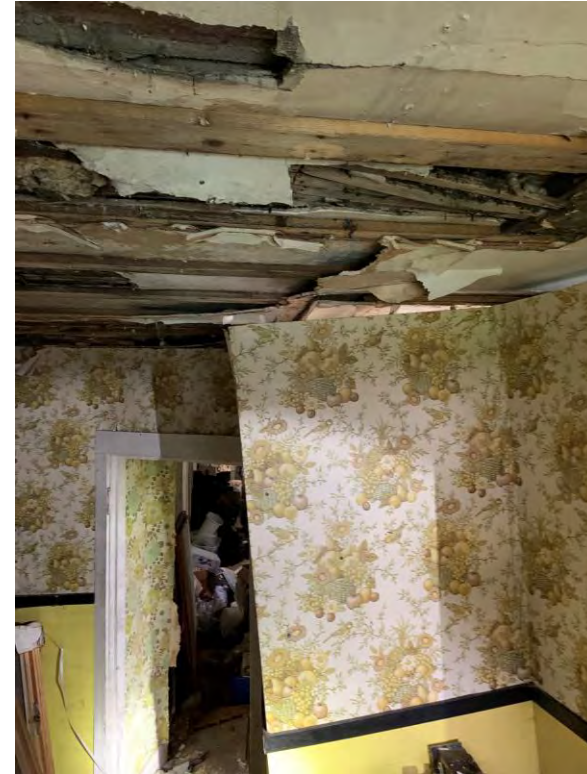
Main floor bathroom. Interior walls separating from exterior walls.

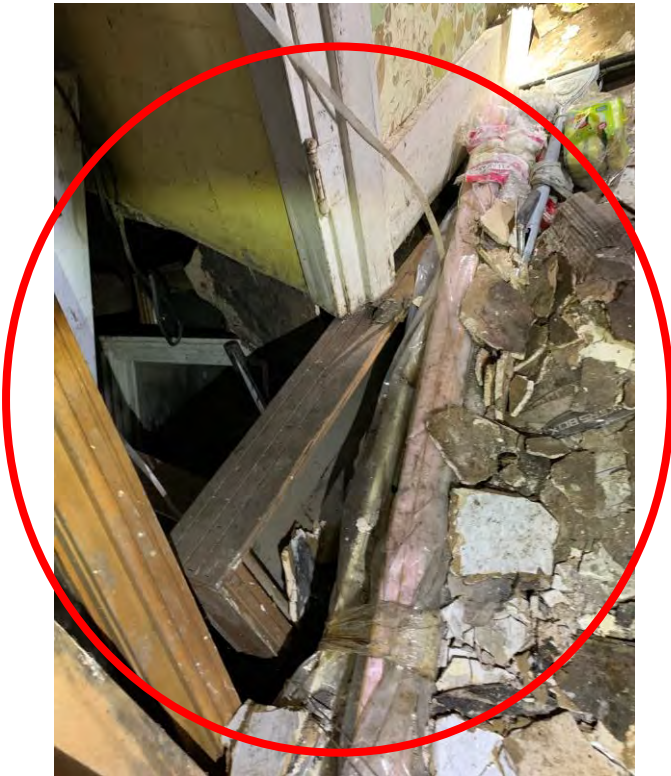
Refrigerator has fallen into the basement due to the collapsed floor.

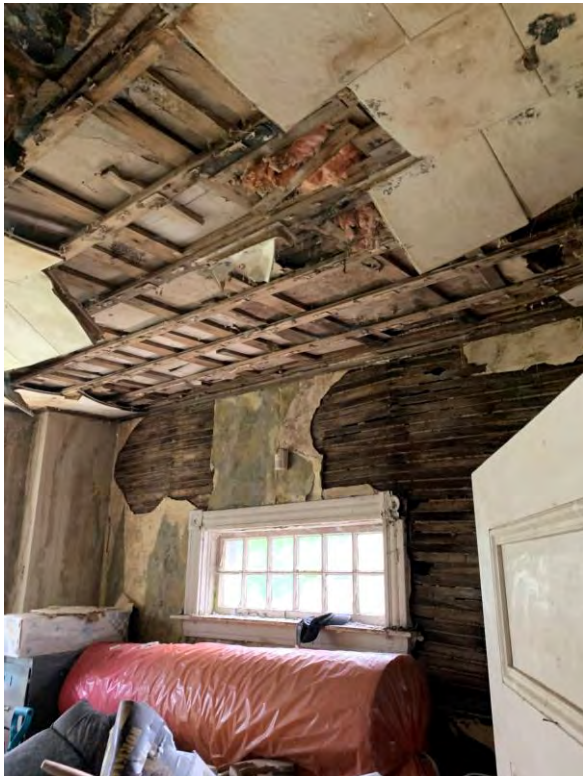
Main floor water damage.

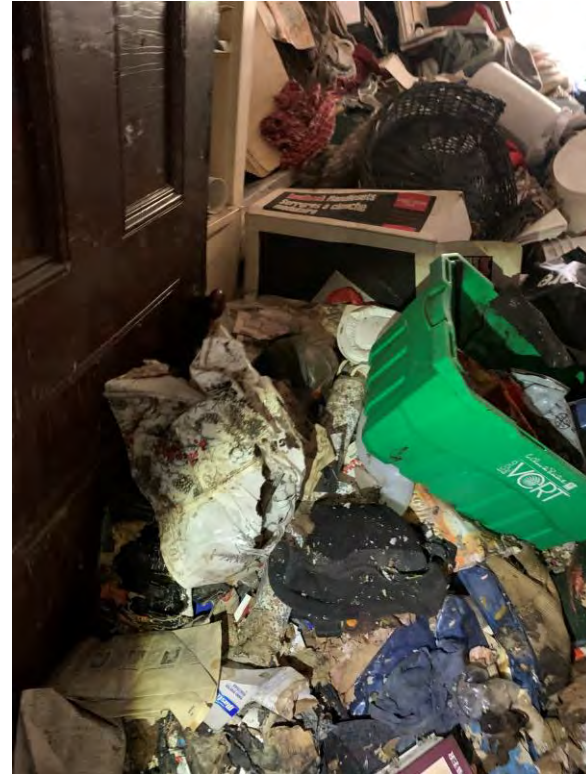
Second-floor hoarding/garbage.

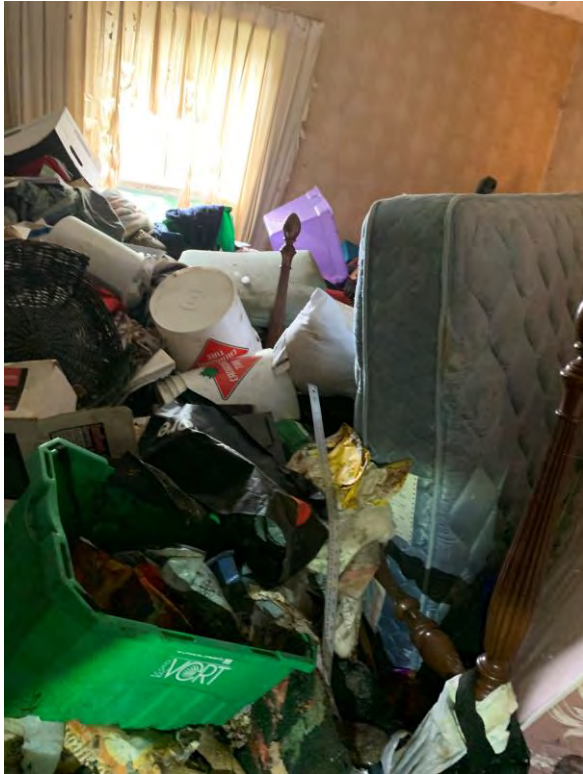
Second-floor hoarding/garbage.

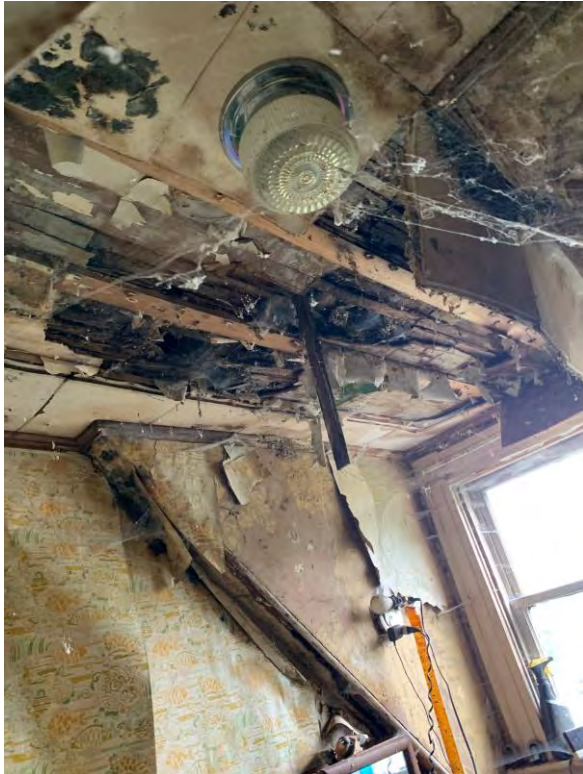
Second-floor bathroom water damage.

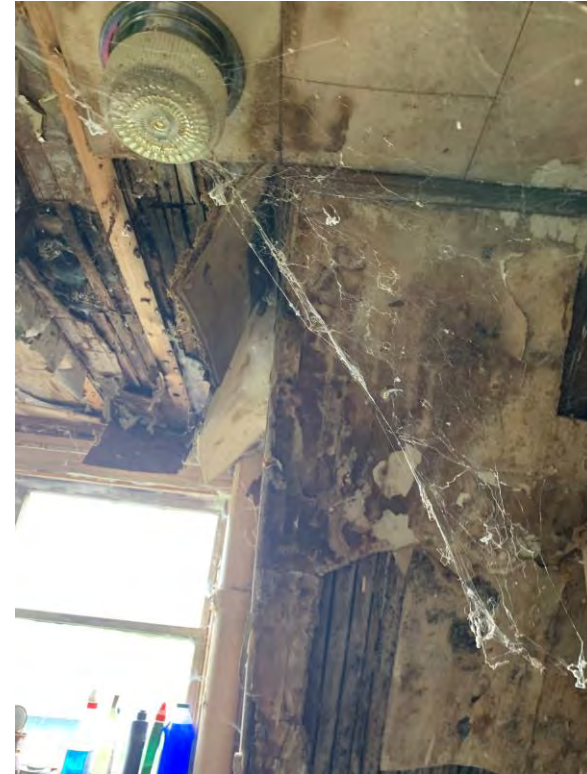
Second-floor bedroom. Light fallen onto mattress and papers.

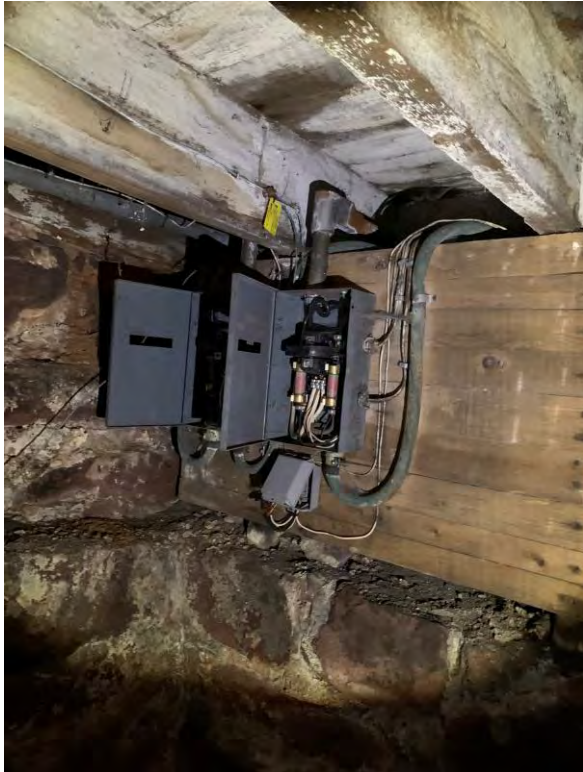
Basement: Main gear box in extremely poor condition. Accessible through occupied unit

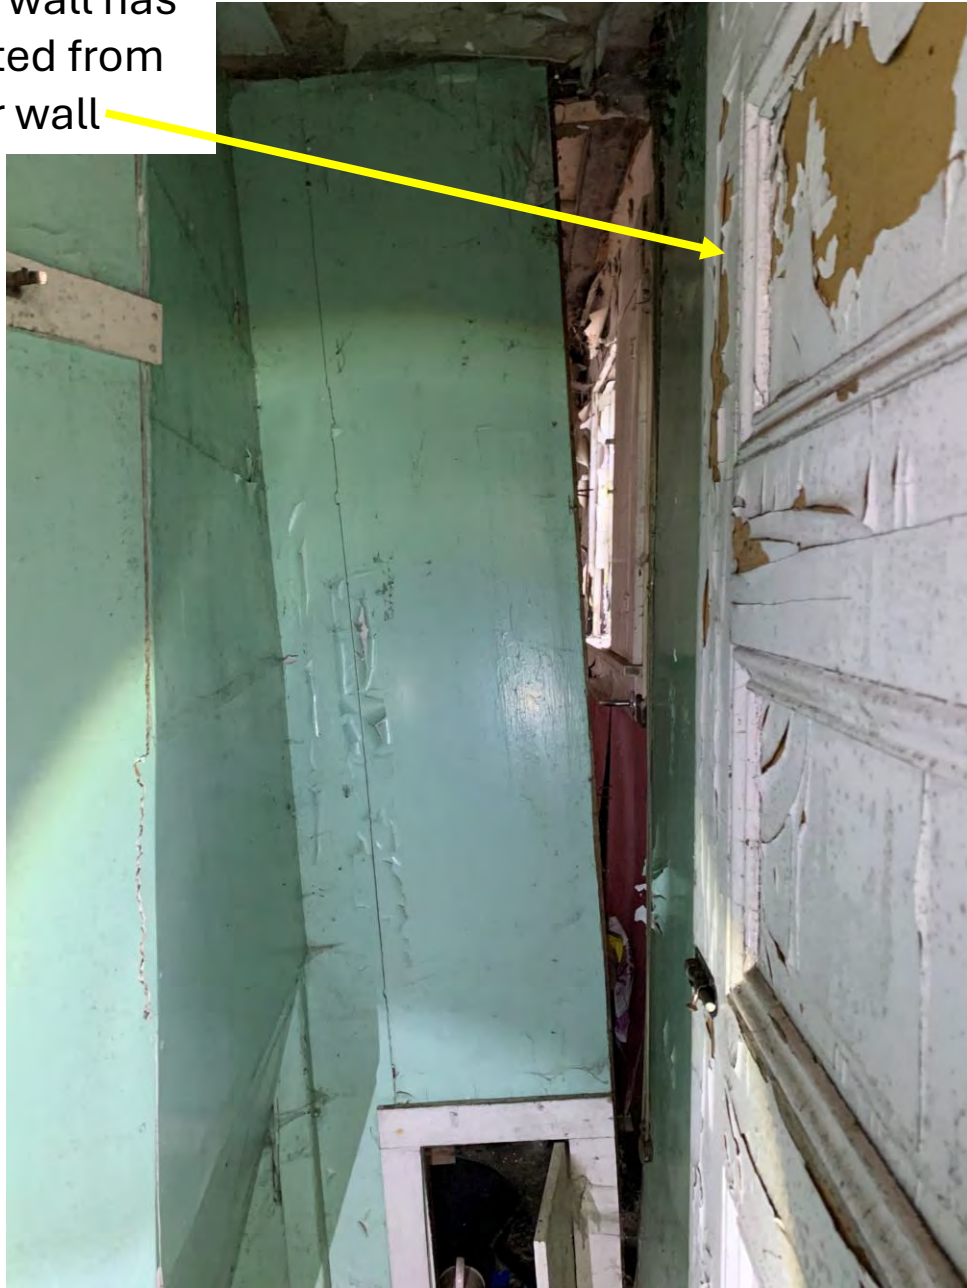
Interior wall has separated from exterior wall

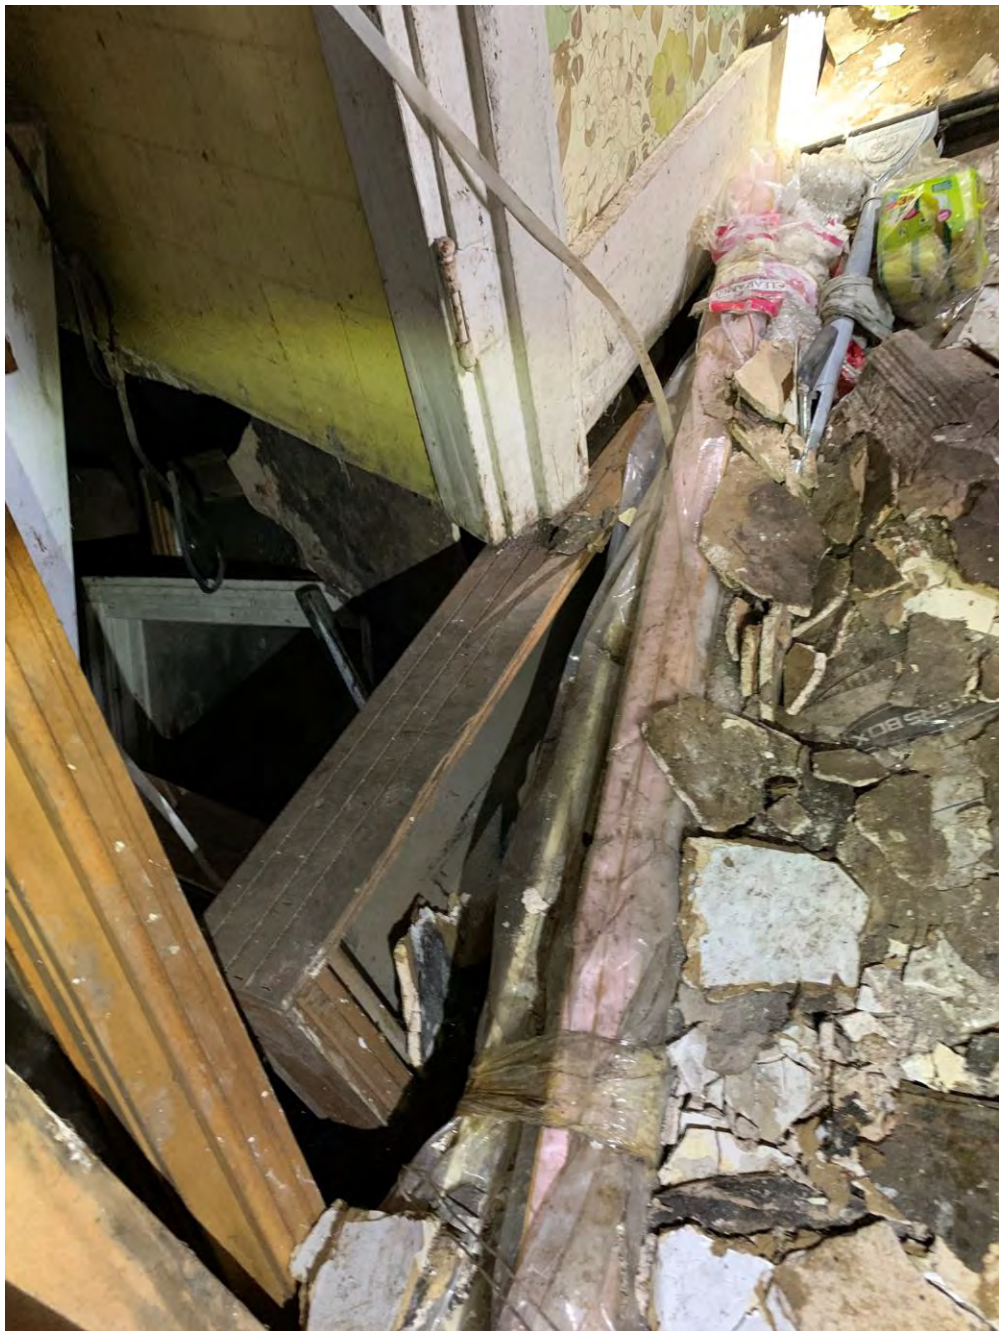
**Kitchen has collapsed into basement
and little to no floor remains (refrigerator
has fallen into the basement)**

A section of the floor at the rear of the building has collapsed due to extensive rot and decay caused by continued water infiltration. This structural failure is placing significant stress on the remaining walls, flooring, and ceiling, further weakening the building. If not addressed, this ongoing stress is likely to result in a major collapse in the near future.

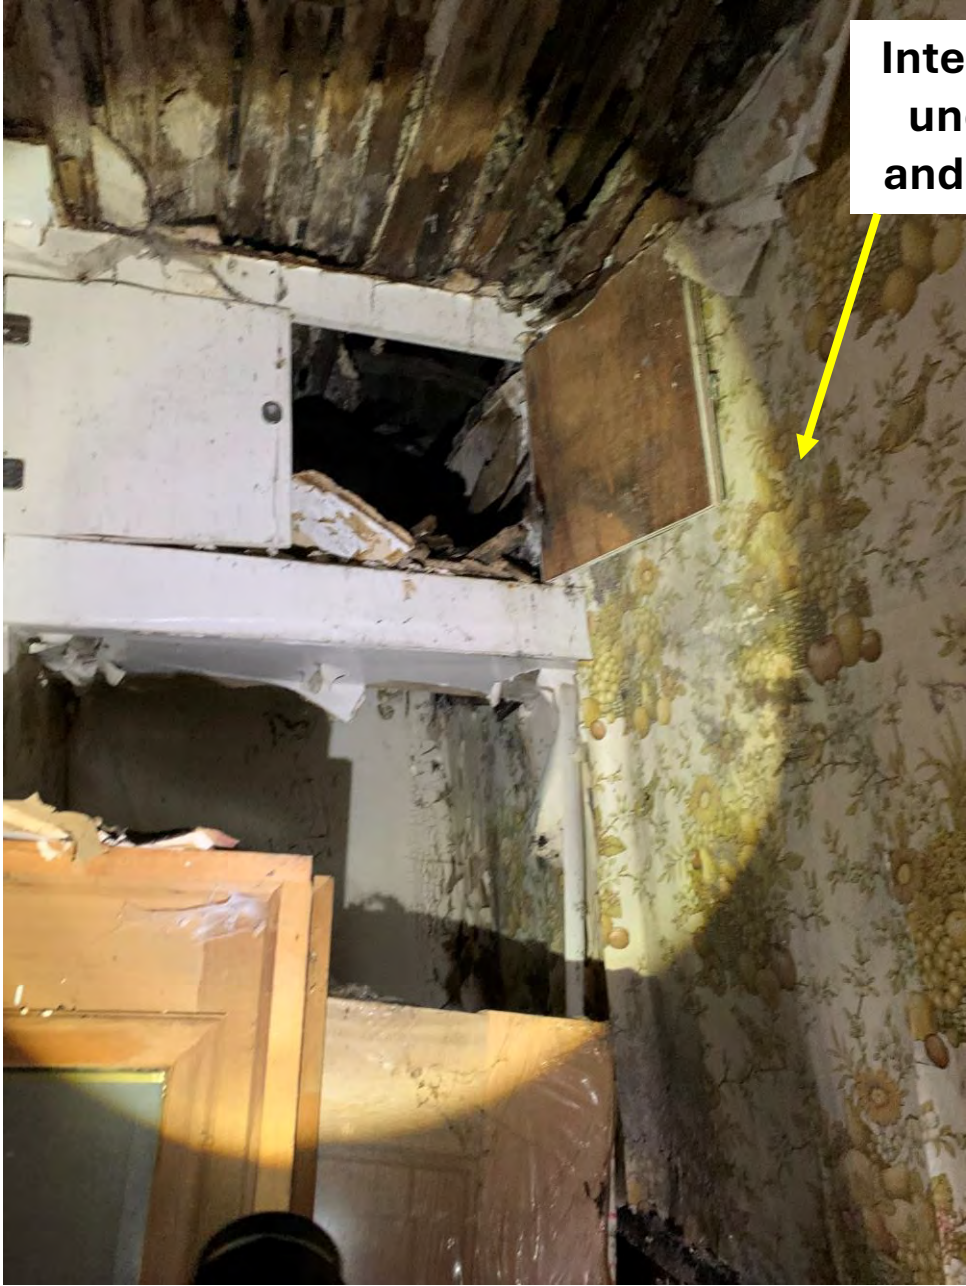
Interior wall separates unoccupied kitchen and occupied kitchen.

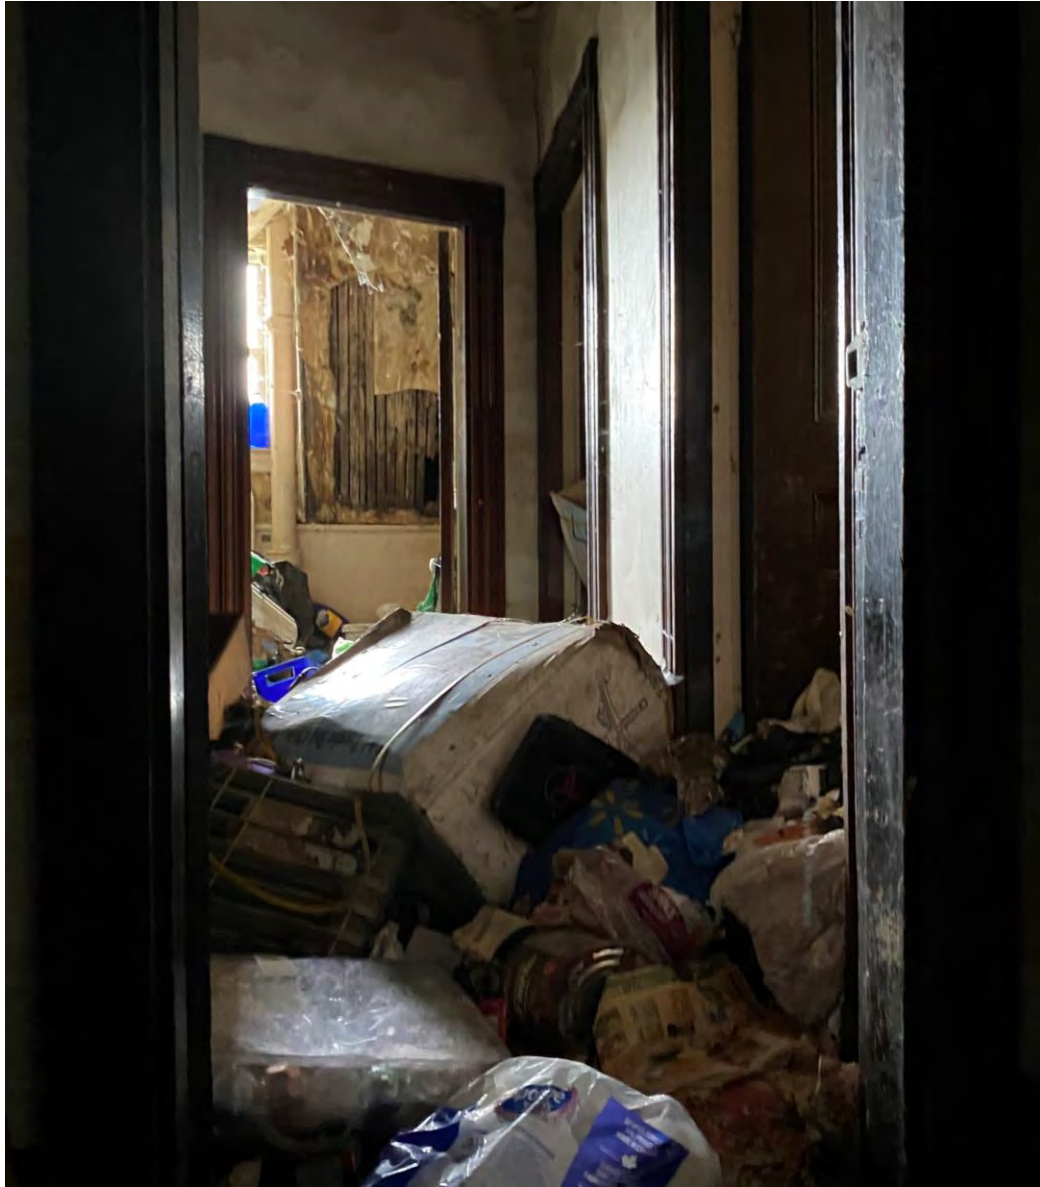
Door from the unoccupied space leads to occupied space

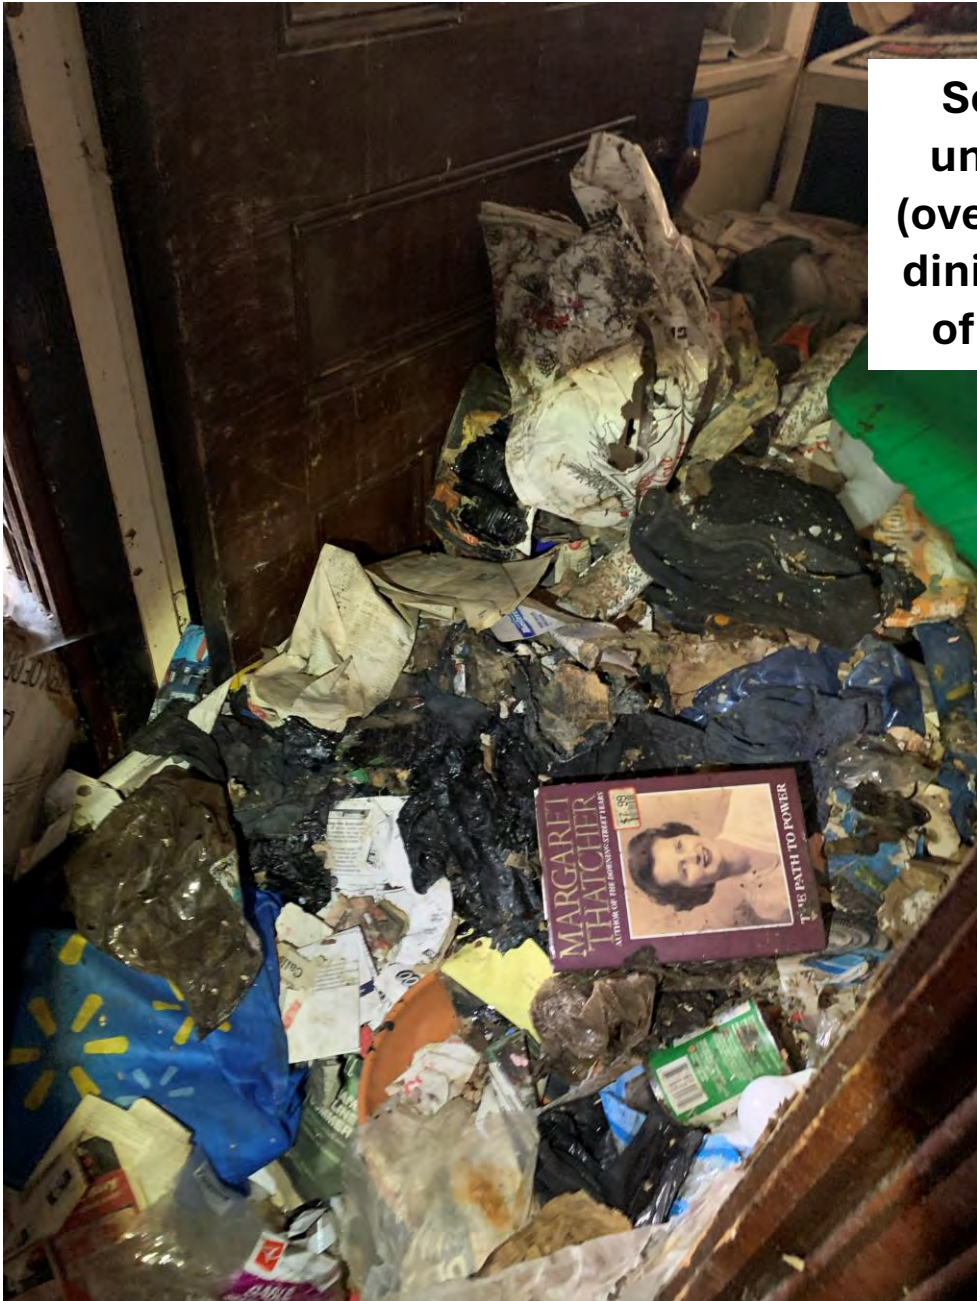
Second floor of unoccupied unit (over the main floor dining/living space of the occupied)

The interior walls and ceilings on the unoccupied side of the building are in poor condition, primarily due to significant water damage. The insulation, vapor barriers, and finishes have also failed, and multiple holes are present in the walls and ceilings, leaving the interior exposed to the elements.

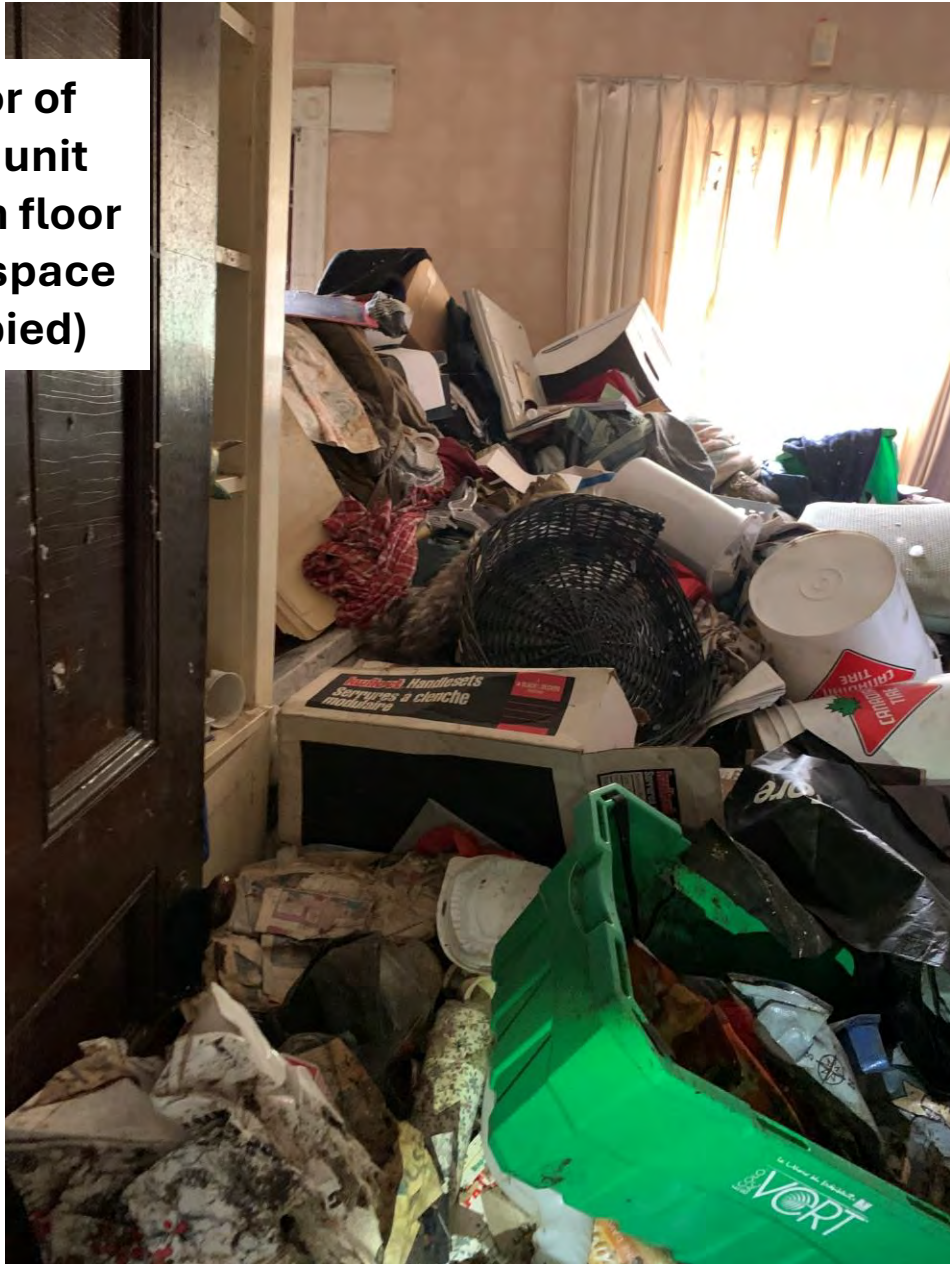
Second floor of unoccupied unit (over the main floor dining/living space of the occupied)

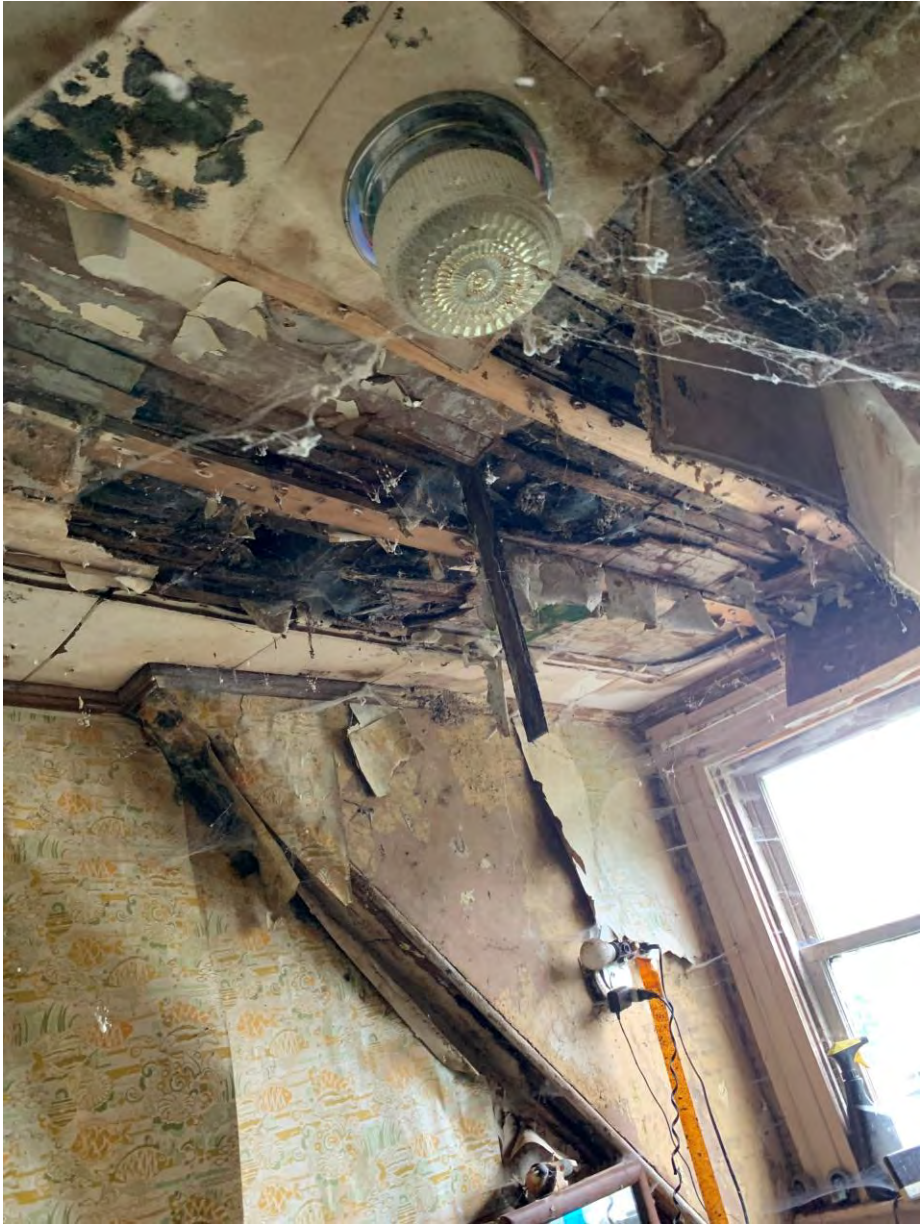
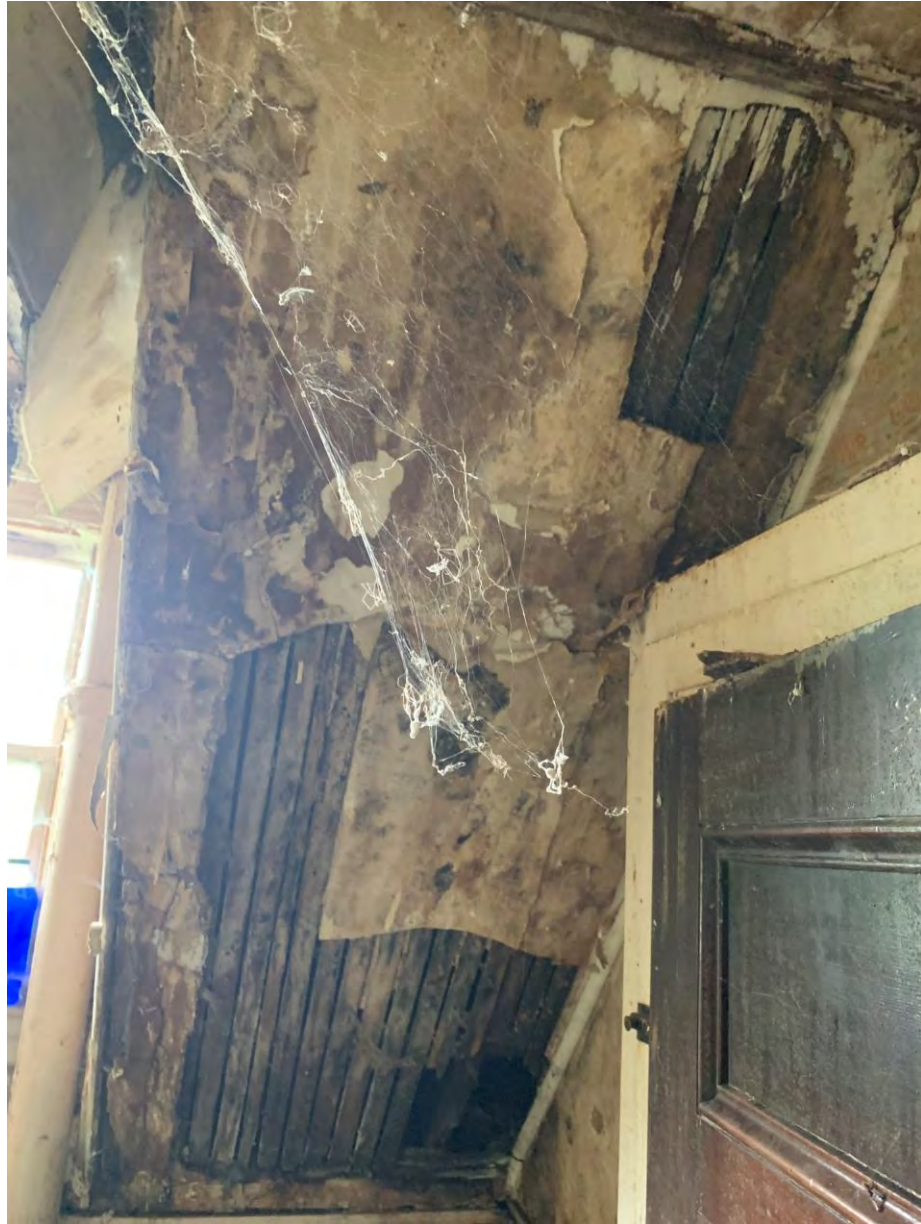
Main gear switch and fuse box in basement of the occupied unit

operational, it is at risk of failing due to weather exposure affecting the basement, which serves both units.

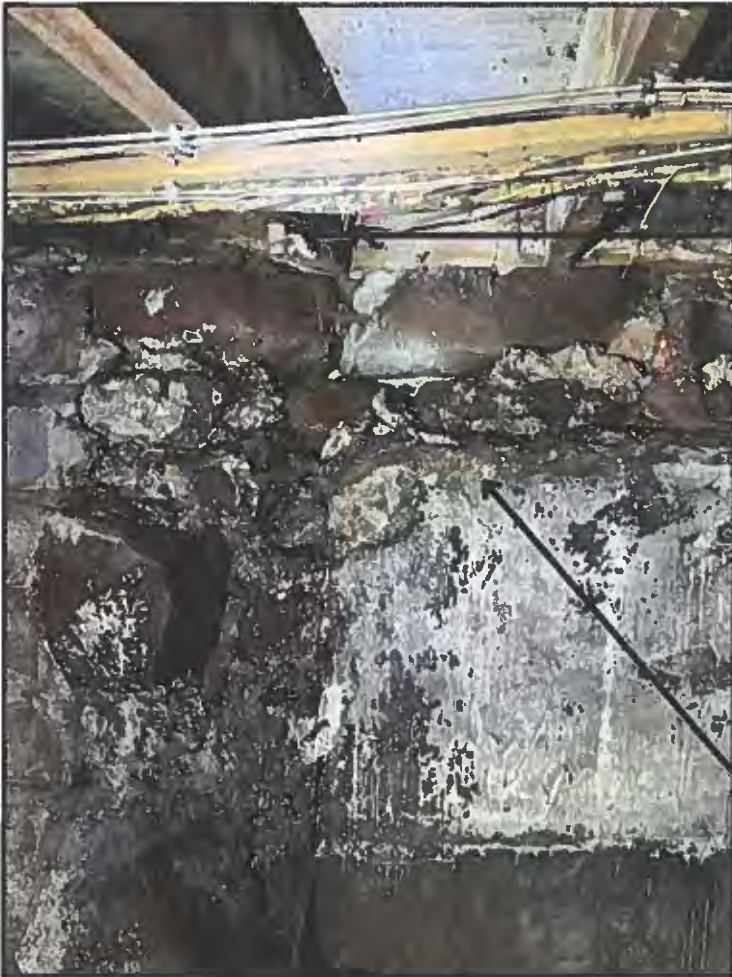
**Outdated knob
and tube wiring**

**Significant amount of holes
& loose rocks throughout
foundation**

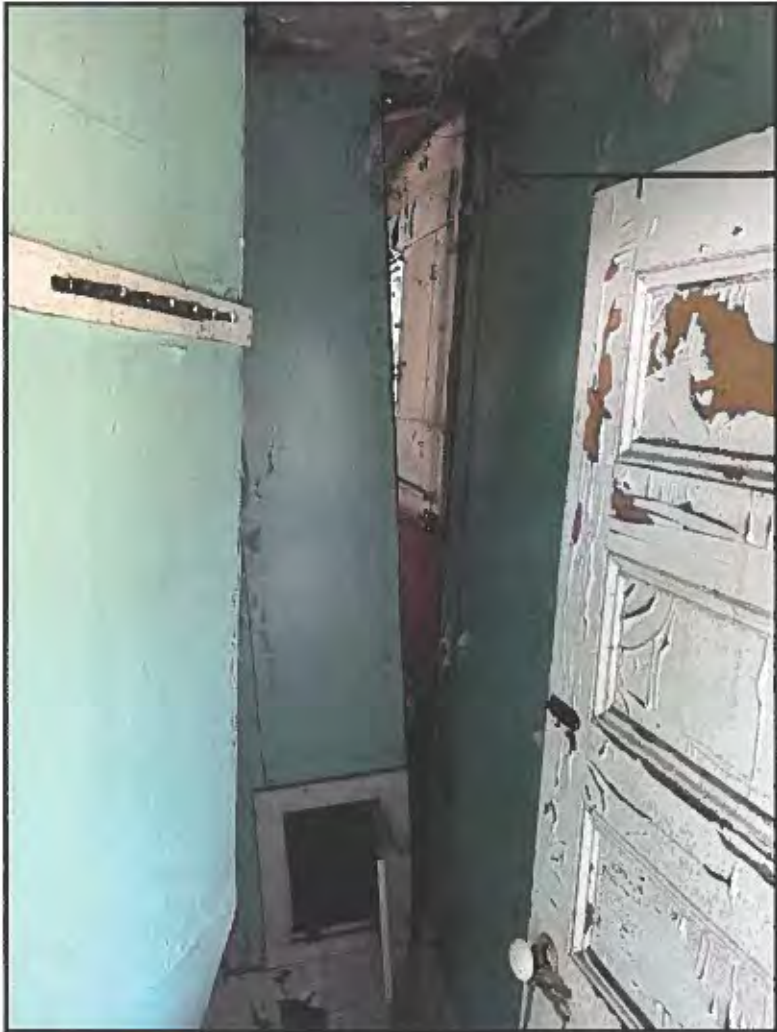
Wall actively pulling away from adjacent wall due to extreme settlement

Slanted door frame due to active settlement

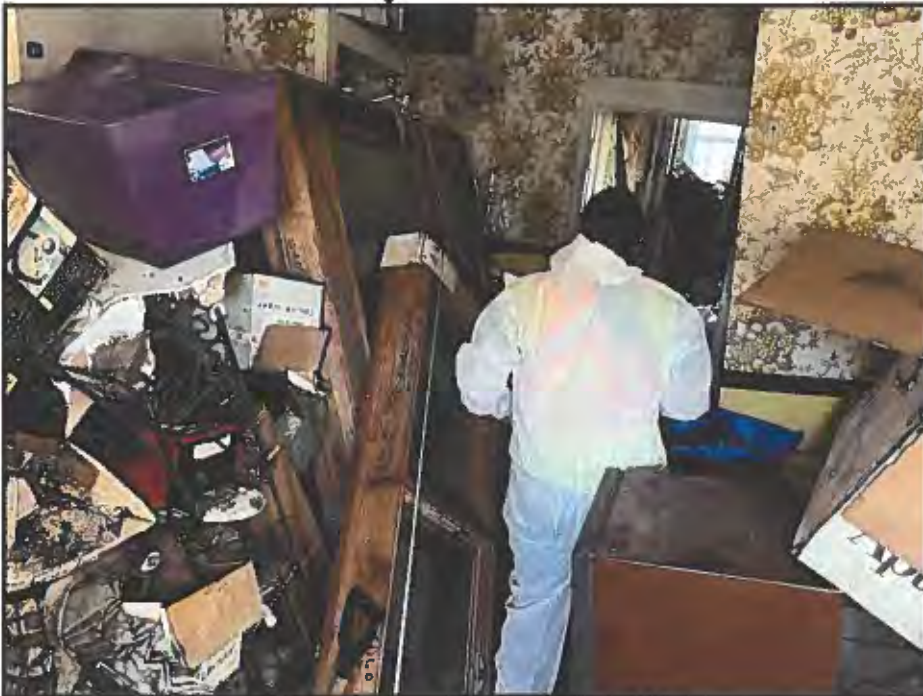
Significant amount of personal belongings and debris, some of which appear to be supporting collapsed walls and structural elements. Removal of this material may trigger further structural instability and potential collapse of the surrounding areas.

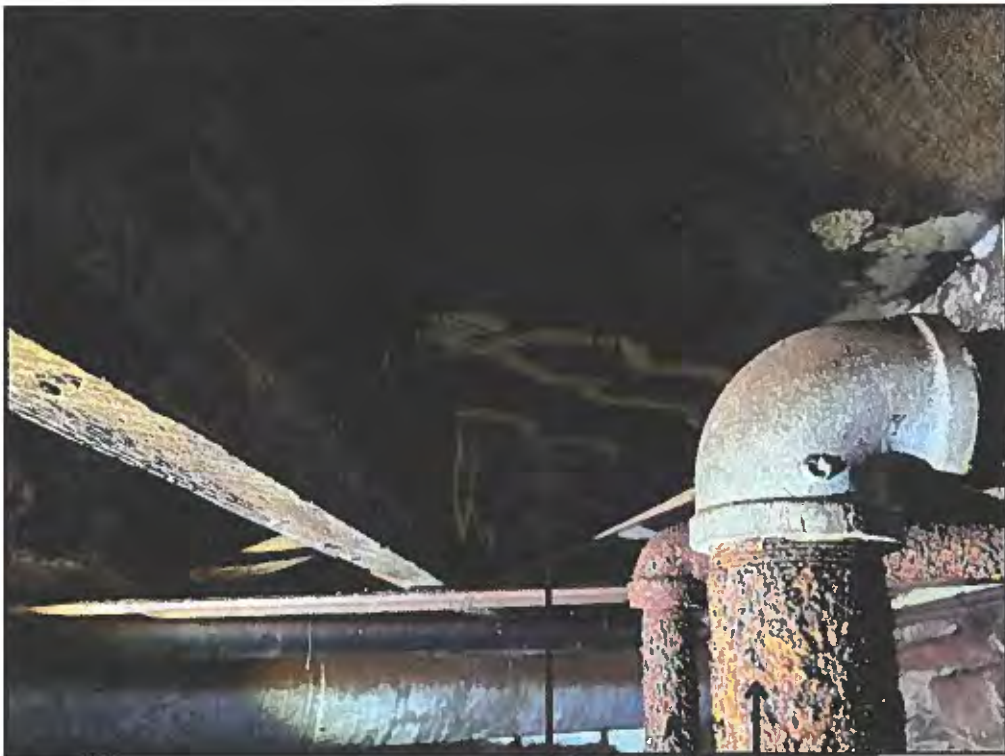
Mold present in various areas throughout the house

Outdated plumbing

Various bio hazards and mushroom growth
