Town of Amherst
Planning Advisory Committee Meeting
Agenda

RE: Recommendation of 19 Spring Street, Amherst, NS (PID: 25031626)

To: Planning Advisory Committee
From: Emily Wainwright, Dangerous and Unsightly Premises Administrator
Date: September 23, 2024
Re: Recommendation of 77 Station Street (PID 25124017)

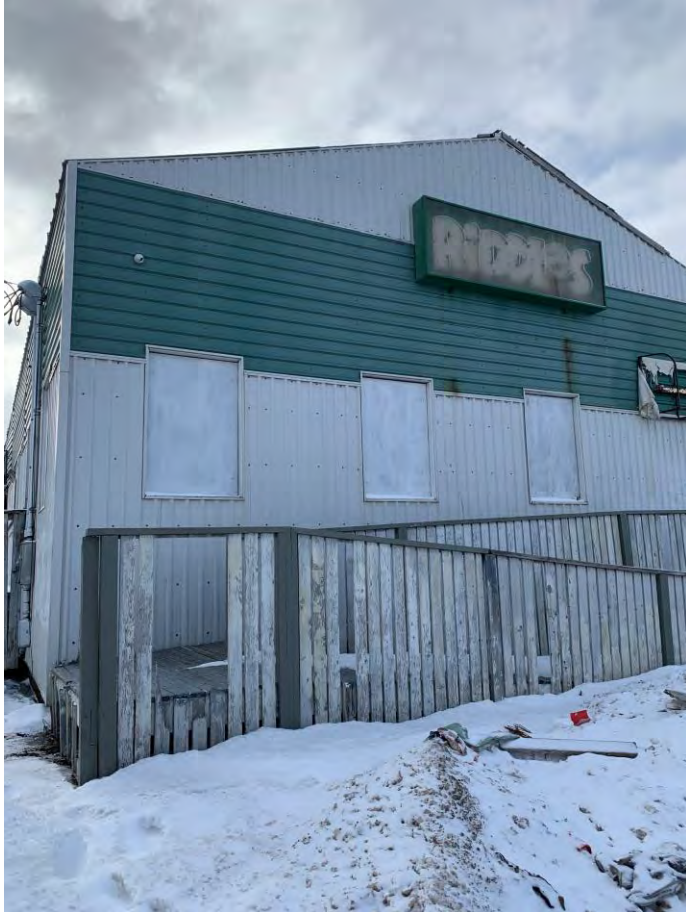
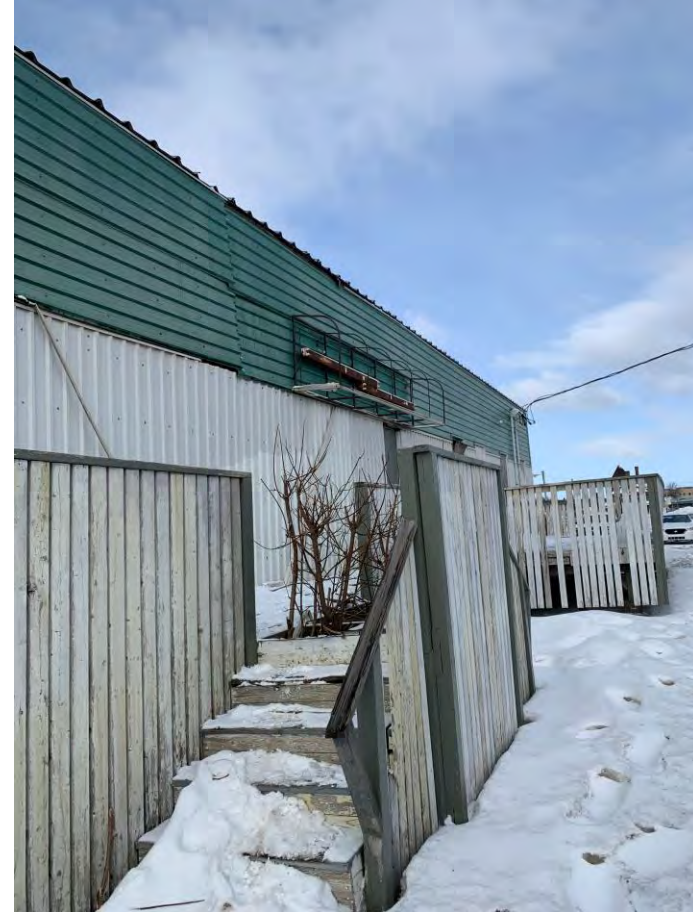
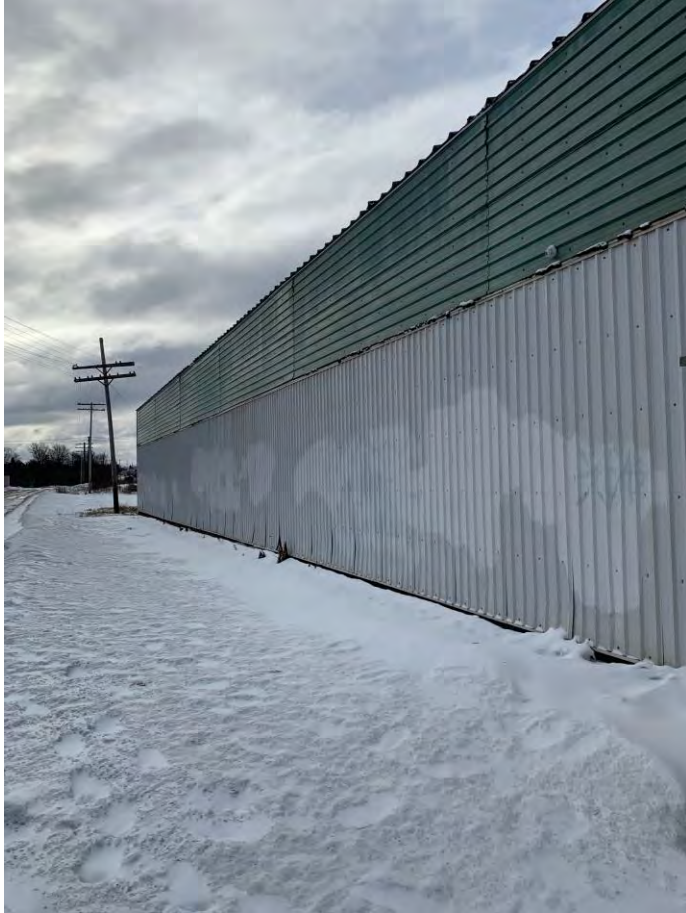
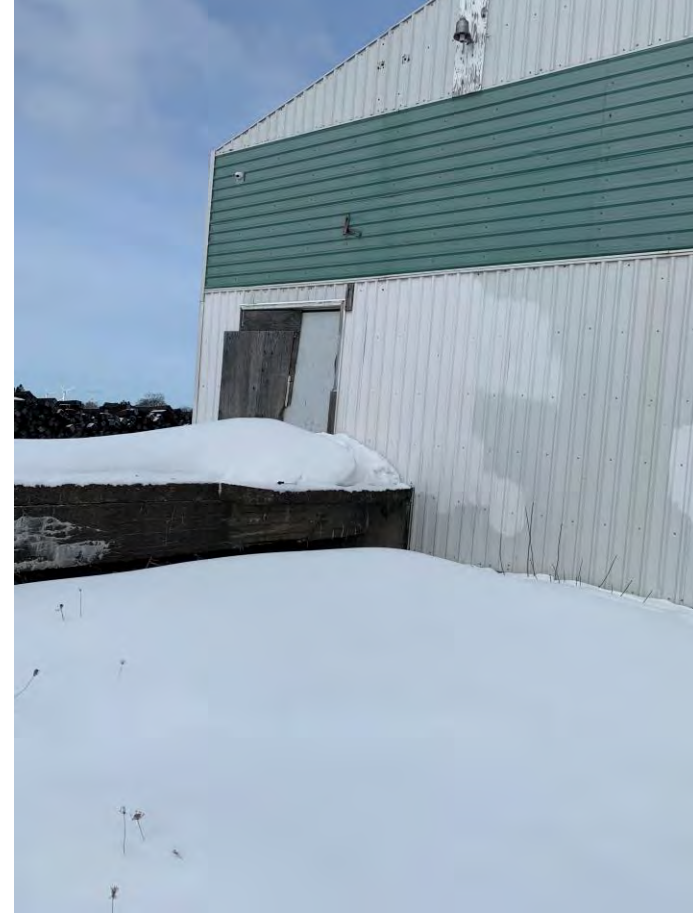
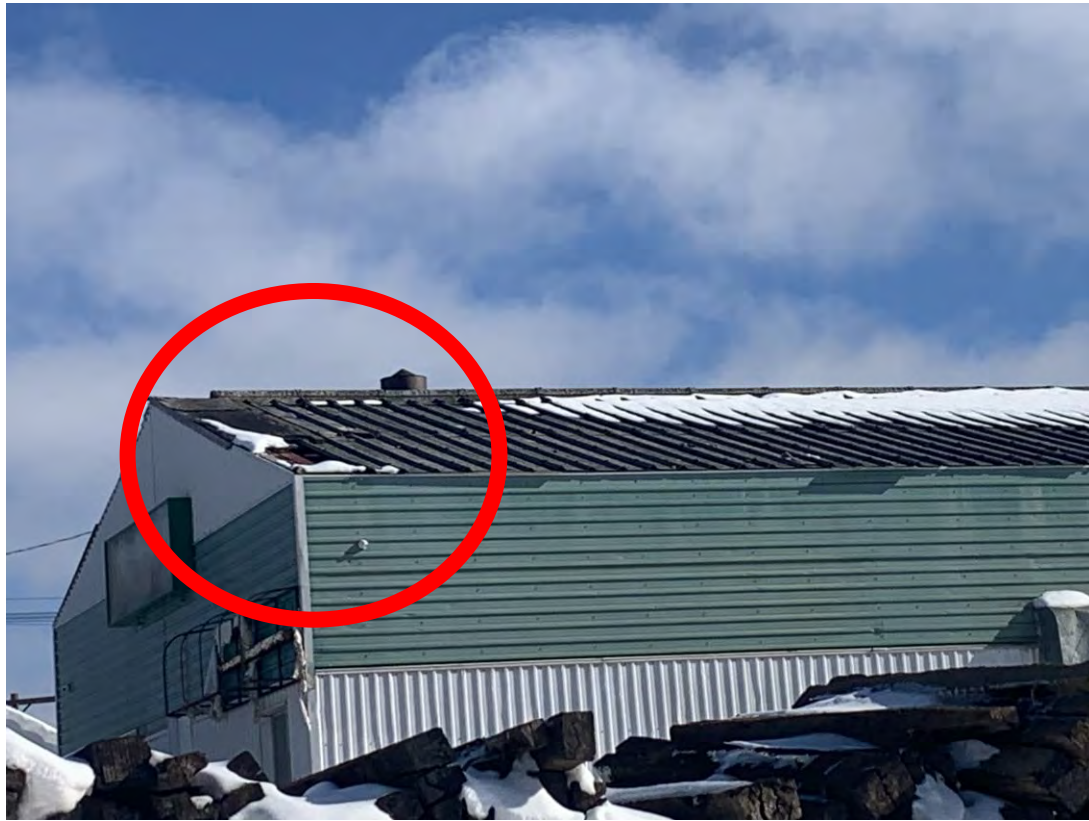
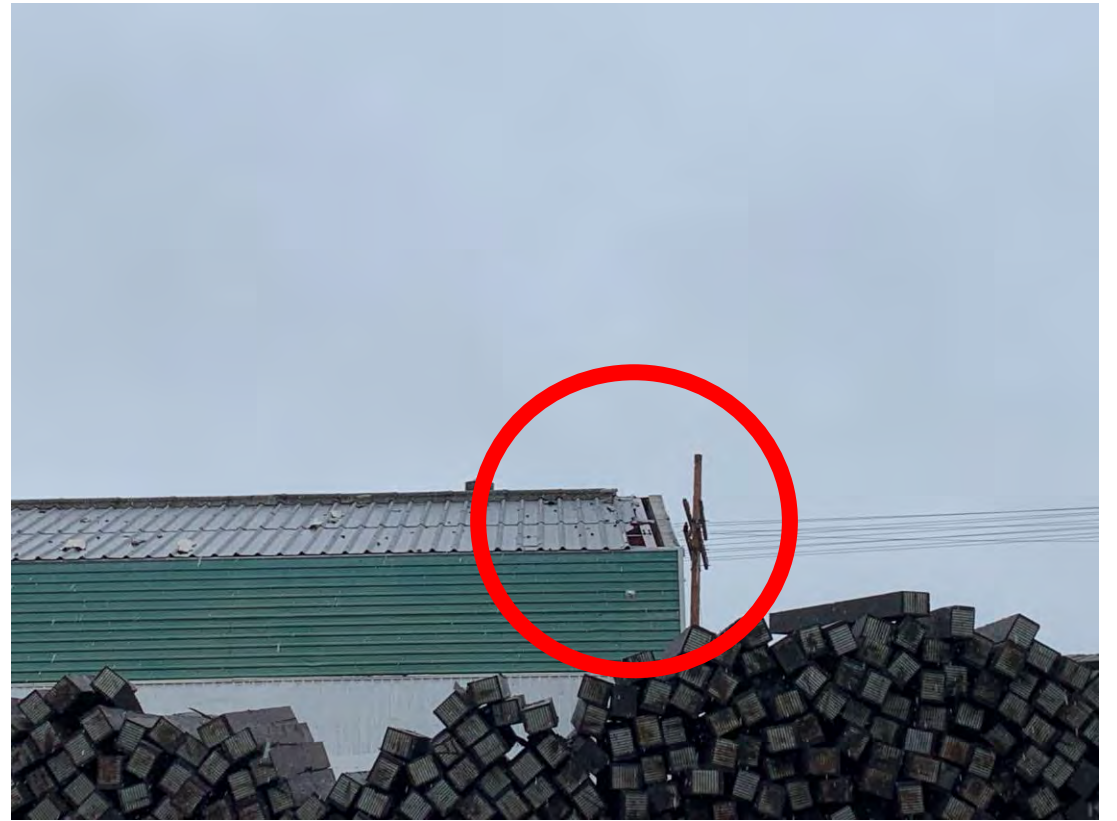
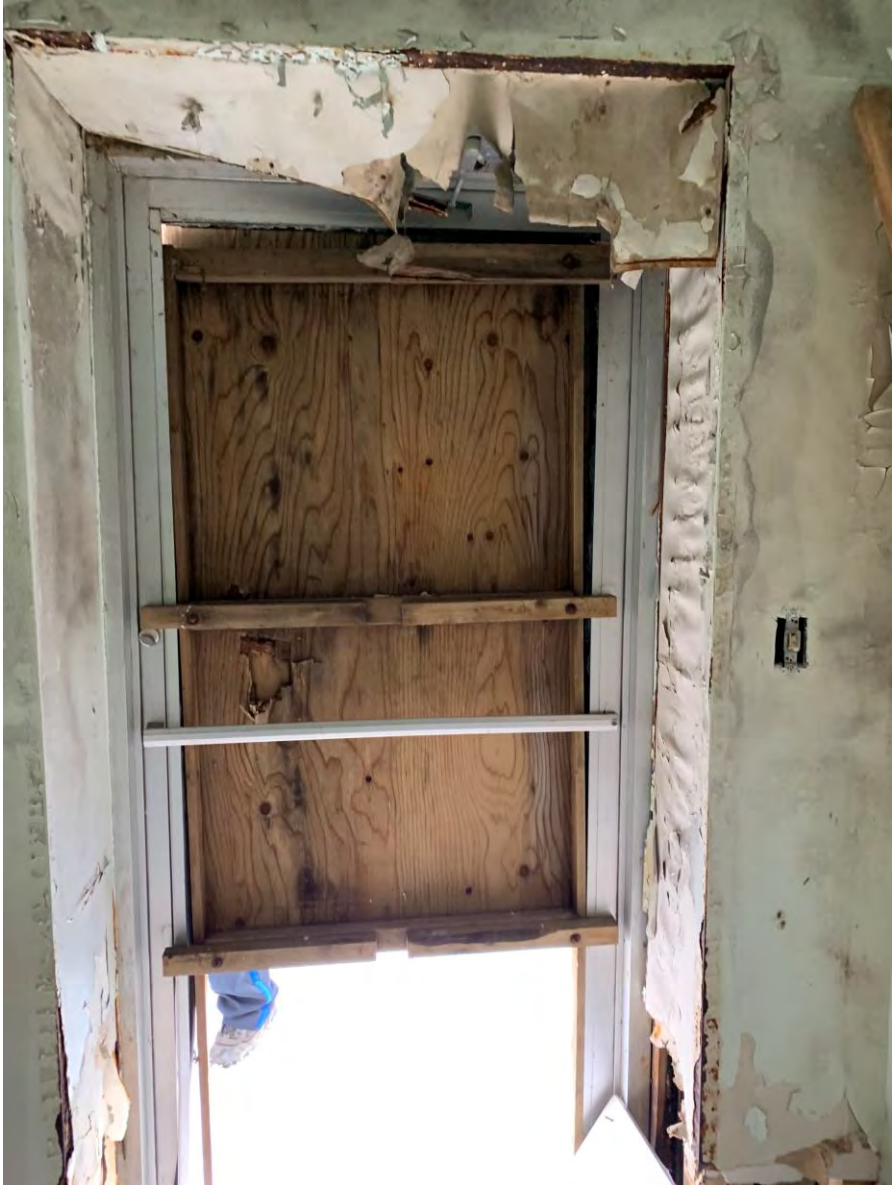
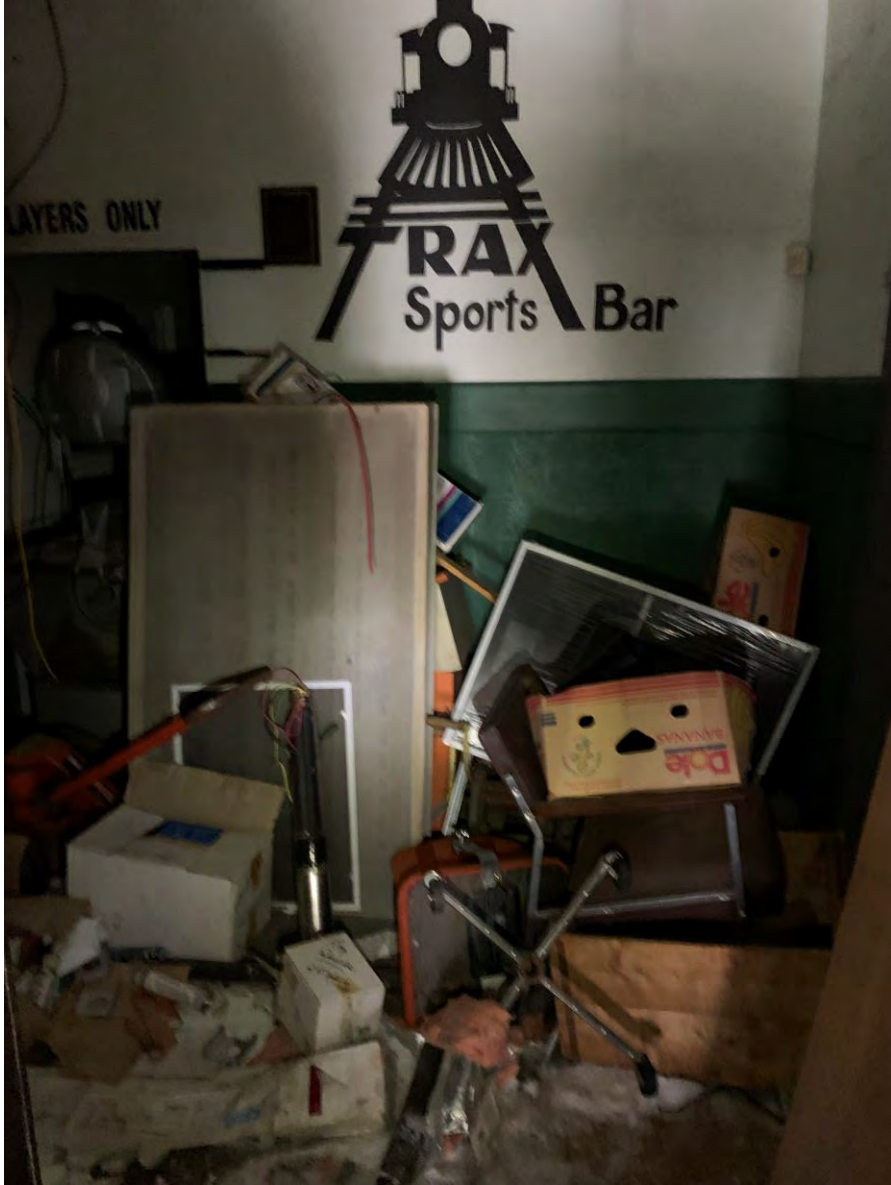
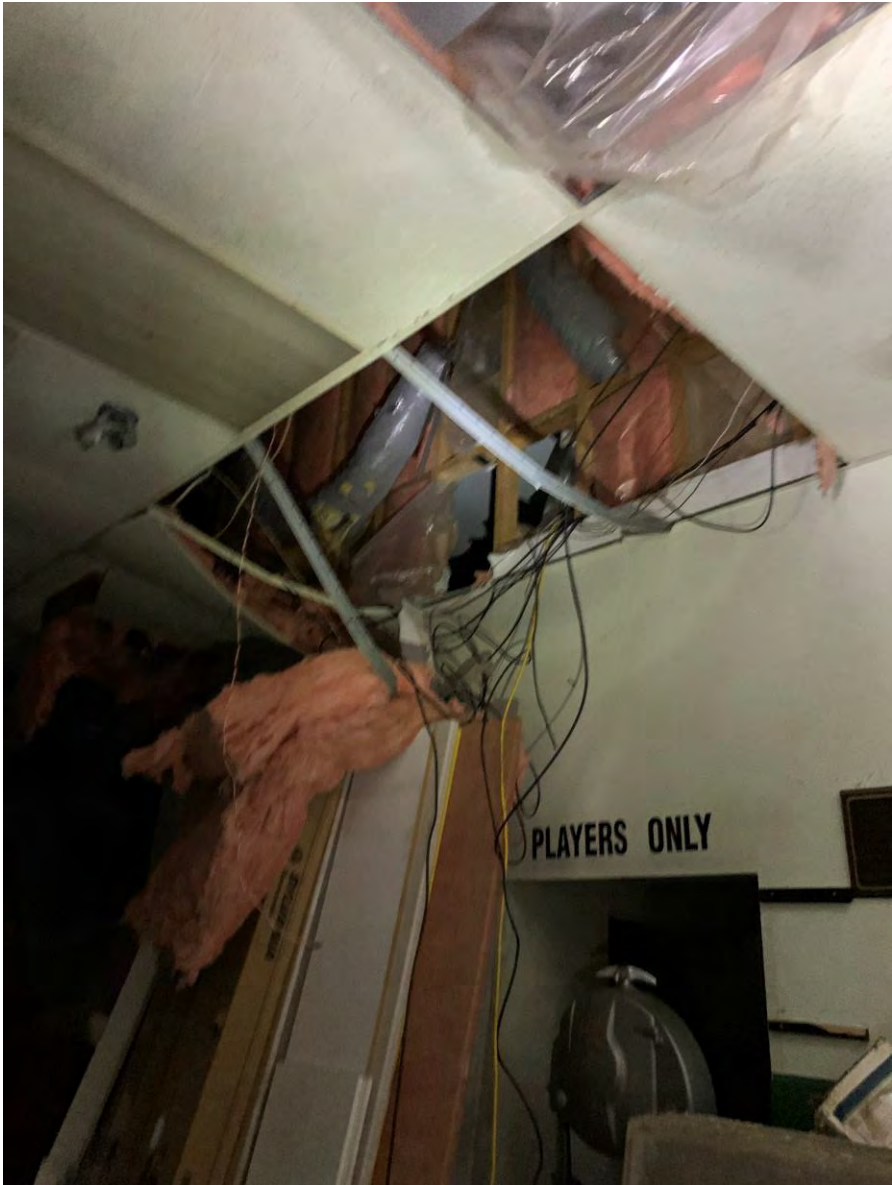
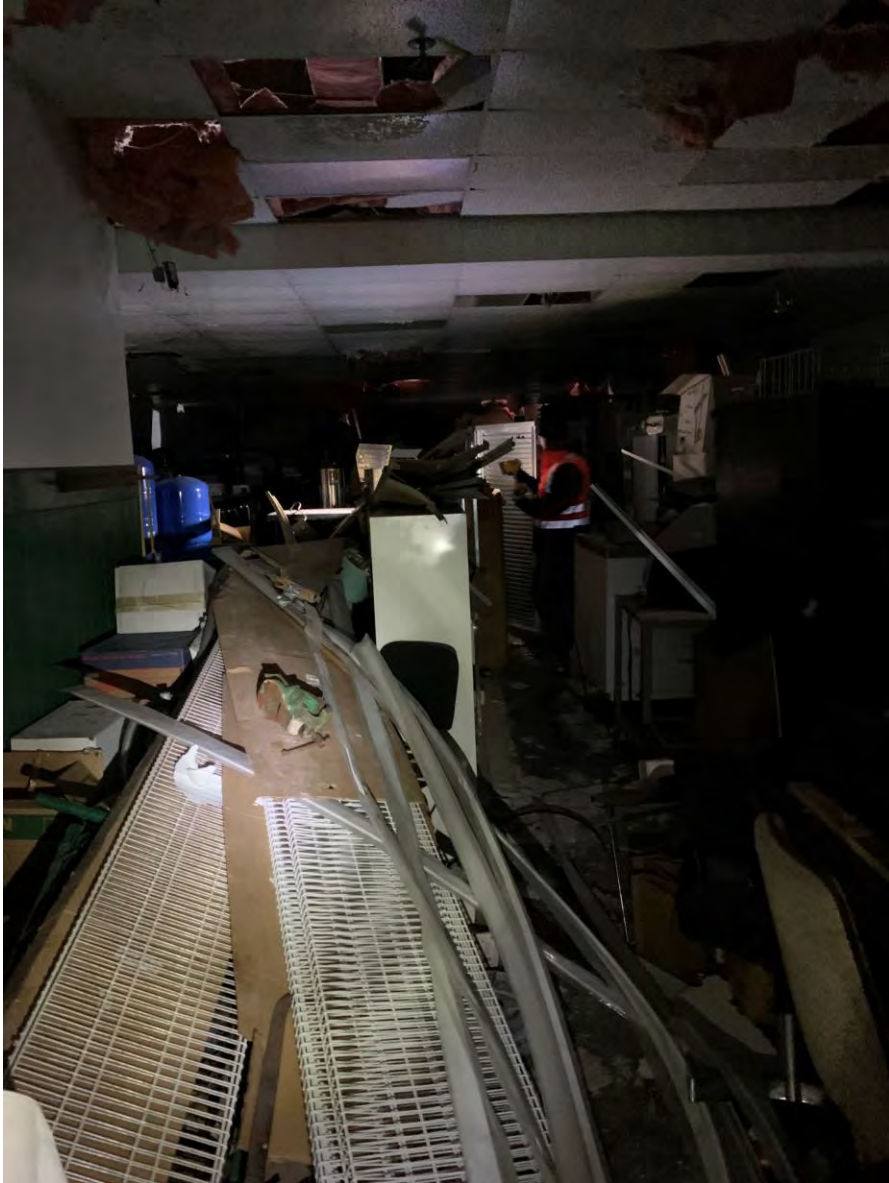
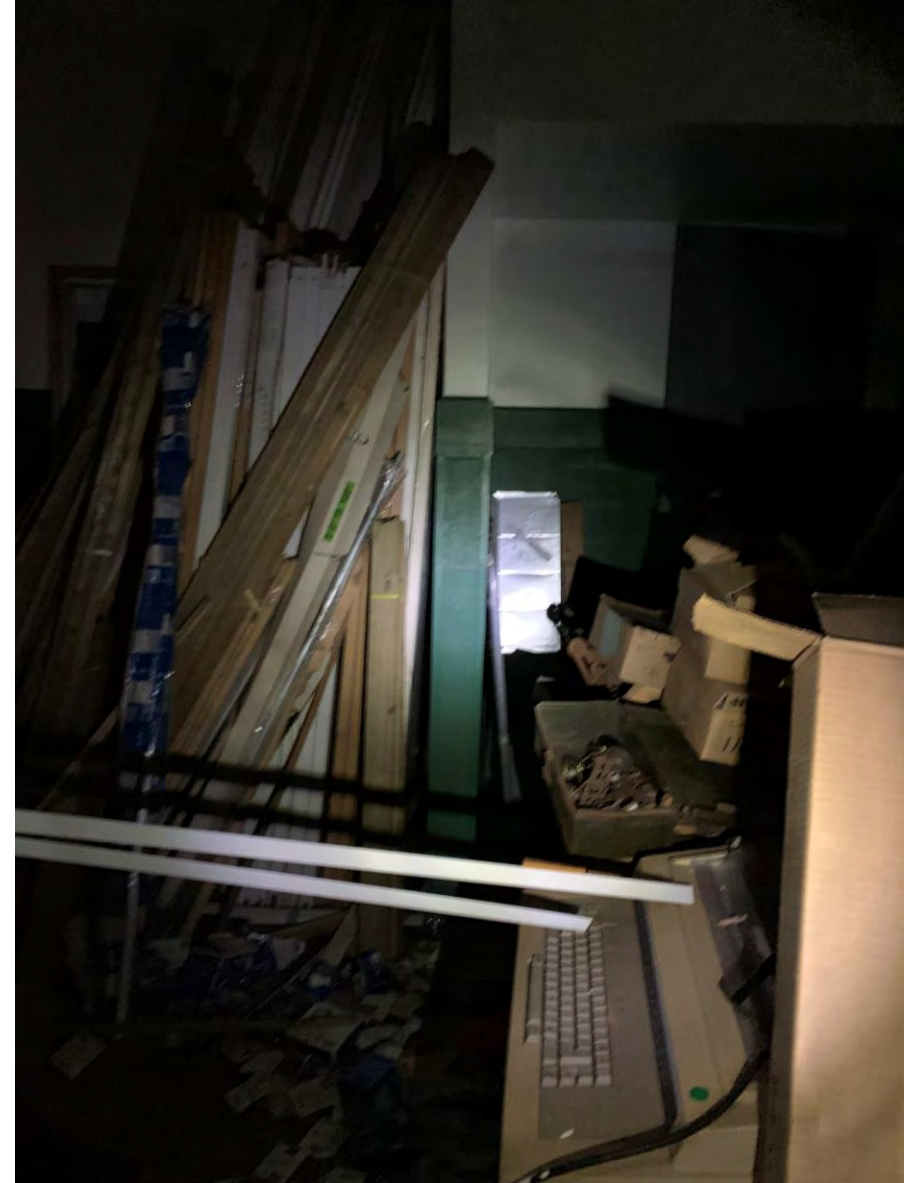
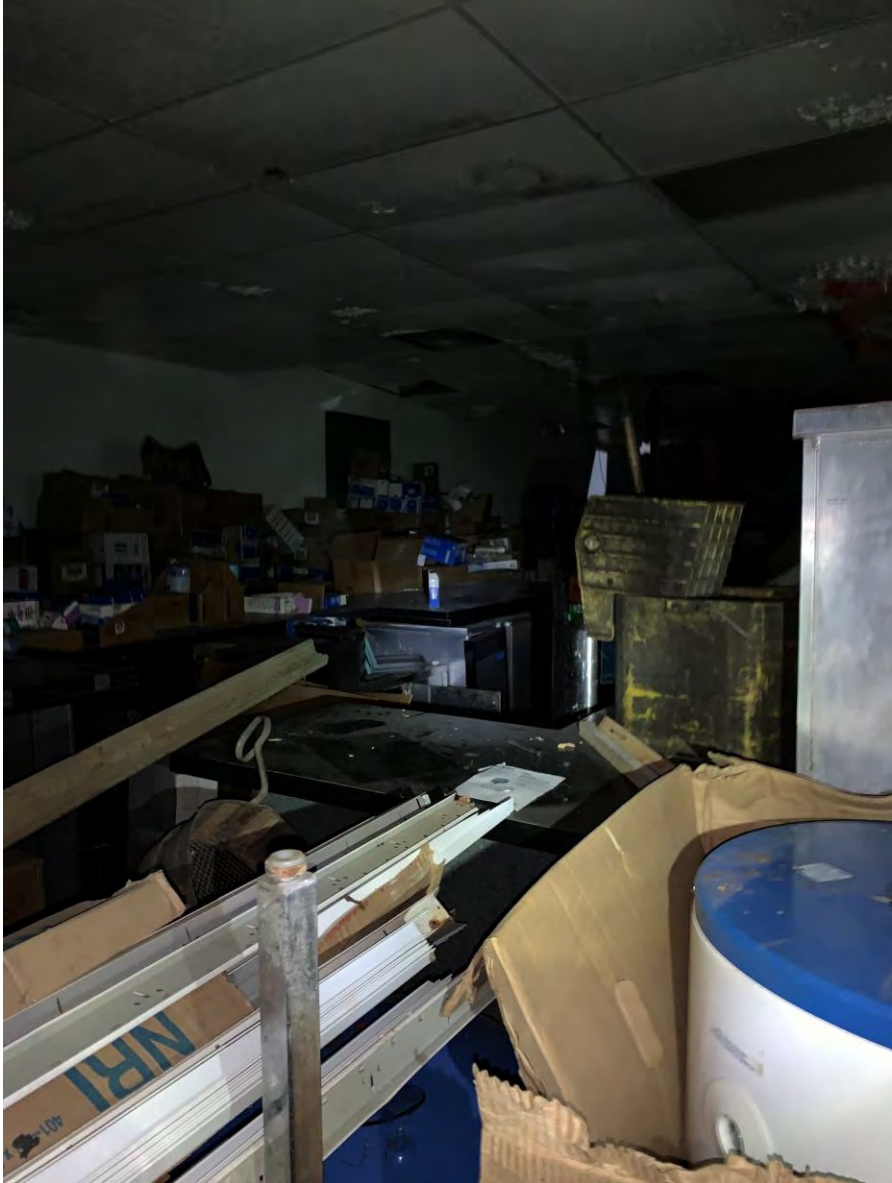
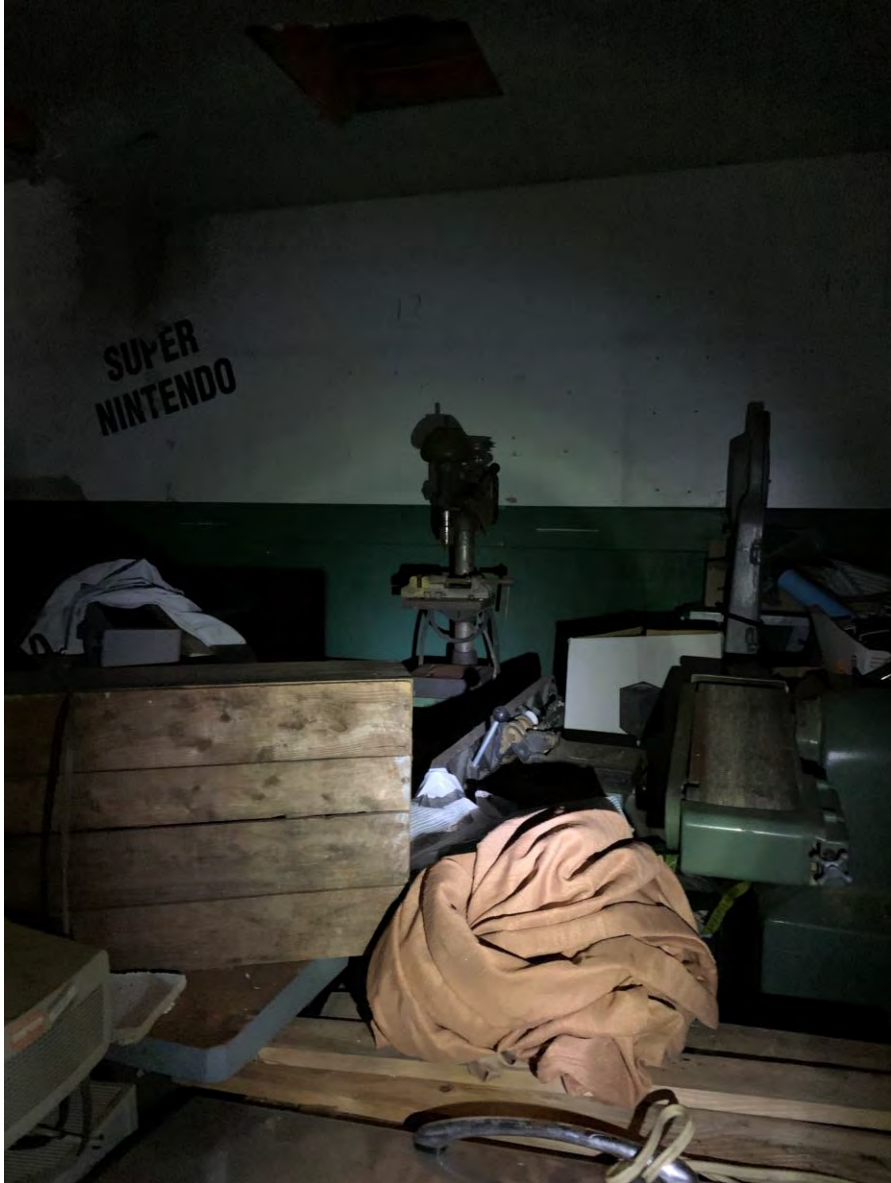
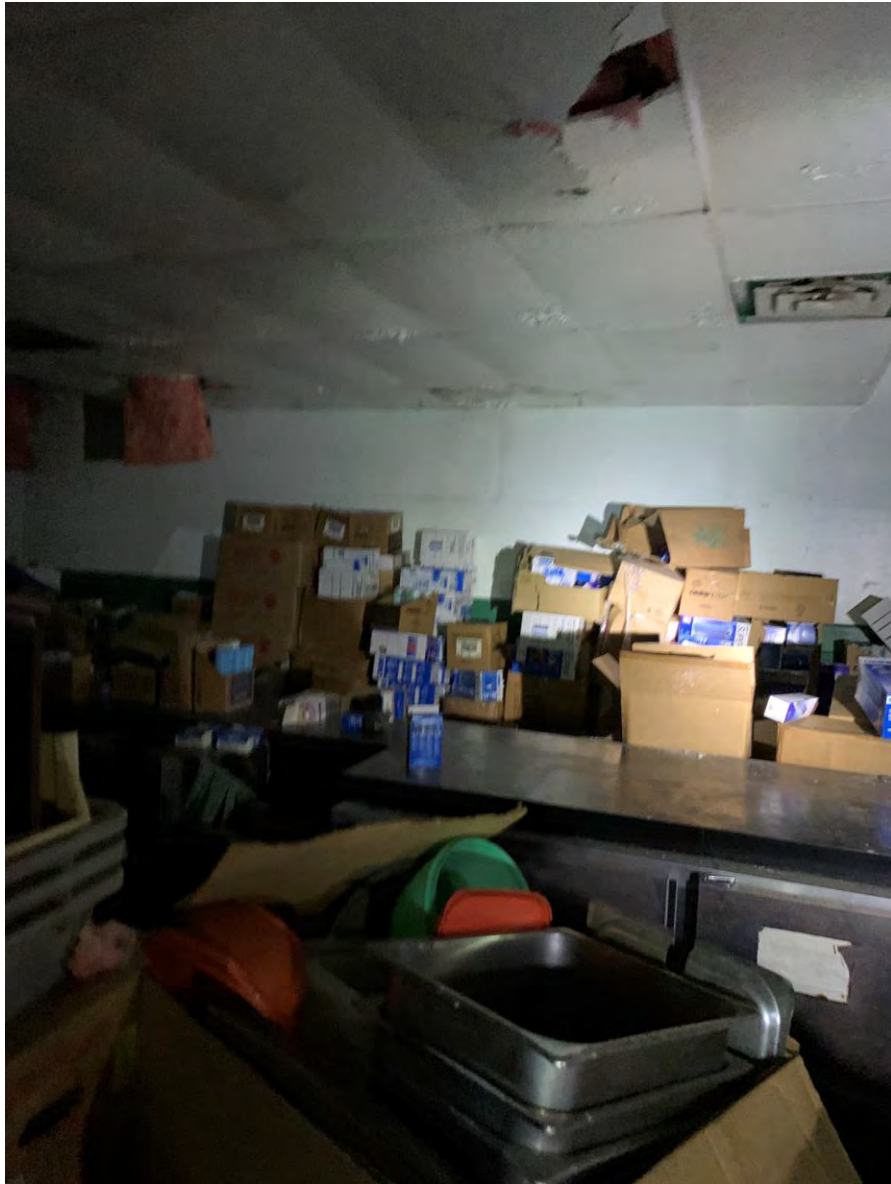
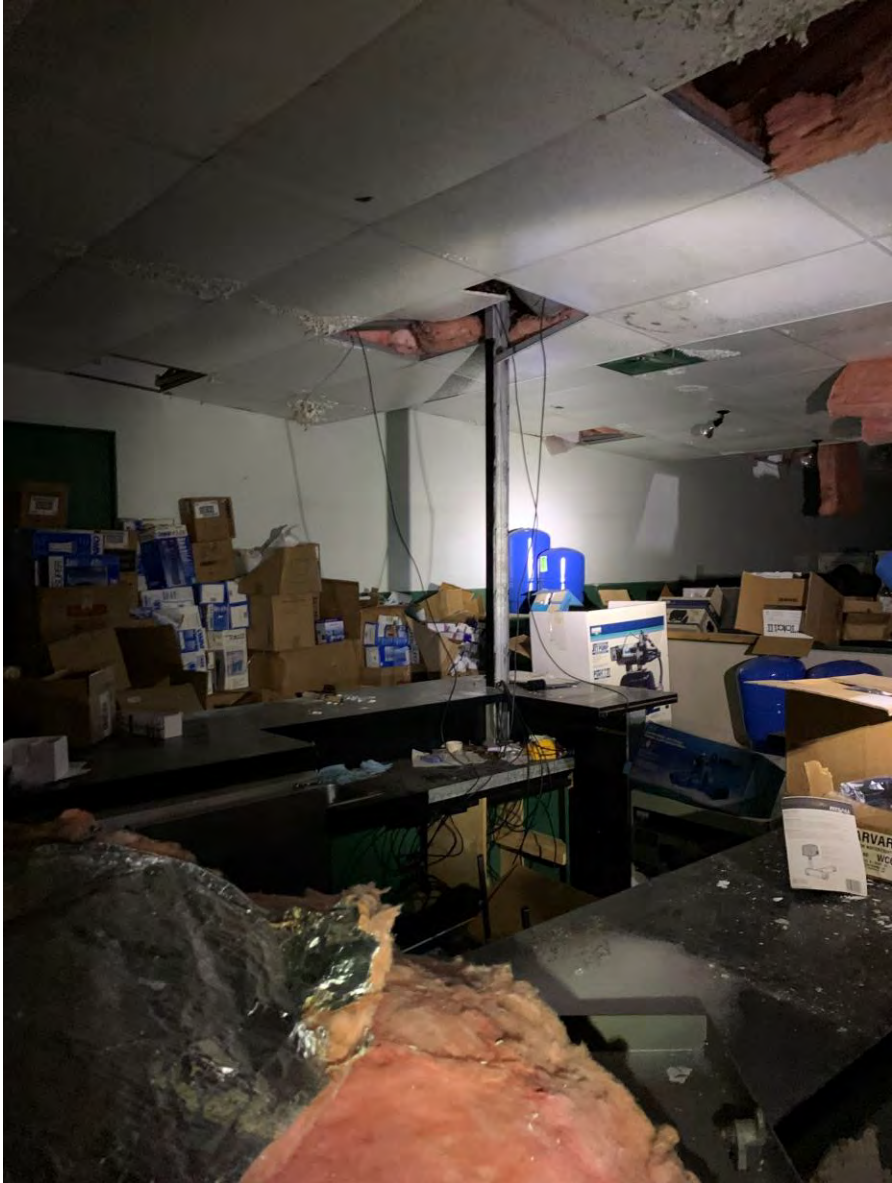
February 15, 2024 – Interior Inspection

An inspection of 77 Station Street was completed by the Dangerous and Unsightly Premises Coordinator, the Building Official II, and the Amherst Police Department on February 15, 2024. The following was noted and photographed:

- The exterior of the building is metal.
- All doors and windows have been boarded up.
- One door facing Station Street had obvious signs of repeated entry, where individuals have removed sheet metal, which was installed by public Works, as per APD.
- The roof is asbestos tile with large openings.
- Graffiti is noted on the side facing the train tracks.

- The door facing Spiring Street had been cleared of snow, signs of attempted entry.
- Clothing, blankets, and other items were found around the property.

- Signs of water damage inside the building.
- Exposed heating and HVAC system.
- Large quantities of tools, hardware, water pumps/systems, furniture, etc. make it extremely hard to navigate through the building.

- Building is made with steel beams and concrete walls.
- The electrical panel has been stripped and copper/wires have been removed.
- Used cigarettes found inside the building.

- Wood pallets inside the building seem to have been placed in a way that was being used as a ladder to gain access to the ceiling and/or roof.
- The floor of the second-floor office is rotten and very soft due to leaking roof above.

- The basement has an oil tank, which appears empty, furnace and hot water heater.
- Large accumulation of hazardous waste, including paint and stain in various conditions (possibly hundreds of cans of various waste).

- 1) That the Planning Advisory Committee order that the building and loading dock located at 77 Station Street (PID: 25124017) be demolished, with all contents removed, back fill the hole, within 90 days of this meeting, with all work to be done by the property owner. Failure by the property owner to do the work will result in the Town completing the work and sending all contents of the building to an appropriate solid waste facility, or impound yard, with all costs charged to the property owner’s tax account.

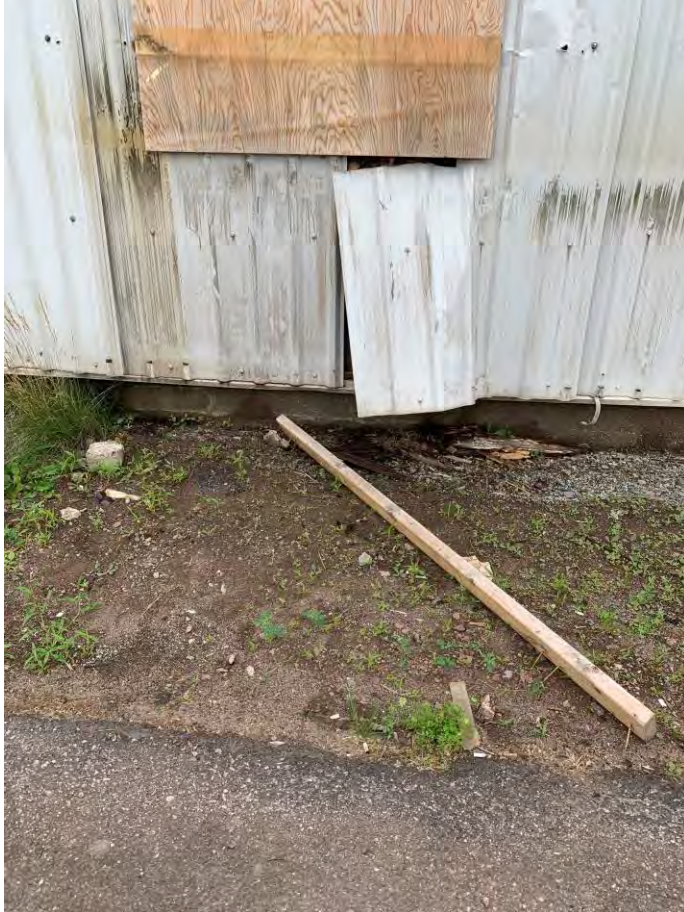
July 17, 2024 – Temporary Fencing

- An attempt was made overnight to break into the basement of the building (facing Station Street).
